Aviation Occurrence Investigation – AO-2008-008

**Engine failure – Jabiru, NT – 11 February 2008**

**VH-VAZ**

**Beech Aircraft Corporation 1900**

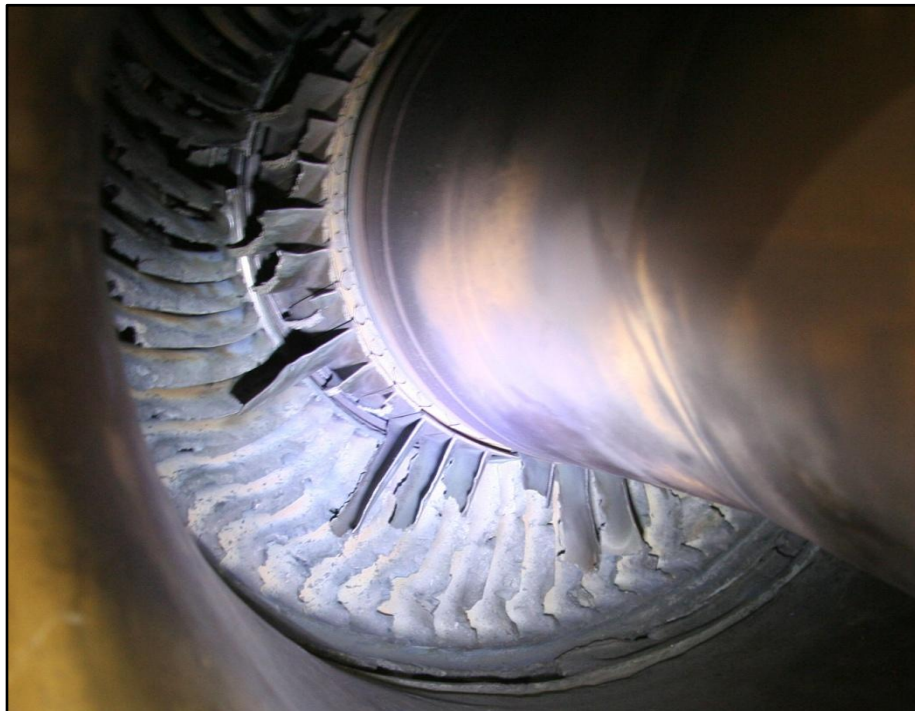
The passenger reported to the flight crew that debris, which was described as being 'white chunks of metal', was coming out of the exhaust of the left engine. Observers on the ground reported seeing a puff of smoke, followed by flames coming from the left engine. Ground personnel reported that, on inspection, there was visual evidence in the engine exhaust of catastrophic damage to the power, or hot section of the engine (Figure 1).

**Figure 1: View looking into the exhaust of the left engine**

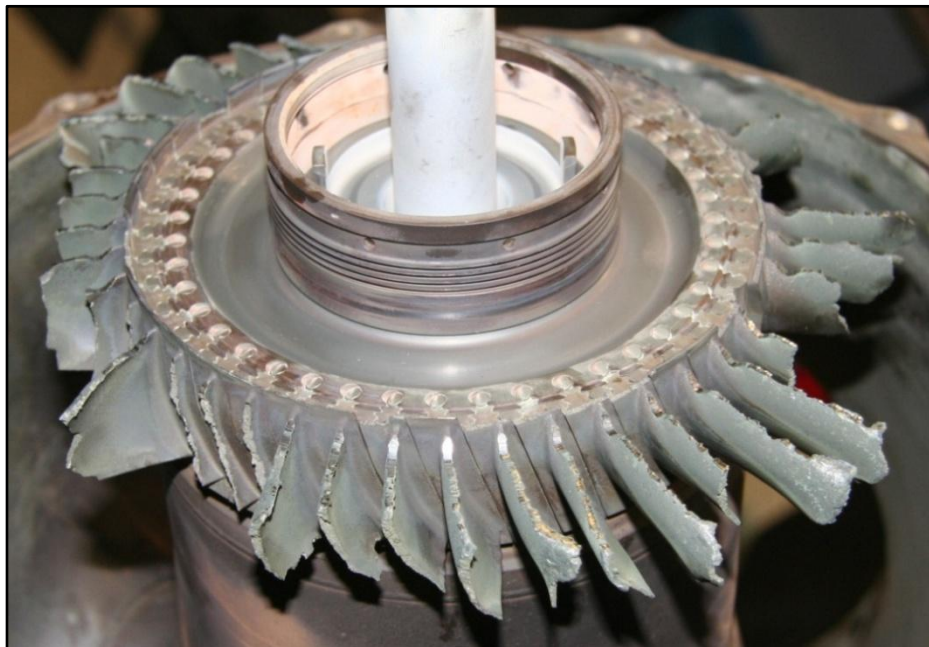
- exhaust duct
- hot section shroud housing
- hot section shroud segments
- power turbine (PT) housing
- PT first and second-stage vane rings
- PT first-stage disk blades
- PT second-stage disk blades (Figure 2).

**Figure 2: Power turbine second-stage disk**

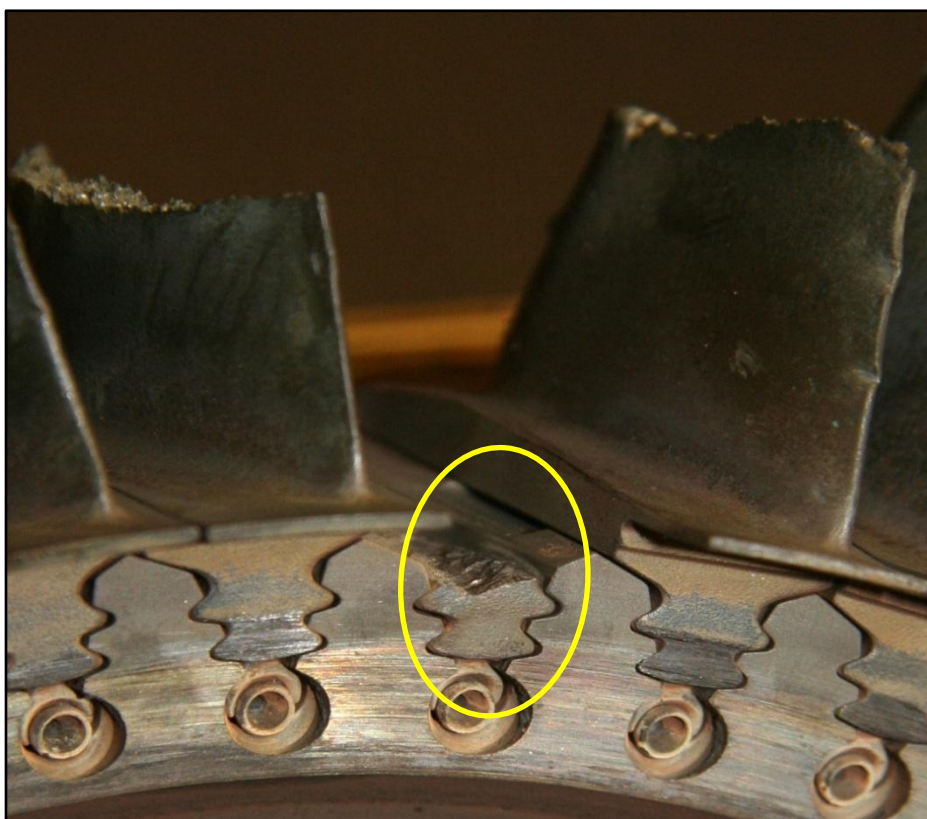
The compressor turbine disk (CT) sustained minor impact-related damage to the aft side (power turbine side) of the blades. There was minor splatter of molten metal on, and minor damage to, the leading edges of the CT disk blades. One PT second-stage blade had separated from the assembly below the blade platform (Figure 3).

**Figure 3: Power turbine second-stage turbine blade close up**

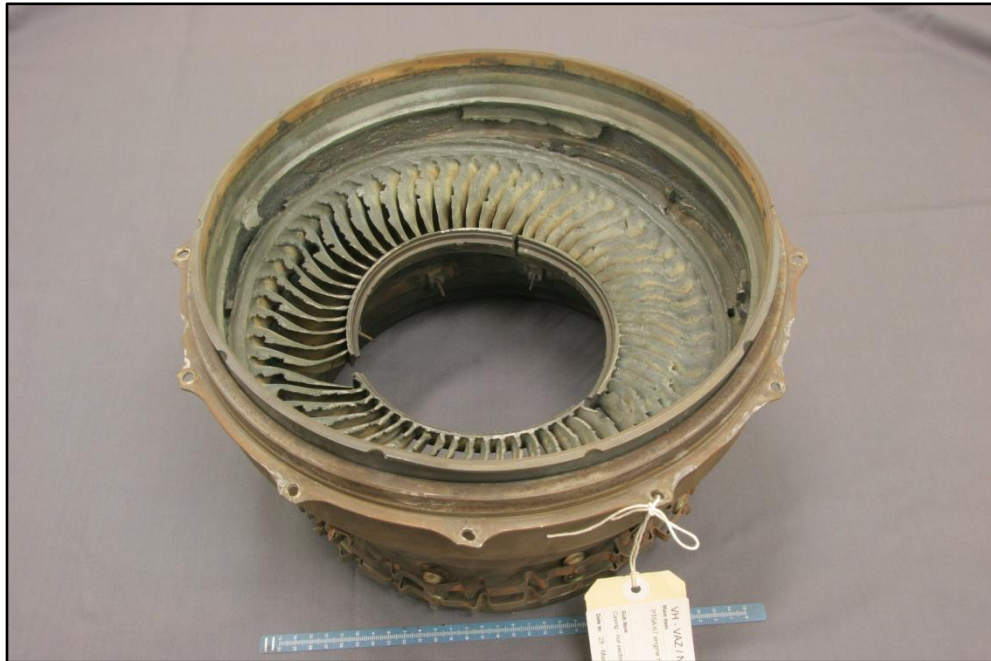
**Figure A1: Power turbine stator housing (down-stream end upward)**

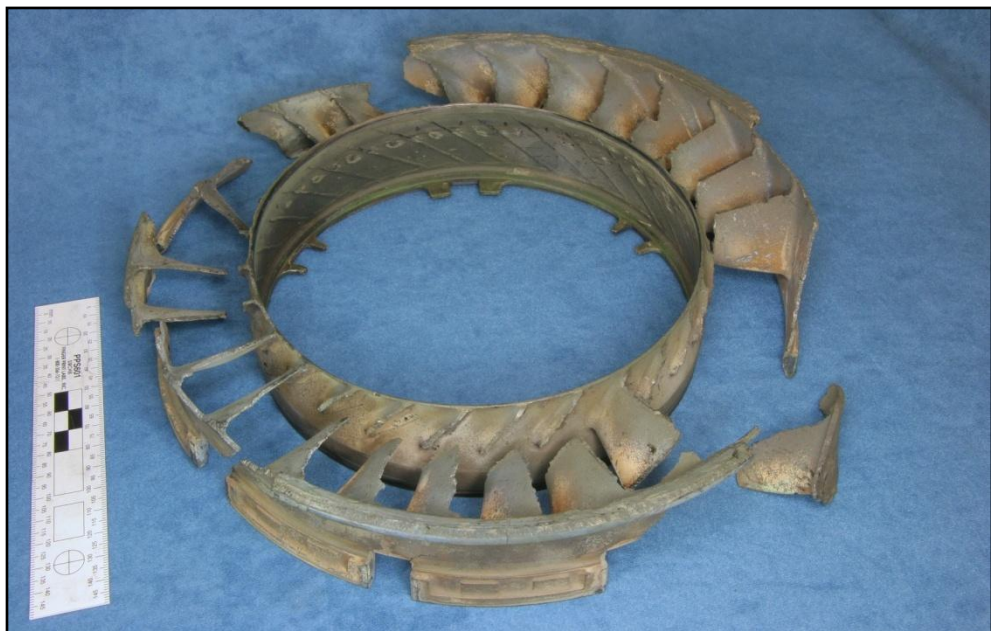
The first-stage power turbine stator ring had sustained extensive structural break-up, with multiple fractures through the vanes and outer shroud sections (Figure A3). Five main ring segments and many smaller fragments were removed from the engine, with the interstage baffle plates separated from the stator ring bore. Visually and under the stereomicroscope, all principal fracture surfaces exhibited similar irregular and lightly oxidised characteristics – consistent with the fractures occurring during the breakdown event. Some evidence of pre-existing cracking was noted at the recess corners within the outer ring (Figure A4), however none of the cracks showed features suggesting their direct contribution to the break-up of the ring structure. The vane aerofoil sections, although damaged from the breakdown event, did not show any other evidence of advanced service-related degradation.

**Figure A3: Main power turbine stator ring sections – as received**

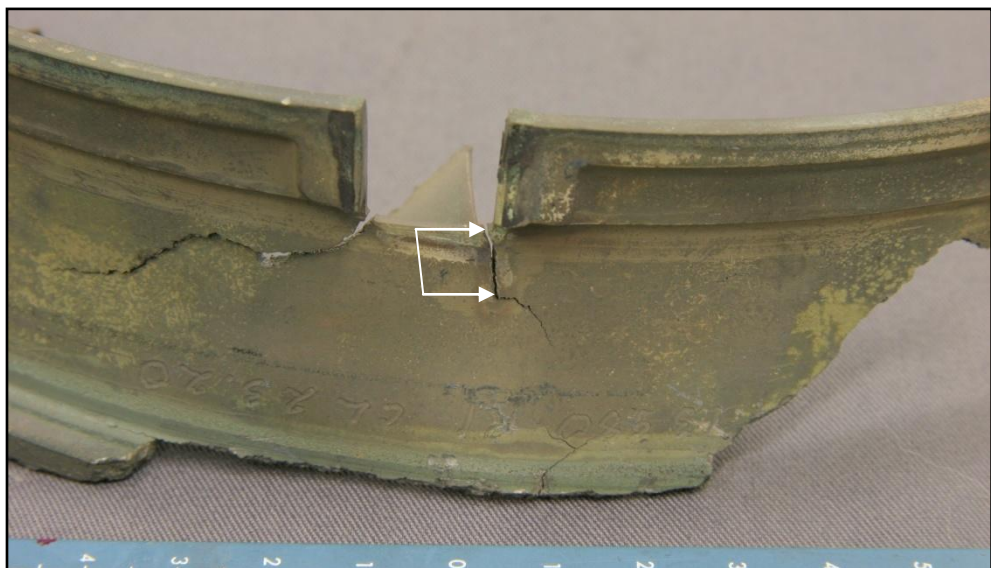
**Figure A4: Suspected prior cracking of stator ring – between arrows**

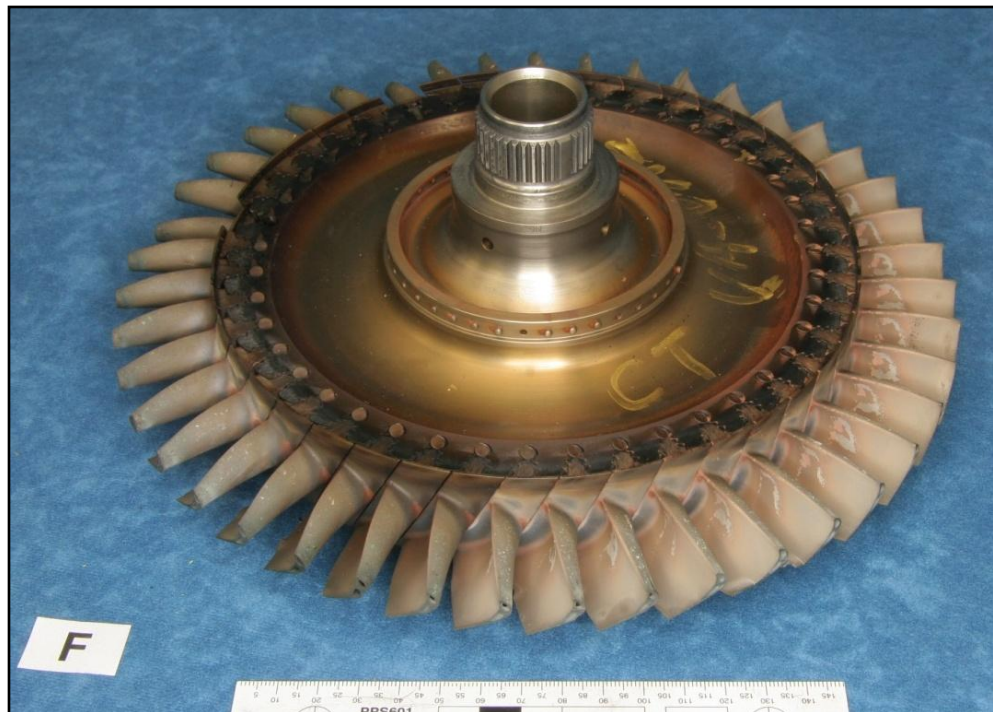
The engine compressor turbine disk and blade-set presented comparatively low levels of mechanical damage, when compared against the downstream turbine components. The leading edges and tips of all blades showed only light debris impingement effects and adherent products (Figure A5). The blade trailing edges, around approximately one-half of the disk circumference, showed localised impact, deformation and edge breakage at the mid-span position (Figure A6). The regularity and form of the damage suggested a hard-body foreign object impact mechanism (Figure 7), with the absence of similar leading-edge damage suggesting the ingress of the material from a downstream location.

**Figure A5:Upstream face of the engine compressor turbine disk**

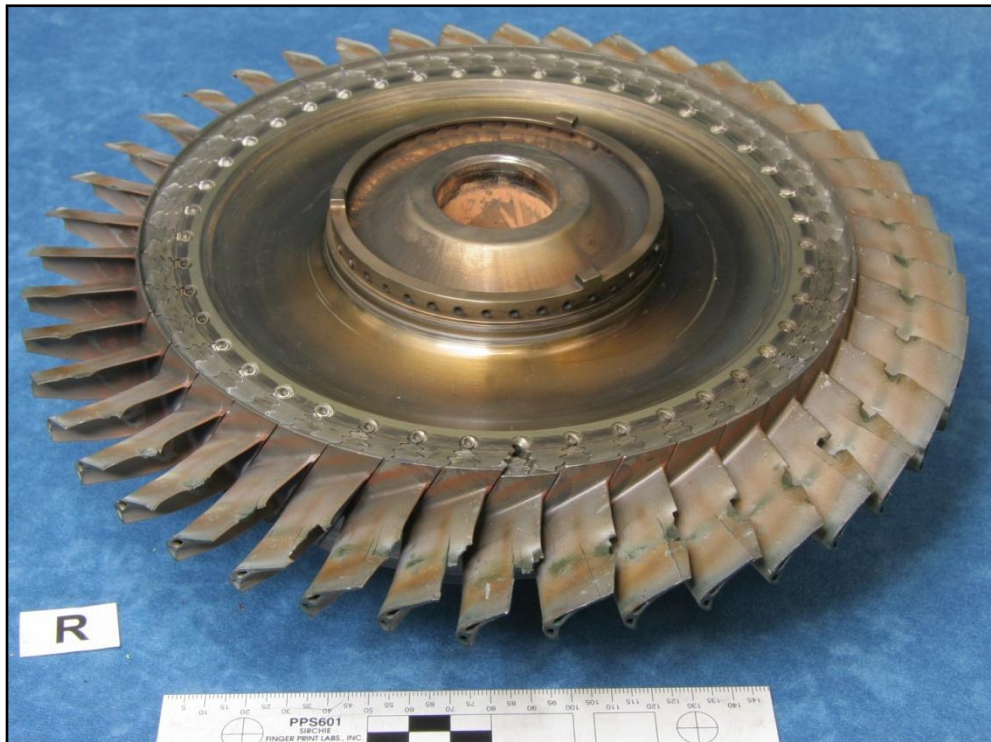
The downstream face of the compressor turbine disk showed evidence of light rotational contact against the stationary outer periphery of the interstage baffle or the inner rim of the power turbine stator ring.

**Figure A6:Downstream face – compressor turbine disk**

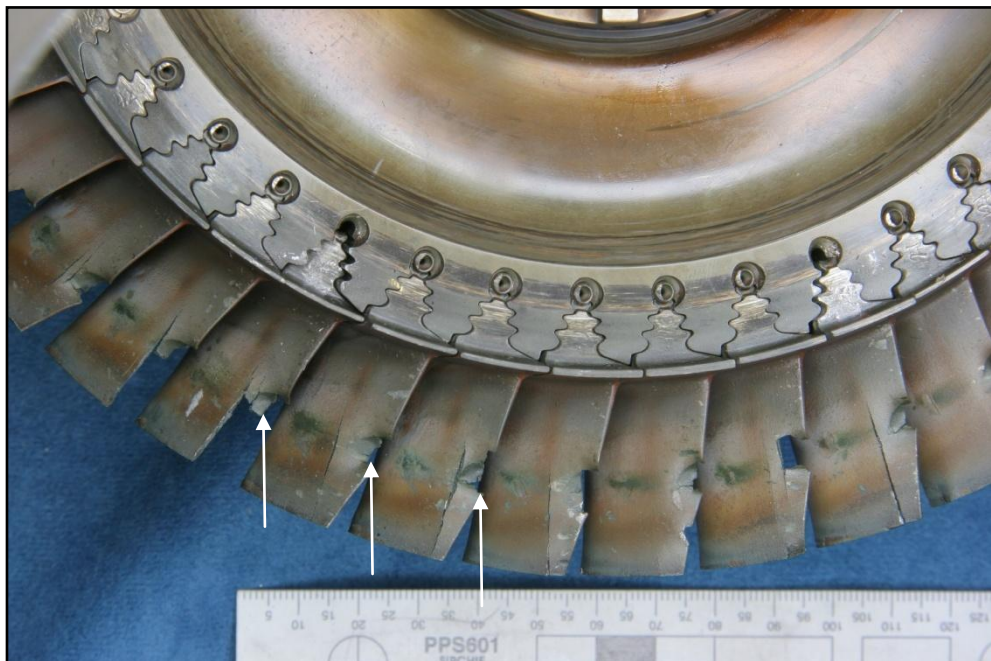
**Figure A7: Suspected hard-object impact damage to compressor turbine blade trailing edges (arrowed)**

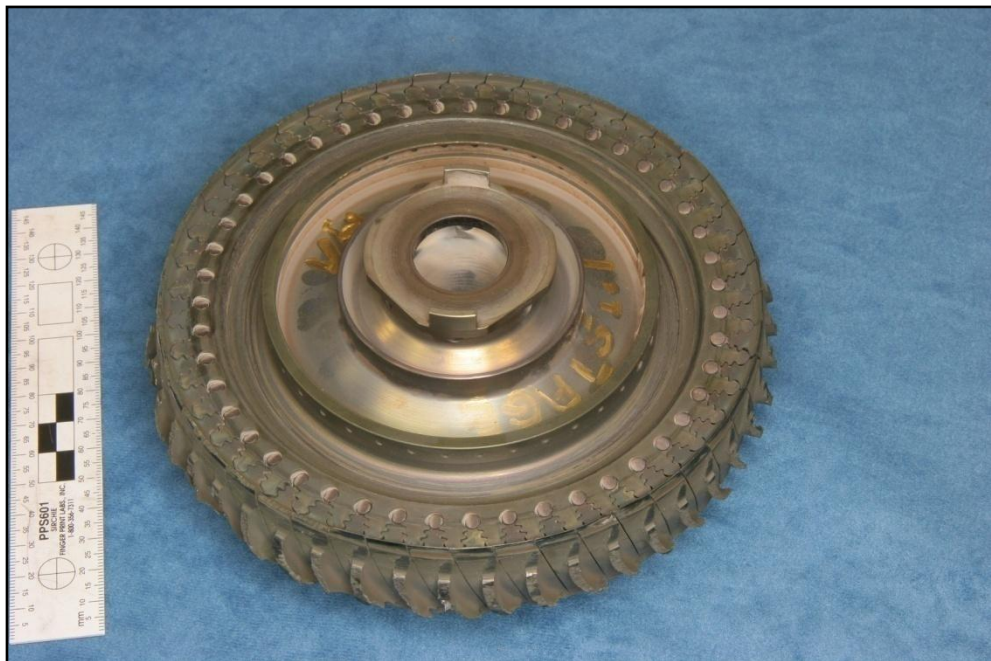
As-received, the first-stage power turbine disk assembly presented the fracture of all blades through the aerofoil section at the base of the root platforms (Figure A8). Fracture characteristics were consistent, and typical of forced failure under bending or impact overstress conditions.

**Figure A8: First stage power turbine disk and fracture blade set**

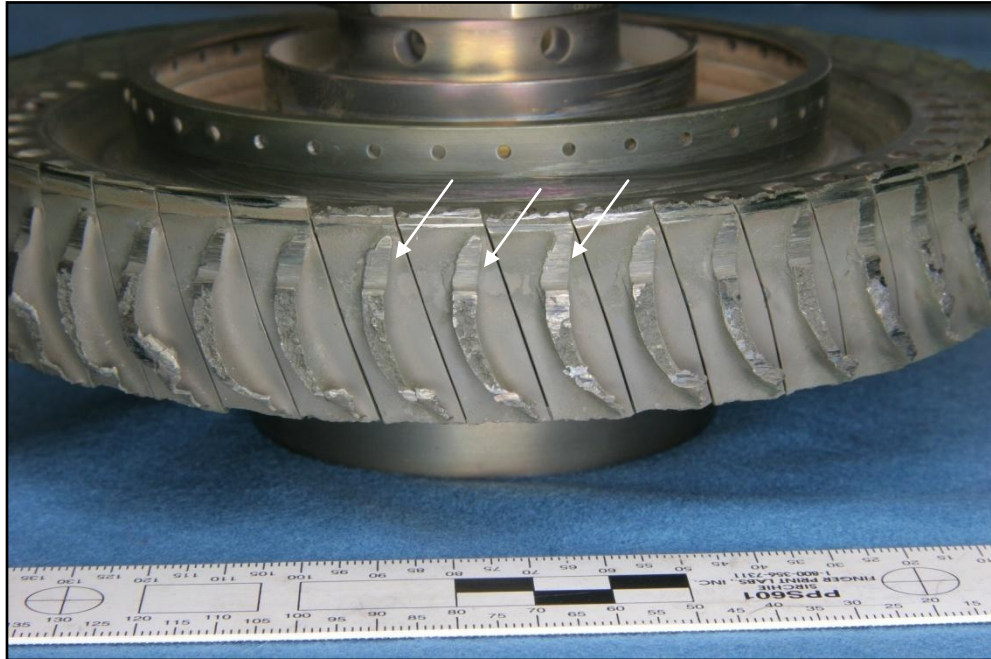
The leading edges of the blades at the root platform transition, had sustained extensive rotational contact wear, or ‘machining’ damage, extending for approximately one-third of the blade chord width (Figure A9). The blade platform extensions beyond the upstream and downstream disk faces had also been machined or broken away in many areas. Corresponding wear to the upstream inner circumference of the power turbine stator ring suggested that it was interference between the two components (stator ring and turbine disk) that had produced or contributed to the observed blade damage.

**Figure A9: Rotational wear damage to the blade leading edge transition (arrowed) – result of interference with the stator ring**

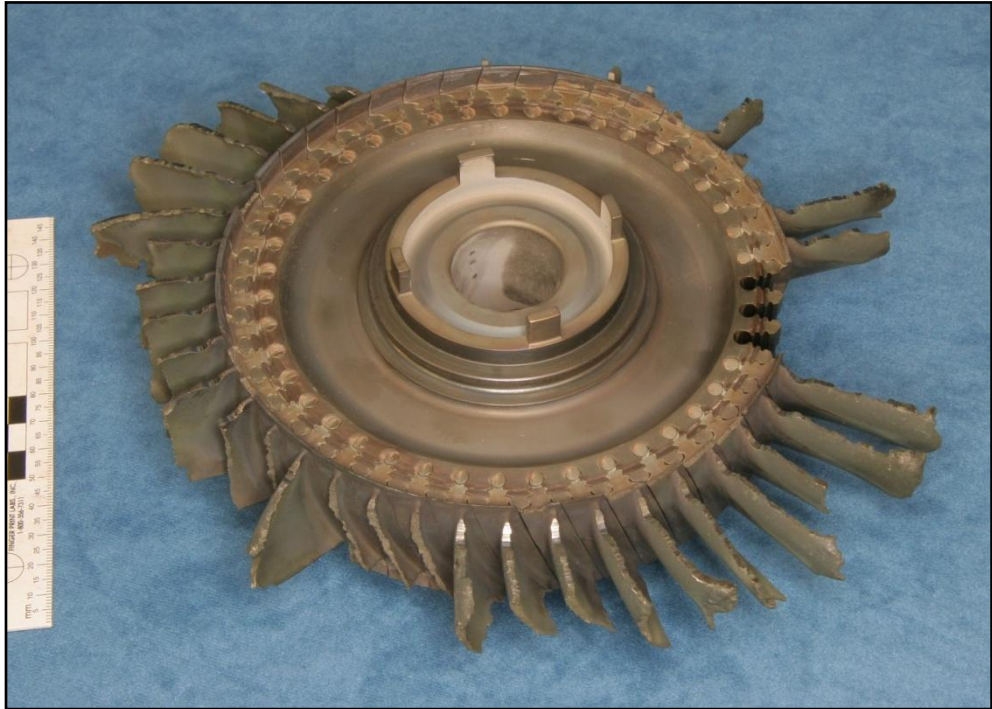
The second-stage power turbine disk assembly was received with three blades removed from their fir-tree slots. Approximately half of the remaining blades had fractured through the aerofoil section, at varying positions along the span, while the remainder had failed at the root platform transition (Figure A10). All observable blade aerofoil fractures resembled those of the first-stage blades, with all being typical of forced fracture under localised impact or more general bending overstress conditions.

**Figure A10: Second-stage power turbine disk – as received (upstream face)**

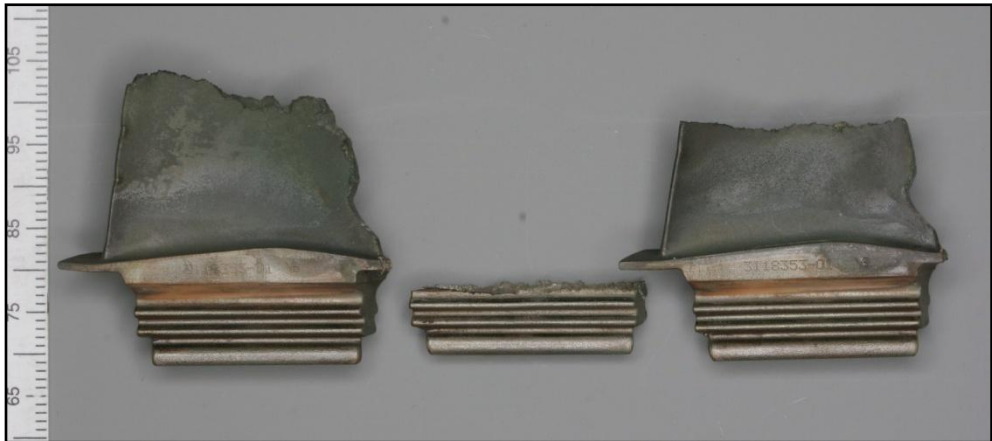
Of the three removed blades, one had fractured transversely through the fir-tree root transition beneath the blade platform (Figure A11). That blade (Figure A12) presented a fracture surface that was characterised by two distinctive regions – a flat and uniformly discoloured zone extending from the trailing edge corner / break-edge of the first fir-tree waist, transitioning sharply to a prominent dendritic morphology for the remainder of the section.

**Figure A11: Blades removed from the second-stage power turbine disk**

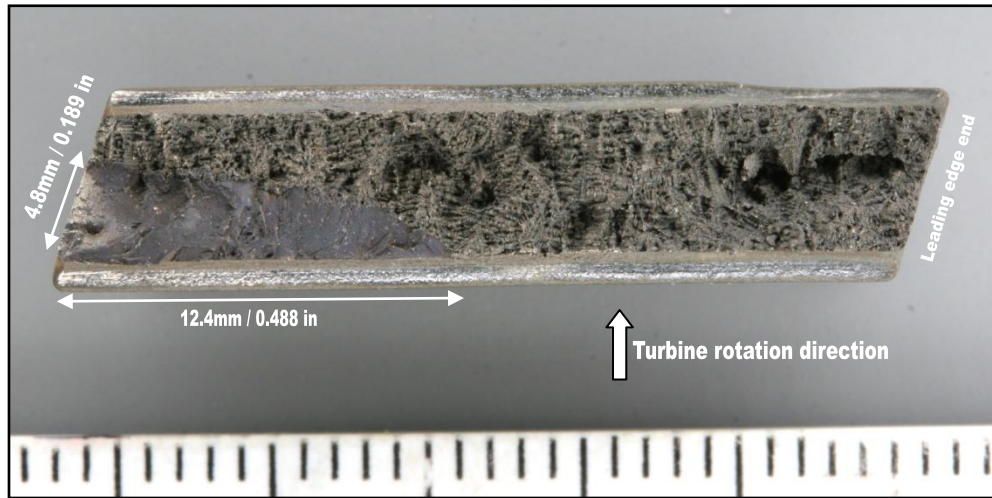
**Figure A12: Fracture surface regions from the sub-platform failed blade**

The region of comparatively flat, transverse fracture at the root trailing corner extended for approximately 12.4 mm chord-wise and for 4.8mm in a through-thickness orientation (Figure A12). Although stained and discoloured, the surface detail in the corner region was moderately well-preserved, and under low-power microscopy, presented curved, concentric fatigue crack progression markings. The transition to coarse dendritic fracture occurred abruptly at the limit of fatigue cracking, with the remainder of the fracture being typical of ductile overstress failure in cast nickel-superalloy components.

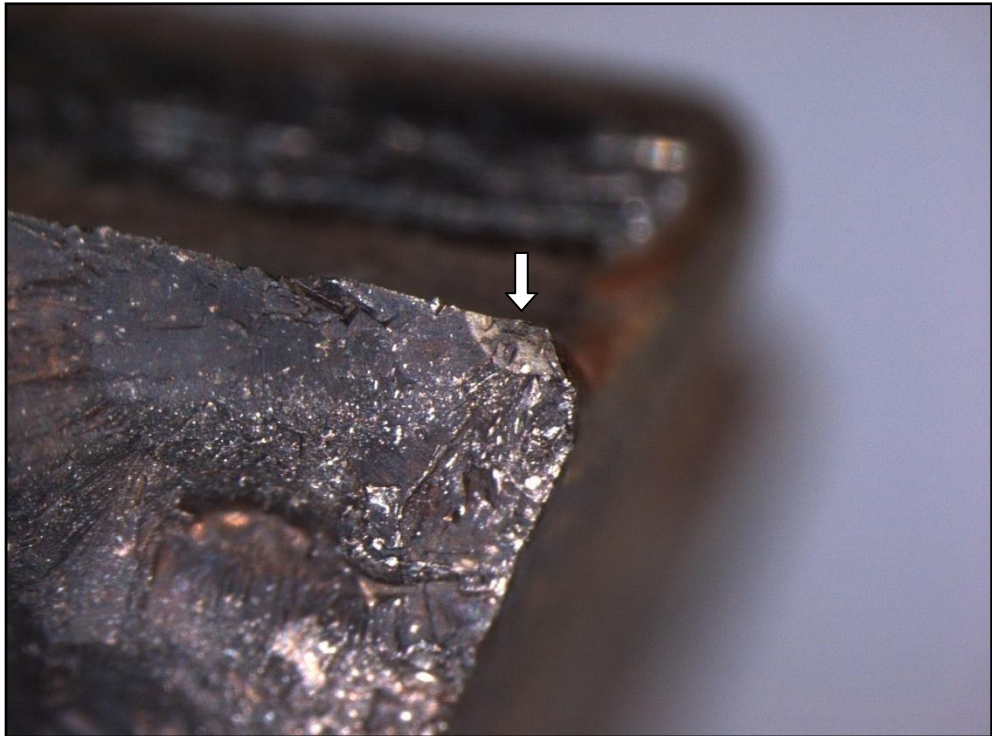
Close study of the fracture morphology at the section corner revealed a hemispherical surface sub-zone of bright crack progression markings, surrounding an irregular darker feature (Figure A13). The zone was located on the root trailing edge, immediately adjacent to the corner break-edge transition to the blade trailing edge end (Figure A14).

**Figure A13: Corner region at the origin of fatigue cracking (arrowed)**

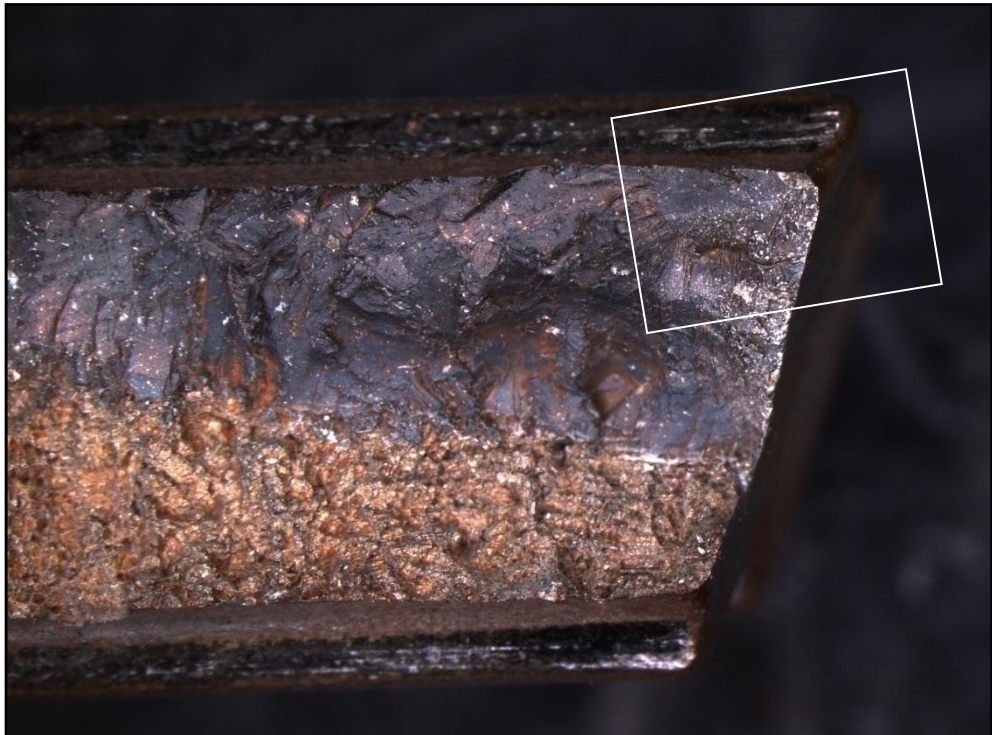
**Figure A14: Location and orientation of fatigue crack origin (enclosed area represented in Figure A13)**

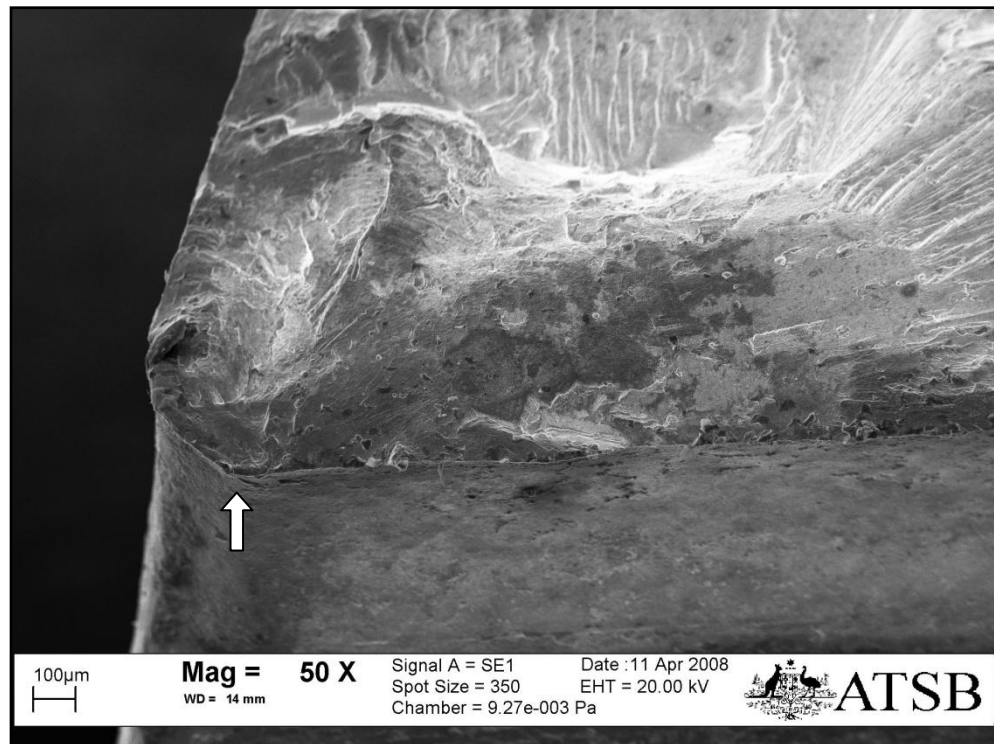
Scanning electron microscopy (SEM) techniques were employed to further examine and characterise the fatigue crack origin and surrounds. Although somewhat smeared and damaged, the surfaces around the origin showed evidence of the typical concentric radiating striations associated with high-cycle fatigue (HCF<sup>17</sup>) crack growth (Figure A15). Multiple intersecting planes of cracking were evident across the surface – likely representing the underlying grain structure of the blade material.

**Figure A15: Low magnification SEM image of the fatigue crack origin (arrowed) and surrounds**

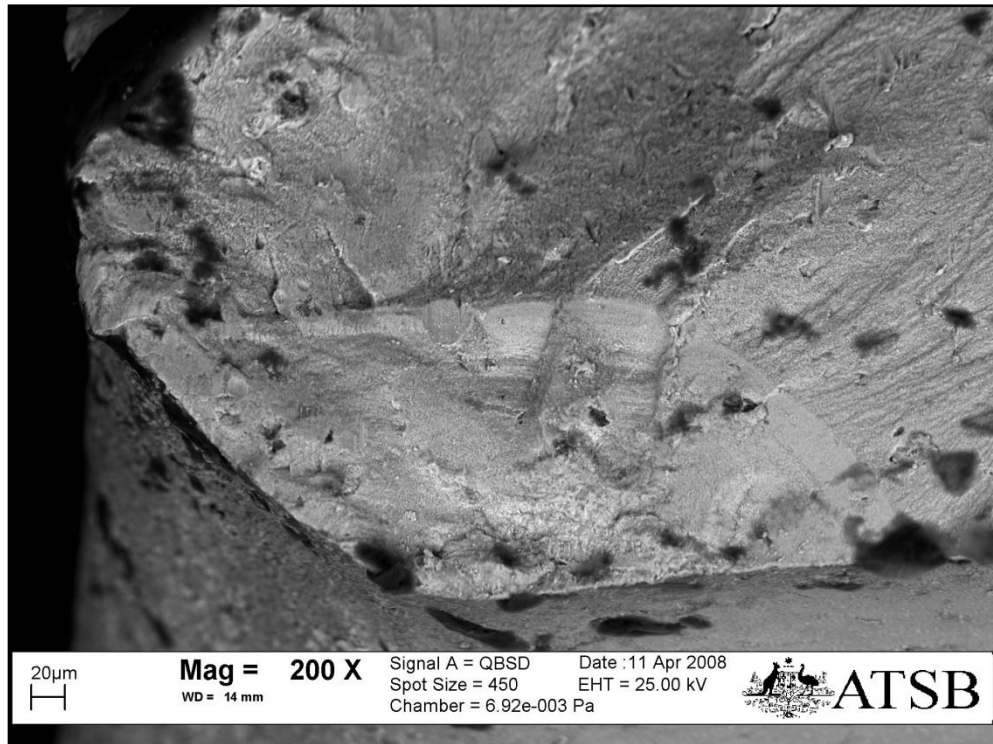
The atomic number contrast provided by back-scattered electron imaging (BSE) of the crack origin (Figure A16) showed no marked compositional variations within the region, aside from random surface accumulations of foreign light-element matter. The electron microscopy did not show any evidence of mechanical damage, tool marks or other localised physical features associated with, or adjacent to the origin region.

**Figure A16: Fatigue crack origin – BSE image**

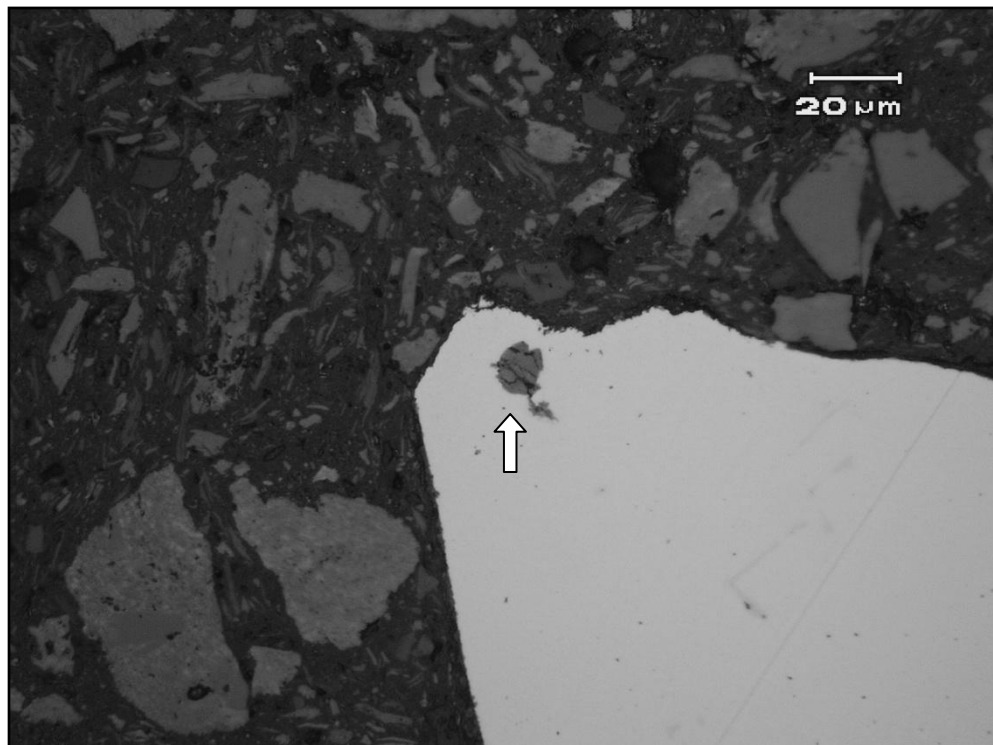
was identified directly associated with the fracture origin, the examination did identify the presence of an isolated spherical non-metallic inclusion located adjacent to the fracture surface (Figure A21). The inclusion measured around 12  $\mu\text{m}$  in diameter and was located at an axial depth of around 0.295 mm from the blade end face. Subsequent sections showed no evidence of this, or other similar inclusions within the bulk material microstructure.

**Figure A21: Spherical sub-surface non-metallic inclusion (arrowed) adjacent to the fatigue origin region (not etched)**

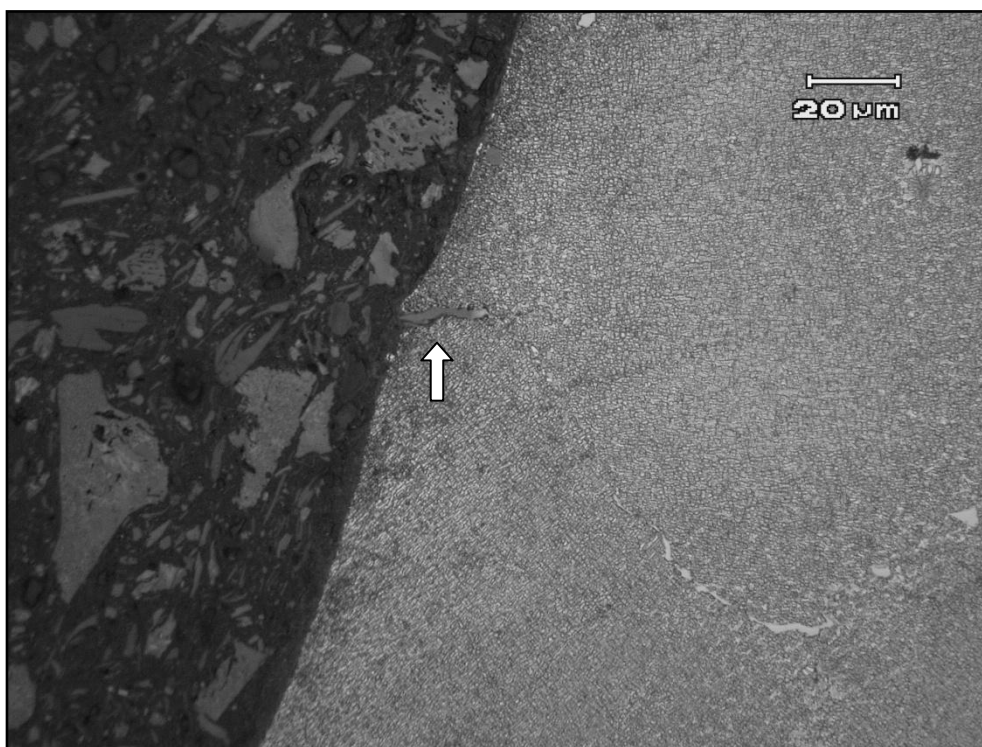
Along the external surfaces of the metallographic sections, several high aspect ratio<sup>18</sup> 'intrusions' were observed – extending to a maximum depth of around 20  $\mu\text{m}$  (Figure A22). In most regions, the intrusions were associated with areas where the interdendritic phase broke the external surface – the intrusions presenting as preferentially oxidised areas of that phase.

**Figure A22:** Intrusive surface feature (arrowed) – appears as oxidised second phase (etched in Kalling's reagent)

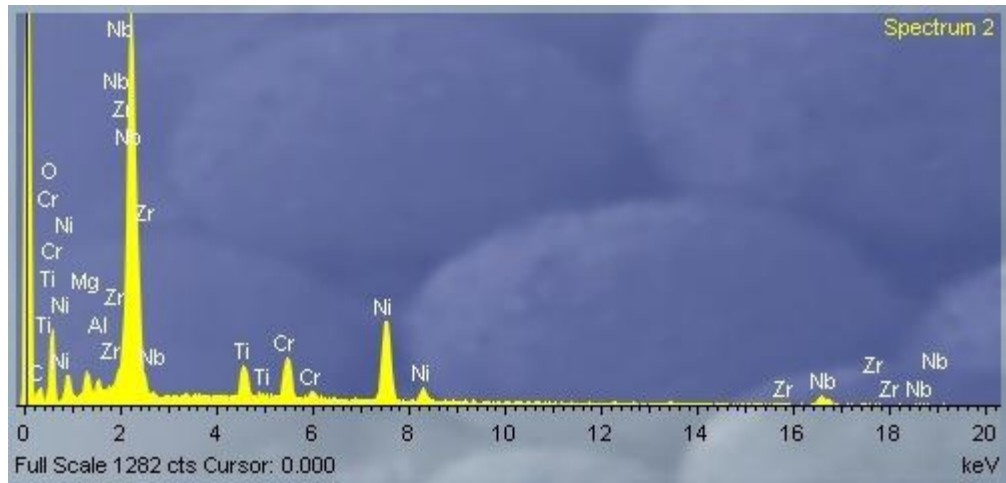
Energy-dispersive x-ray spectroscopy (EDS), conducted on the prepared metallographic sections under the SEM, provided a qualitative indication of the elemental composition of the base metal alloy and the non-metallic inclusion observed microscopically. The base blade alloy presented as a nickel-based superalloy of chromium, molybdenum, aluminium and titanium (Figure A23). The inclusion was predominantly niobium rich, with nickel, oxygen, aluminium, magnesium and zirconium sub-peaks (Figure A24).

**Figure A24: EDS spectrum of the spherical inclusion**
