**ATSB TRANSPORT SAFETY REPORT**

Aviation Occurrence Investigation – AO-2009-005

**Midair collision – Parafield Airport, SA**

**7 February 2009**

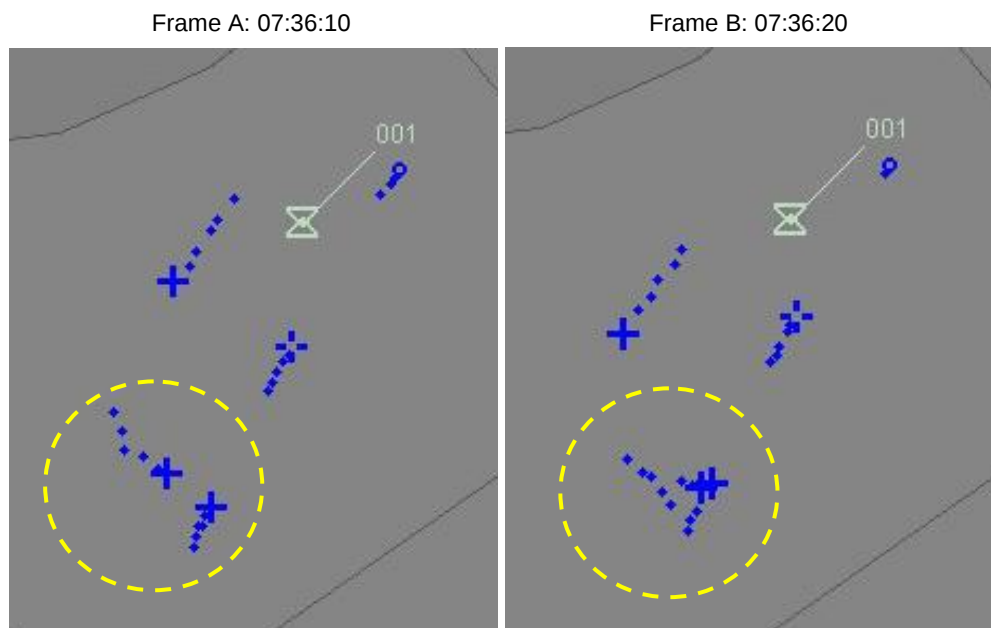
**Figure 2: Radar replay images (TGM and YTG in circled area)**

Each aircraft position was represented by a cross depicted with a ‘history trail’, that provided an indication of the relative motion between recorded tracks (Figure 2). Frame A shows that at 07:36:10, TGM was approaching YTG from the left and Frame B shows that, 10 seconds later, the tracks merge.

Following the accident, Airservices reviewed<sup>4</sup> the recorded information and identified the midair collision.

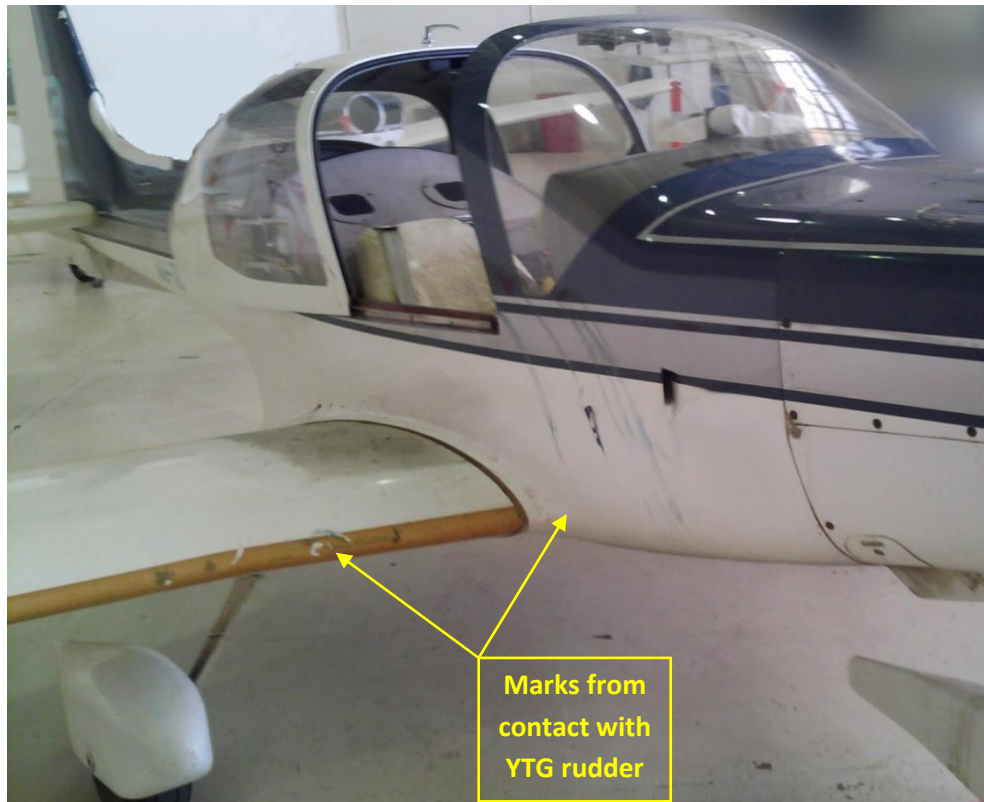
**Figure 3: G-115 Grob, VH-TGM**

The right wing leading edge and right side of the fuselage near the wing root sustained paint abrasion consistent with contact with the Tobago rudder (Figure 3). The adjacent canopy sustained minor scratching.

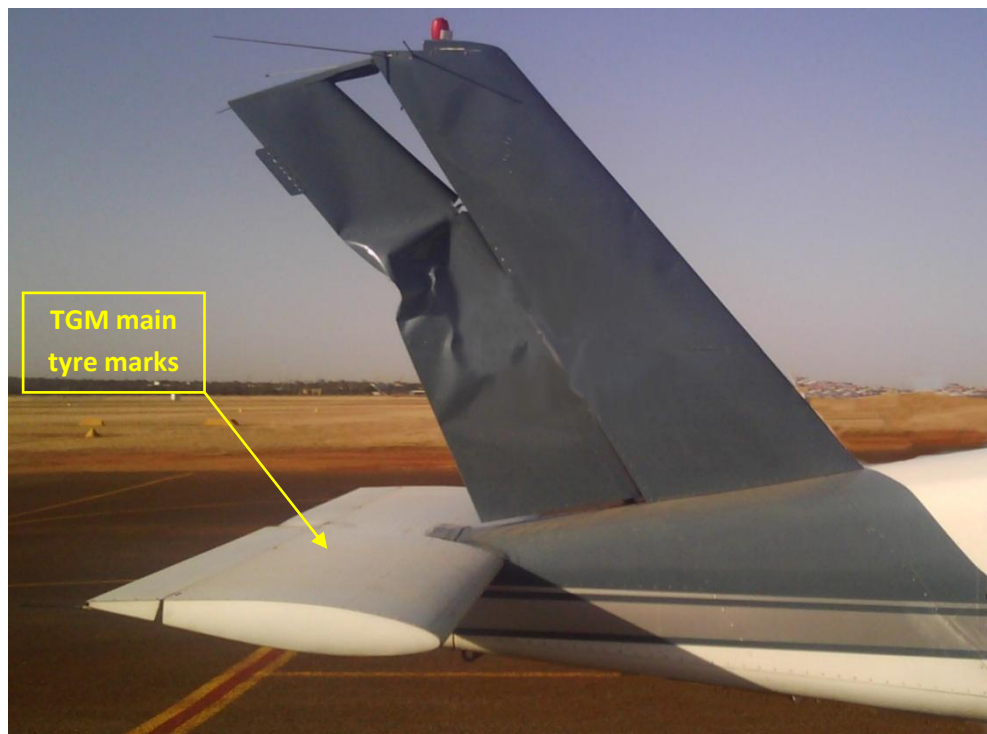
**Figure 4: TB-10 Tobago, VH-YTG**

The rear section of the rudder was damaged (Figure 4) and there were tyre impact marks on the upper surface of the stabilator. A representation of the collision angle between the aircraft is at Figure 5.
