# Tail strike – Brisbane Airport, Qld

## 23 October 2008

INFRA-08534

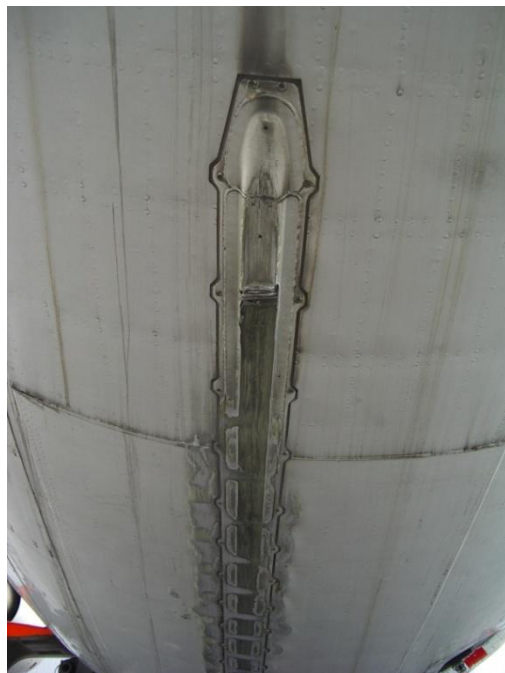
Damage to the aircraft consisted of abrasion to the tail strike indicator through to the fuselage skin and abrasion to the fuselage skin. There was also damage to the aircraft's structural frame under the tail strike indicator.

The PIC conducted a post-flight inspection of the aircraft and found damage to the tail strike wear section of the empennage (Figure 1). The aircraft was removed from service and repaired.

The tail strike indicator, aircraft skin and one of the structural frames were damaged in the incident. The structural frame was repaired and a new skin section and a new tail strike indicator fitted. The damaged section is within the pressurised zone of the aircraft.<sup>4</sup>

**Figure 1: Damaged tail strike indicator and skin**

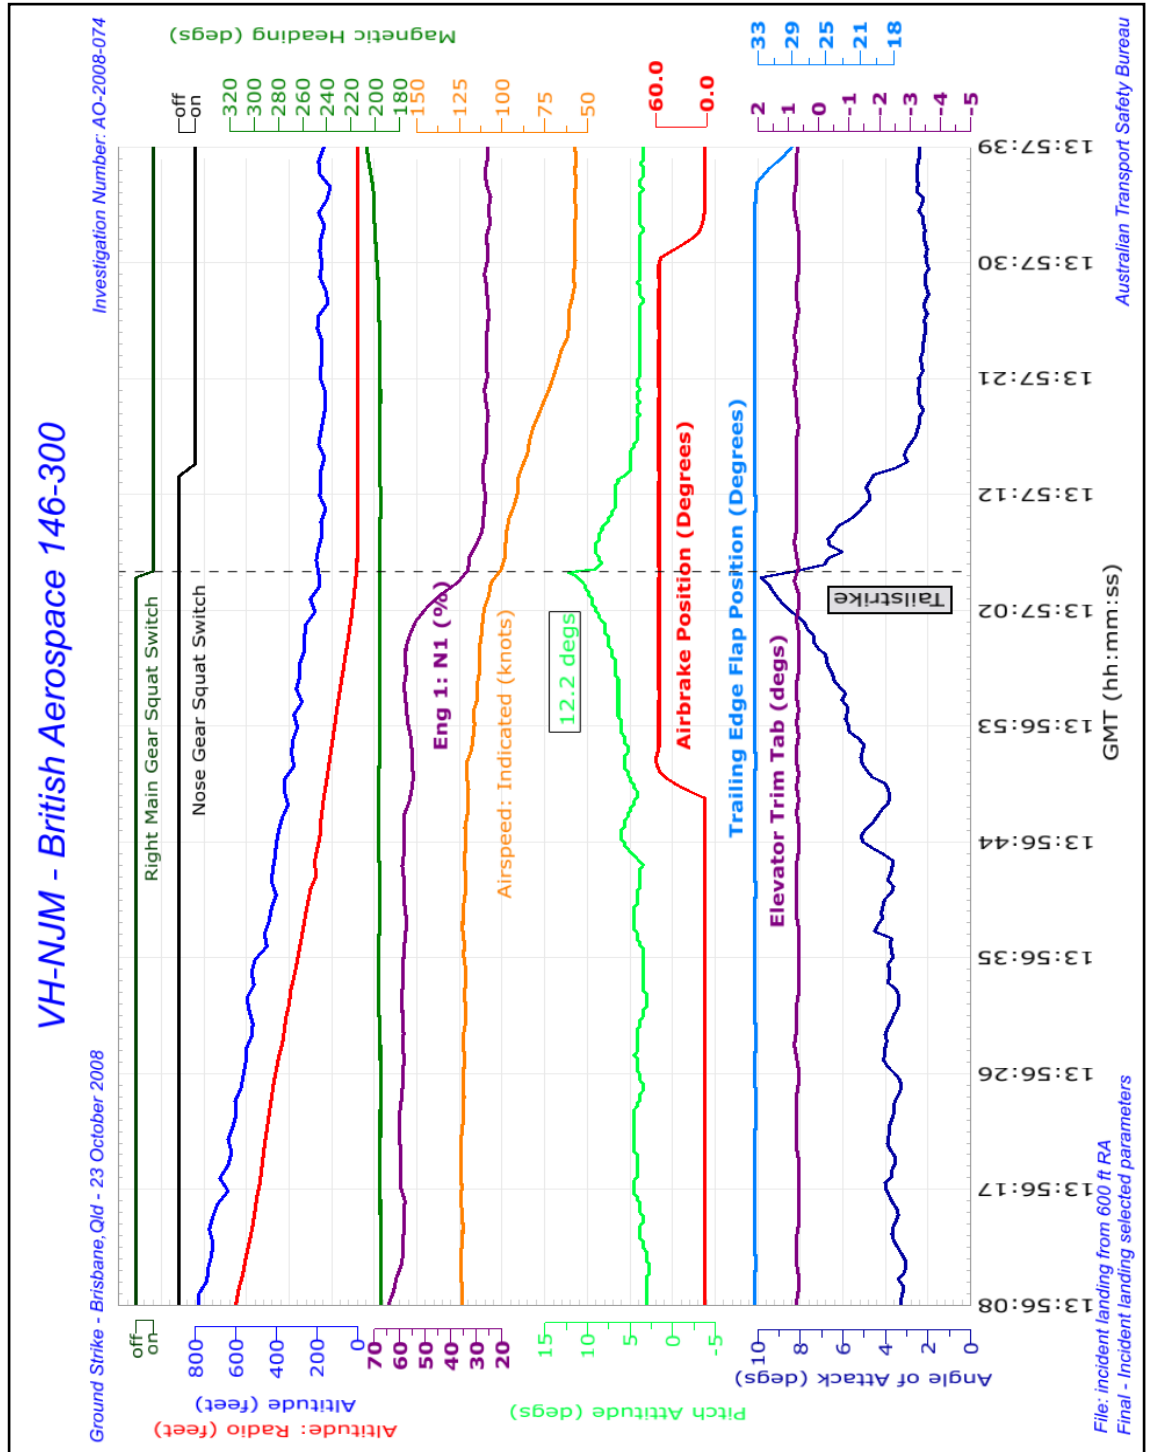
Figure 2: Selected parameters from 600 ft radio altitude

Figure 2 shows that at about 300 ft, the aircraft was at the nominated approach speed of approximately 124 KIAS<sup>5</sup> and at touchdown the aircraft's speed was approximately 107 KIAS.

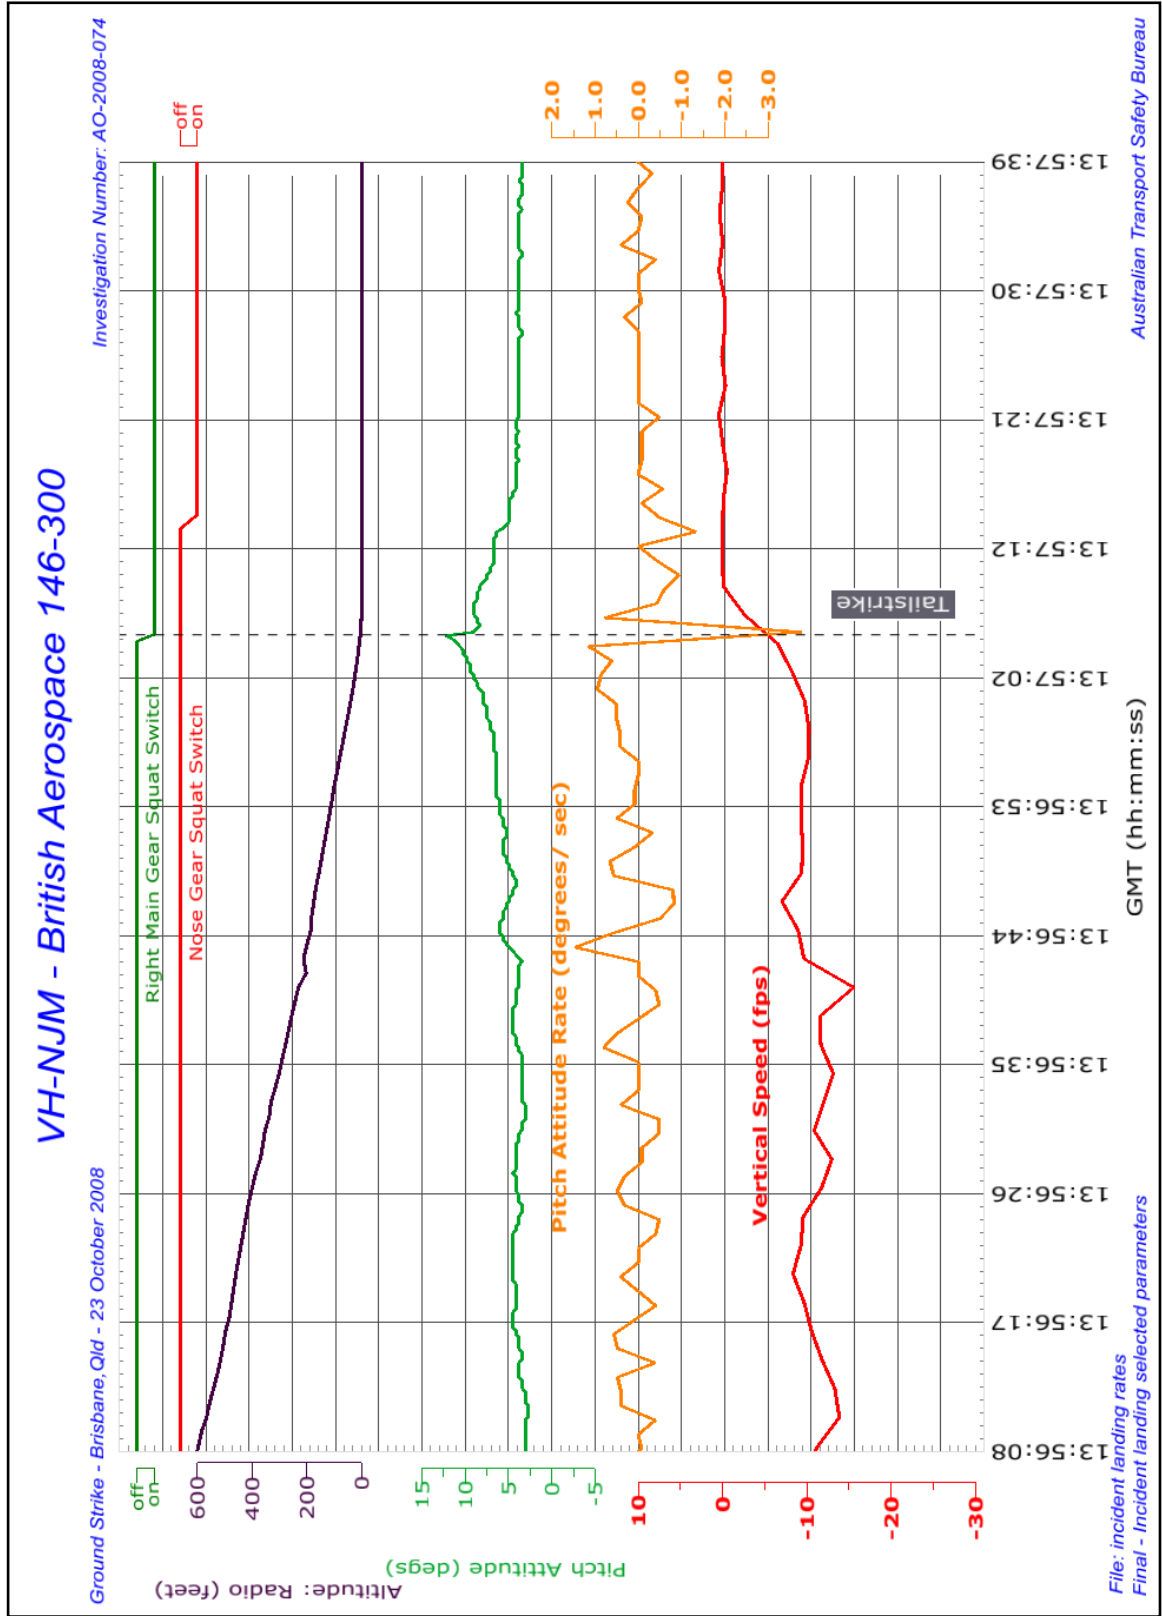
Figure 3 shows that from the same altitude the pitch attitude rose from approximately 7° to 12° at touchdown.

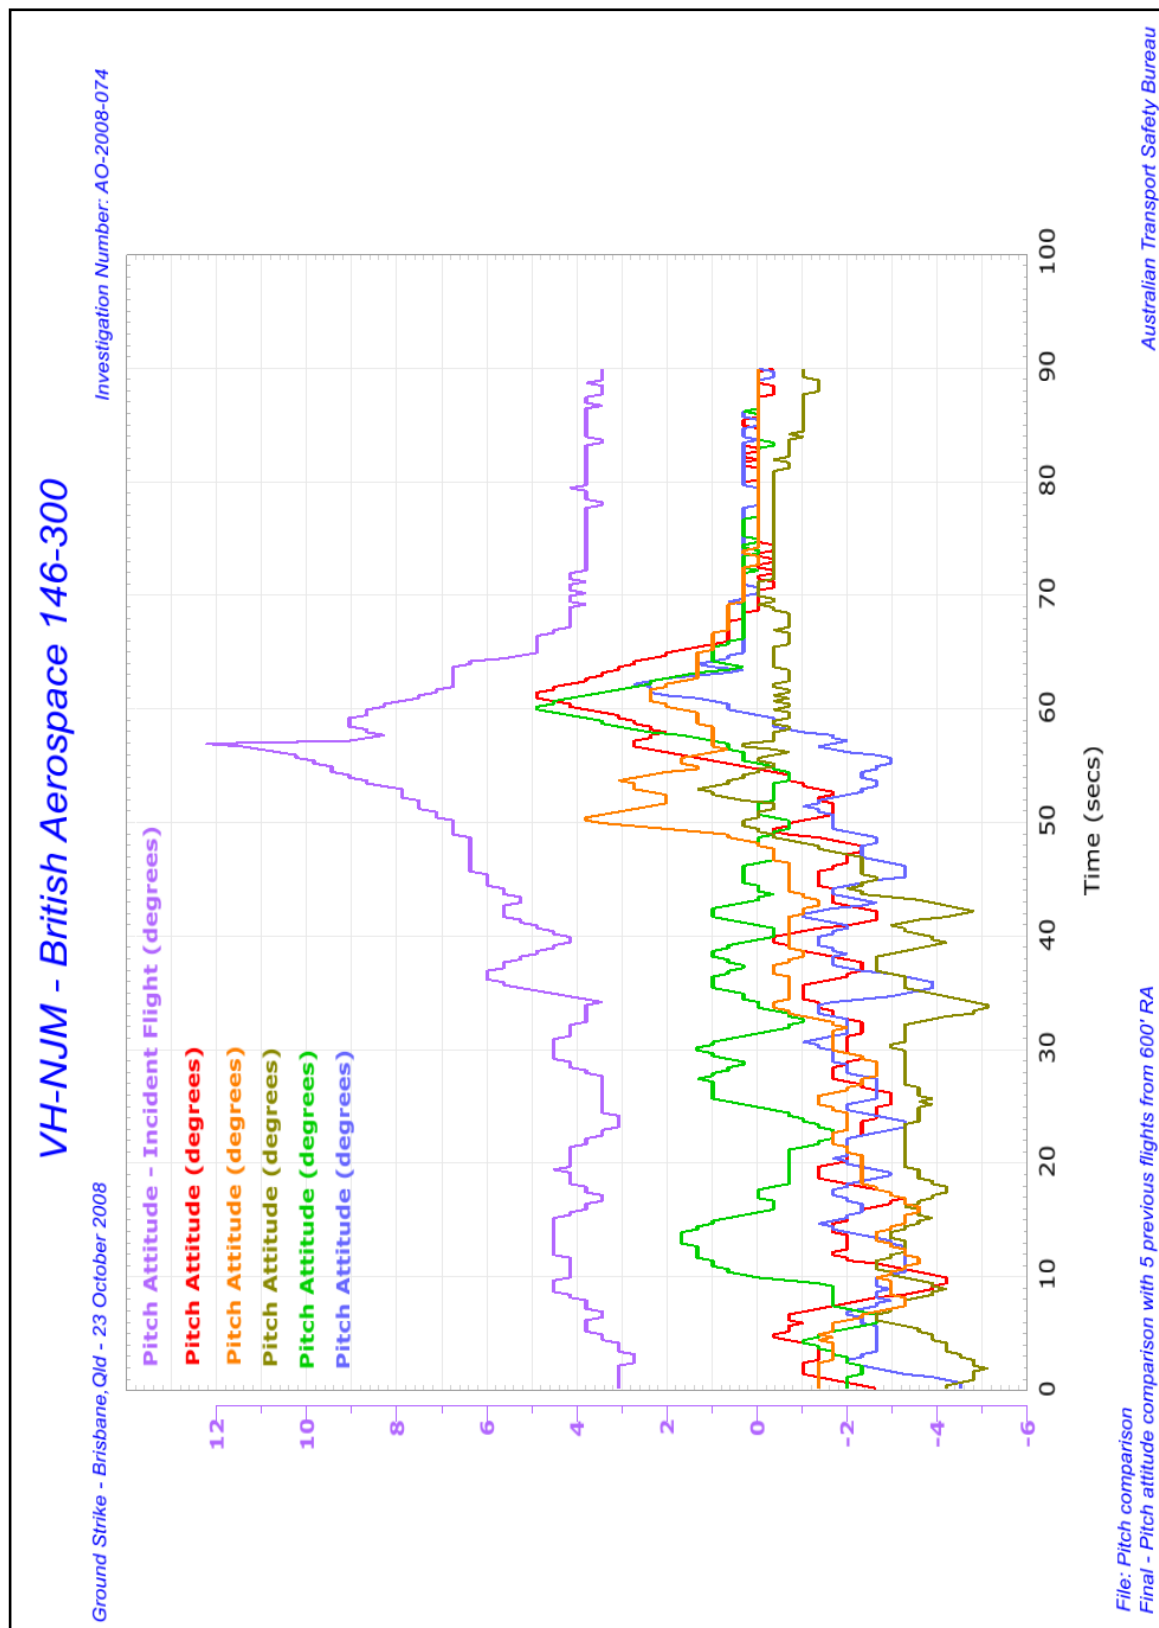
Figure 4:- Pitch attitude comparison with previous flights on FDR

Figure 4 shows a comparison between the pitch angles on this flight compared to previous flights

The aircraft pitch attitude in this event was compared to the pitch attitude during the five previous approaches from 600 ft radio altitude. The comparison of a number of flights in Figure 4 clearly shows the excessive pitch attitude in this event that resulted in the tail strike.
