Aviation Occurrence Investigation AO-2007-041

# Turbulence event – Adelaide Airport, SA

29 August 2007

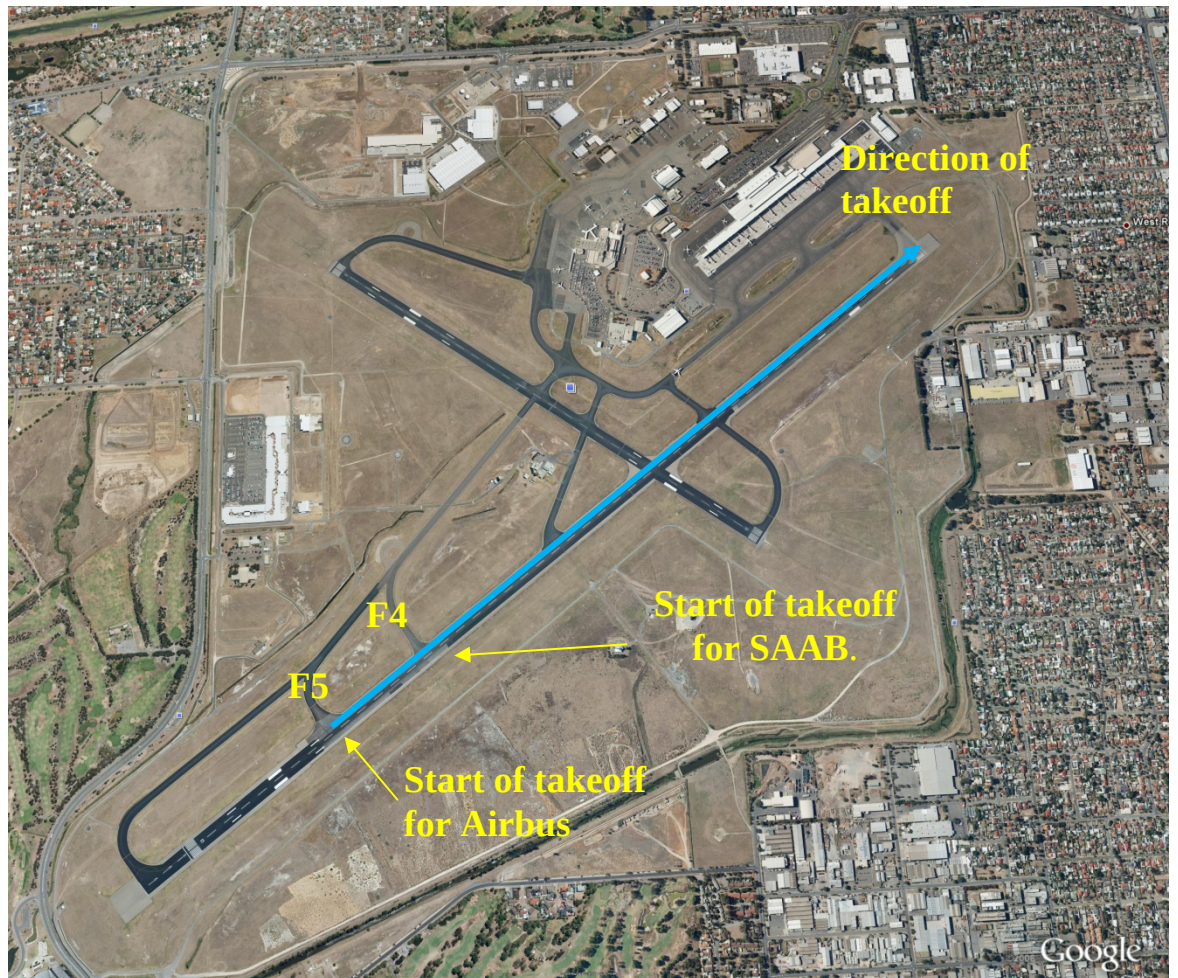
Figure 1: Adelaide Airport showing positions of taxiways F4 and F5 (Google Earth)

The flight crew of the SAAB commenced the take-off roll from their normal departure point for runway 05, which was at the intersection of taxiway F4. This was 351 m upwind of the taxiway F5 intersection with runway 05, and coincided with where the Airbus commenced its take-off roll less than 1 minute previously. The flight crew of the SAAB advised that their point of lift-off was normally the same as for jet aircraft that departed from the same taxiway/runway intersection position.

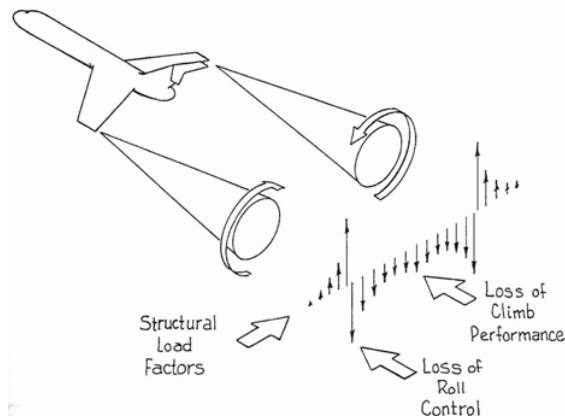
**Figure 2: Effects of wake turbulence**

Wake turbulence is the result of wingtip vortices that are produced by high pressure air below an aircraft wing moving towards the low pressure air on top of the wing; in particular, at the wingtip

(Figure 2). The magnitude and intensity of the vortices is determined by four factors; the amount of lift the wing is generating, the aircraft's wing span, the air density and airspeed of the aircraft generating the turbulence.

The forecast and actual surface wind for Adelaide Airport during the incident was a north-easterly at 5 kts, with no associated turbulence. With calm or light wind conditions, the rate of dissipation of any generated wingtip vortices would be slow (Figure 2).
