ATSB TRANSPORT SAFETY REPORT

Aviation Occurrence Investigation – AO-2007-038

Procedures-related event

Townsville Airport, Qld

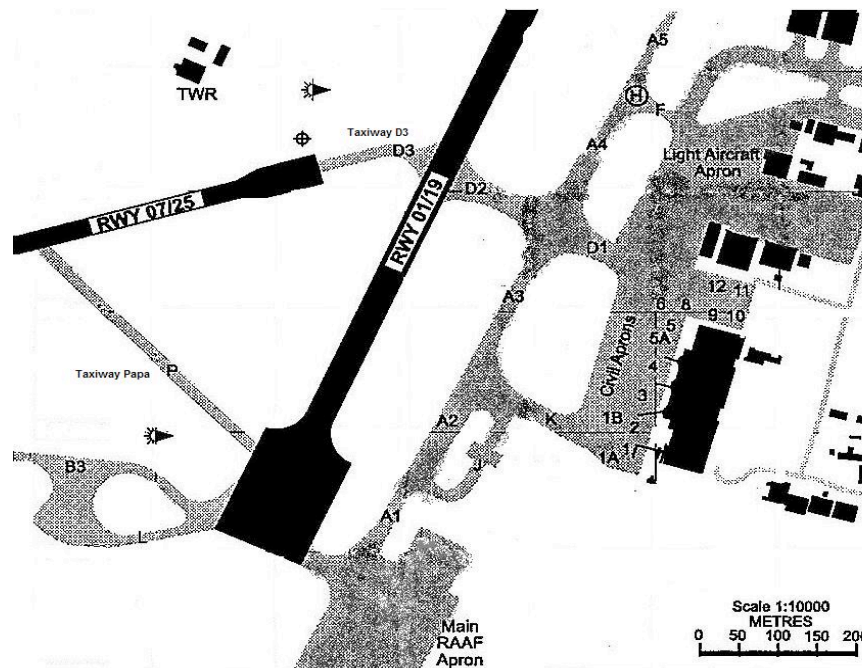
Figure 1: Townsville/Townsville International Airport²

The pilot of the 172 reported on left base for runway 07 and requested a touch-and-go landing for additional circuits. The ADC recognised a potential flight path confliction with the 737 and cleared the pilot of the 172 to make a full-stop landing, rather than the touch-and-go landing as requested. The flight crew of the 737 was cleared to land on runway 01. Runways 01 and 07 converge but do not intersect (Figure 1).

The eastern end of runway 07 was 165 m from the centreline of runway 01. Taxiway Delta three (D3) continued from the eastern end of runway 07 and crossed runway 01 about 700 m north of the runway 01 threshold. The runway strips overlapped.

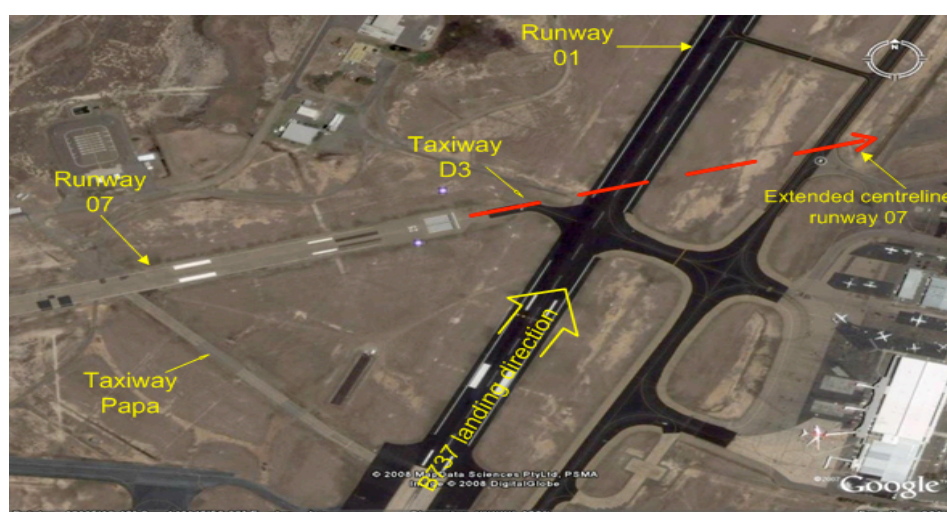
Figure 2: RWY07/25 and RWY 01/19 Townsville¹⁰

The *Sequencing to multiple runways* instruction, dated 12 March 2007, noted that the runways did not cross and referred to the respective runway strips not intersecting. However, an examination of the length of the clearways, and the distance of the take-off surface inner edge relative to the runway end, showed that, in accordance with the civil requirements, that was not the case (Figure 2). The ADF advised that it considered that a portion of taxiway D3 was outside both runway strips. By contrast, under Civil Aviation Safety Regulation (CASR) Part 139, taxiway D3 was inside the runway strips, and transient operations on that taxiway would impinge on operations on both runways.
