**ATSB TRANSPORT SAFETY REPORT**  
Aviation Occurrence Investigation AO-2007-069  
Final

**Collision with water**  
**Pier 35 Melbourne, Vic.**  
**29 December 2007**  
**VH-MEB**  
**Robinson Helicopter Company R44 Raven 1**

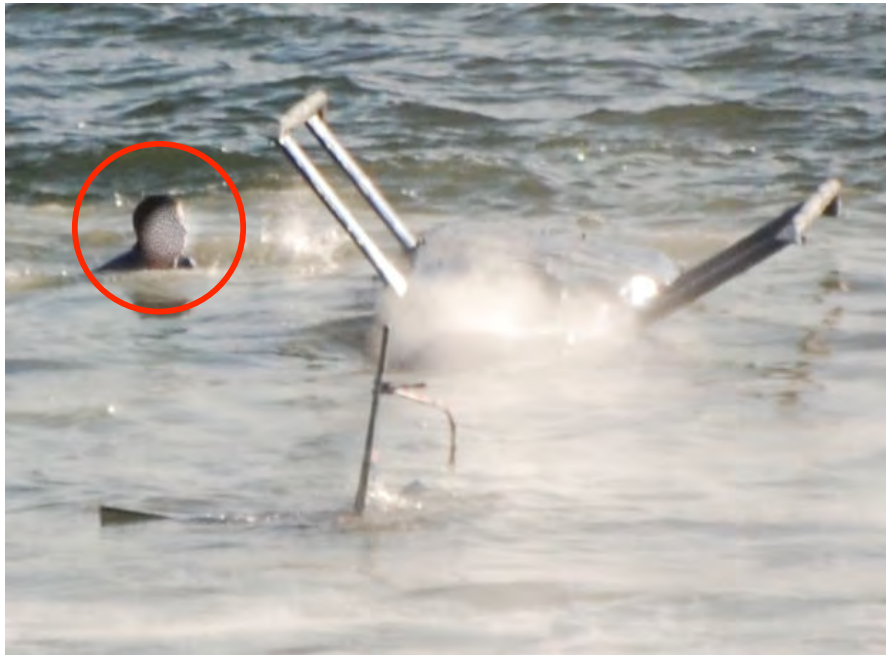
**Figure 2: The helicopter immediately after impact**

waiting for this ship to pass before taking off. The handling pilot, who had exited the helicopter, is circled in red.

The other pilot, who was the chief pilot of the operator, did not exit the helicopter and was fatally injured<sup>3</sup>.

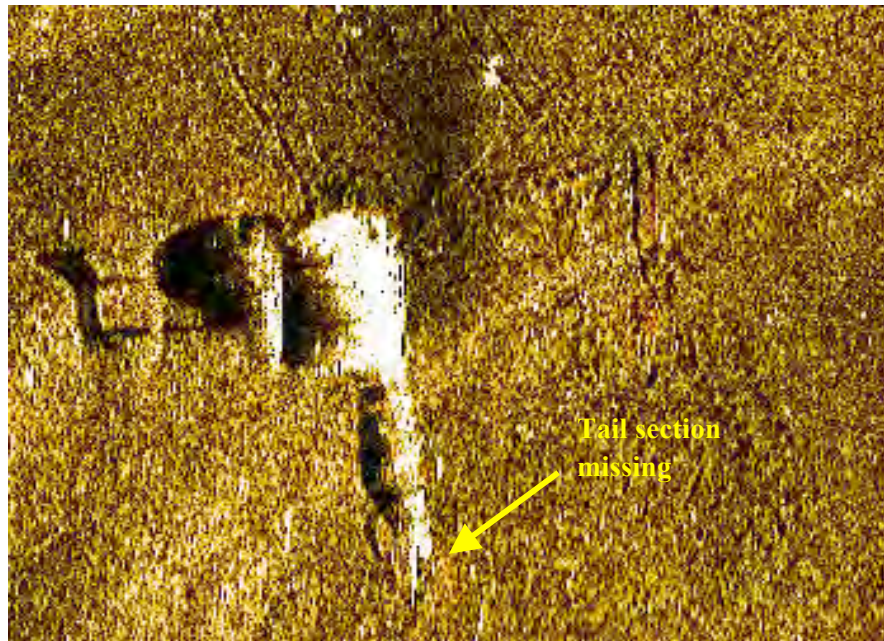
**Figure 4: Sonar image of the helicopter on river bed**

Late in the evening of 29 December 2007, police divers located the helicopter wreckage in the Port of Melbourne channel. Before moving the wreckage, the police used side-scan sonar to record images of the helicopter on the river bed (Figure 4). The sonar images show that the helicopter was lying on its right side, inverted with the tail section missing.

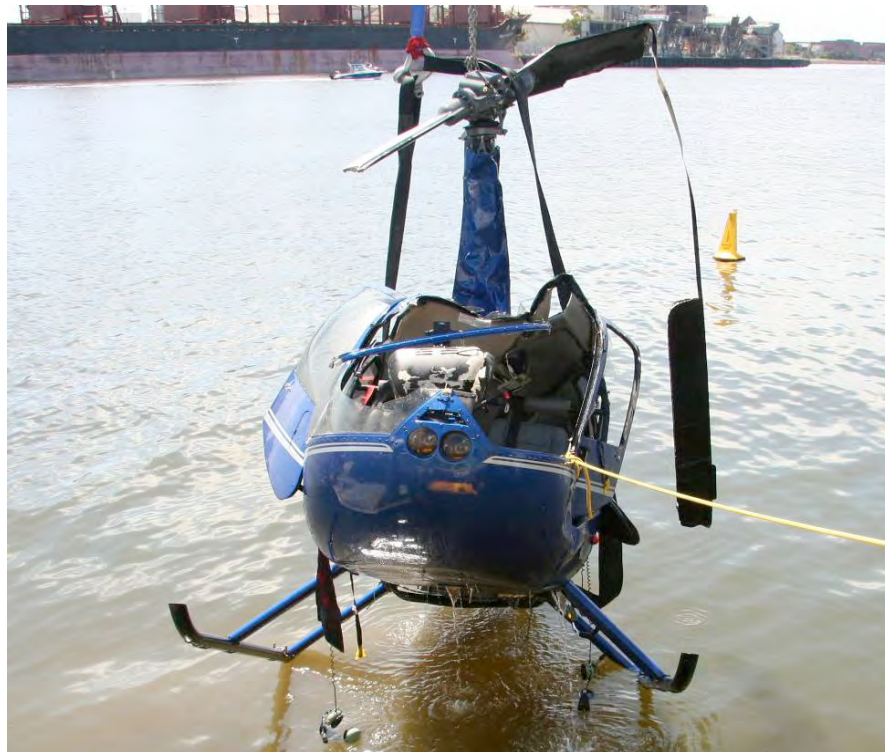
**Figure 5: Recovered helicopter**

On 30 December 2007, at about 1440, the main wreckage was recovered from the river and secured for technical examination by the Australian Transport Safety Bureau (ATSB). A preliminary examination of the wreckage by ATSB investigators indicated a left-side down, slightly forward impact, with damage to the cockpit upper and forward structure. There was impact damage to both main rotor blades and to the main transmission and supporting frame work. Impact damage was also noted to the tail rotor drive system (Figure 5).

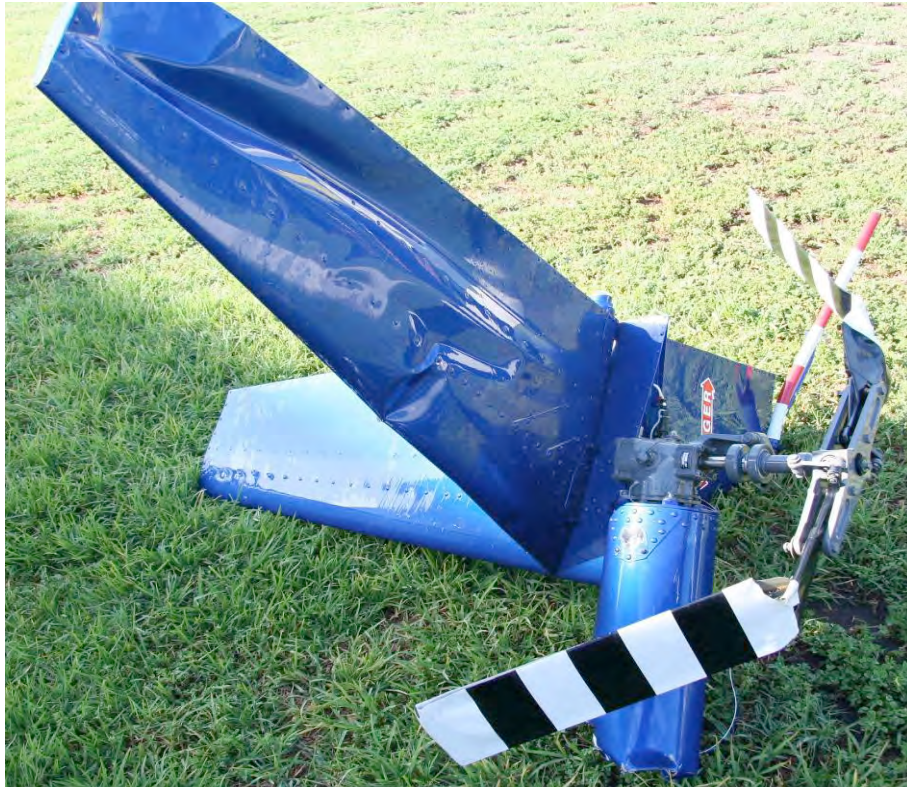
**Figure 6: Tail rotor gearbox and tail rotor**

On 1 January 2008, police divers recovered a large section of main rotor blade, the tail rotor control tube, and the separated section of the tail boom with the tail rotor gearbox and tail rotor attached (Figure 6). The tail rotor blades were intact, but bent towards the tail boom. Photographs taken by a witness on a nearby container ship shortly after the helicopter impacted the water, confirmed that the rear section of the tail boom and the tail rotor were attached when the helicopter was floating inverted in the water (Figure 2).

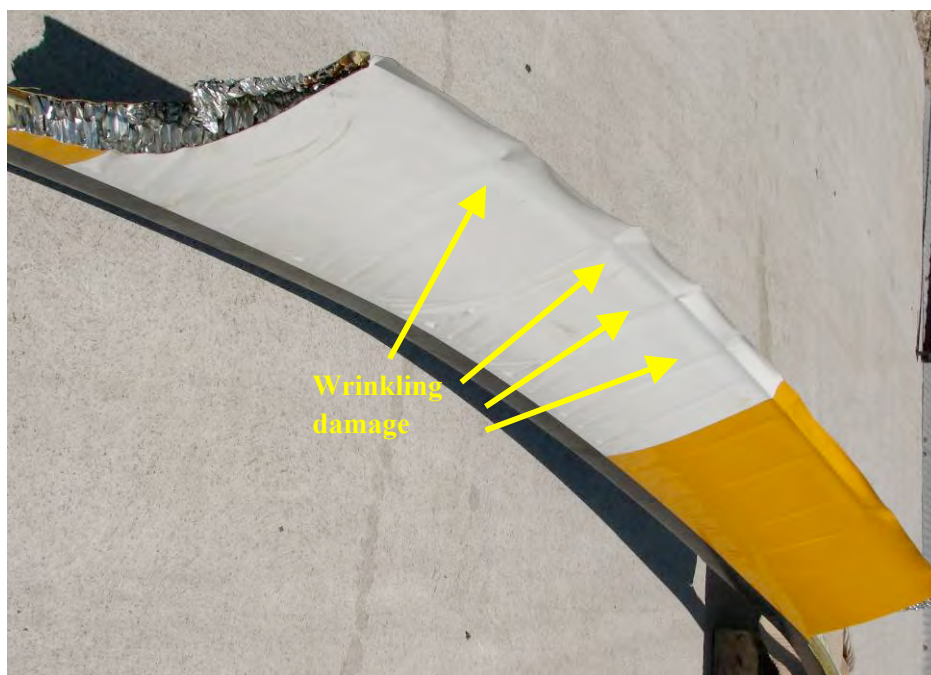
**Figure 7: Main rotor blade damage**

Both main rotor blades were heavily damaged from water impact. The blade sections that were recovered indicated severe blade coning and compression damage or wrinkling on the top surface of the blades (Figure 7). Blade coning is described as when a vertical takeoff is made, two major forces are acting at the same time, centrifugal force acting outward and perpendicular to the rotor mast, and lift acting upward and parallel to the mast. The result of these two forces is that the blades assume a conical path instead of remaining in the plane perpendicular to the mast. The wrinkling damage to the main rotor blades indicated that the blades were probably rotating at below normal operating RPM at the time of impact.

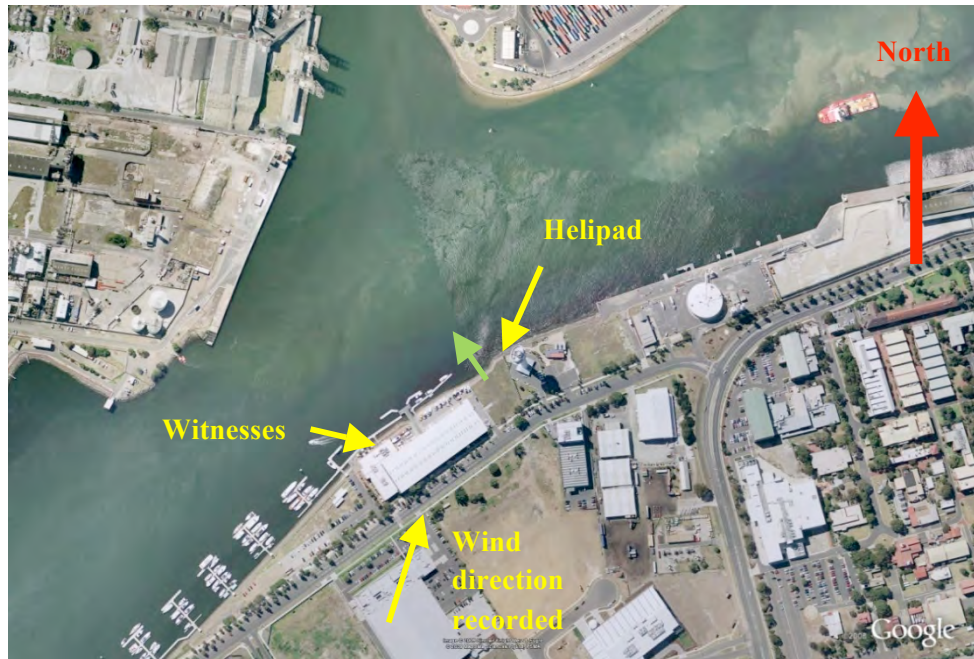
**Figure 8: Pier 35 helipad aerial view (flight path in green)**

The Pier 35 private helipad was reportedly initially designed to be double the size of the existing pad and to incorporate a floating helipad in the Yarra River. That design option was eventually dismissed due to a channel marker in the immediate area (Figure 8).

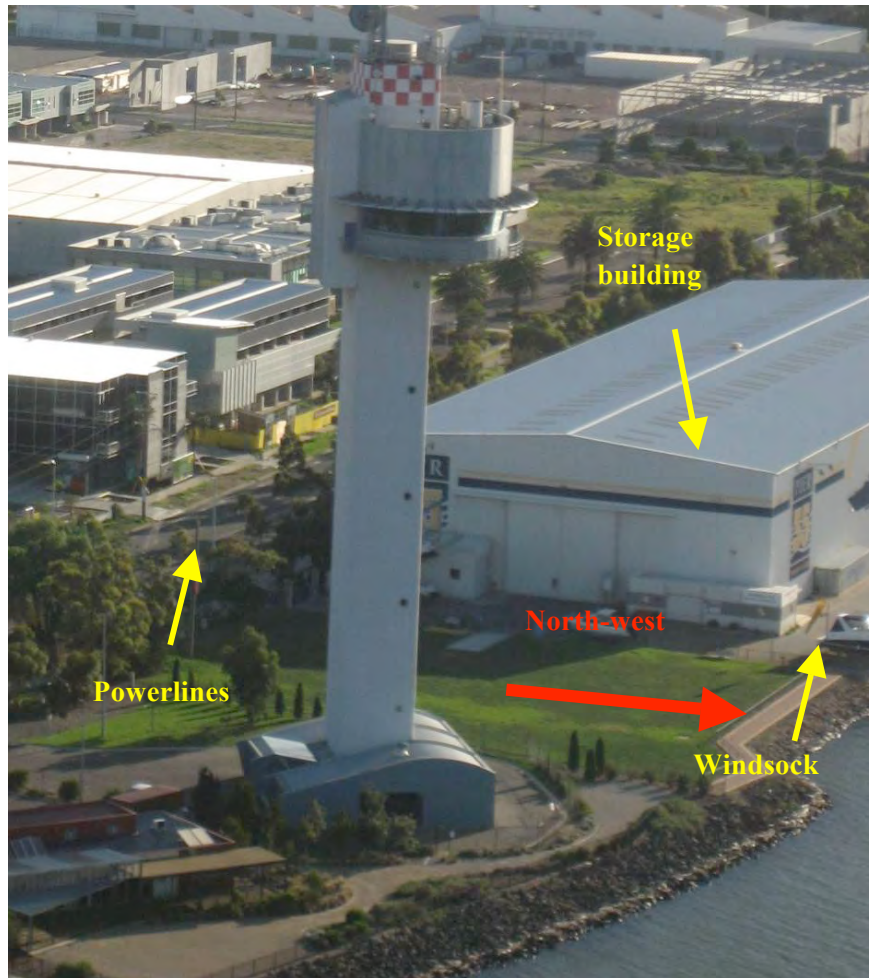
**Figure 9: Pier 35 view during scenic flight**

The helipad was approximately 40 m by 60 m and was adjacent to a 15.5 m high boat storage building (to the southwest of the helipad).<sup>17</sup> A wind sock, fitted to a 5 m tall pole, was located in the north-west corner of the helipad. The helipad was elevated approximately 2 to 2.5 m above the level of the river. To the east side was a 50 m high Port of Melbourne Corporation control/surveillance tower and powerlines were located to the south (Figure 9).

The design of the helipad would require a helicopter take-off profile, if departing to the south, of lifting off vertically then advancing forward (a towering takeoff), regardless of wind direction. This would require high engine power on the helicopter and place the helicopter in a situation often referred to as exceeding the height velocity curve<sup>18</sup>.

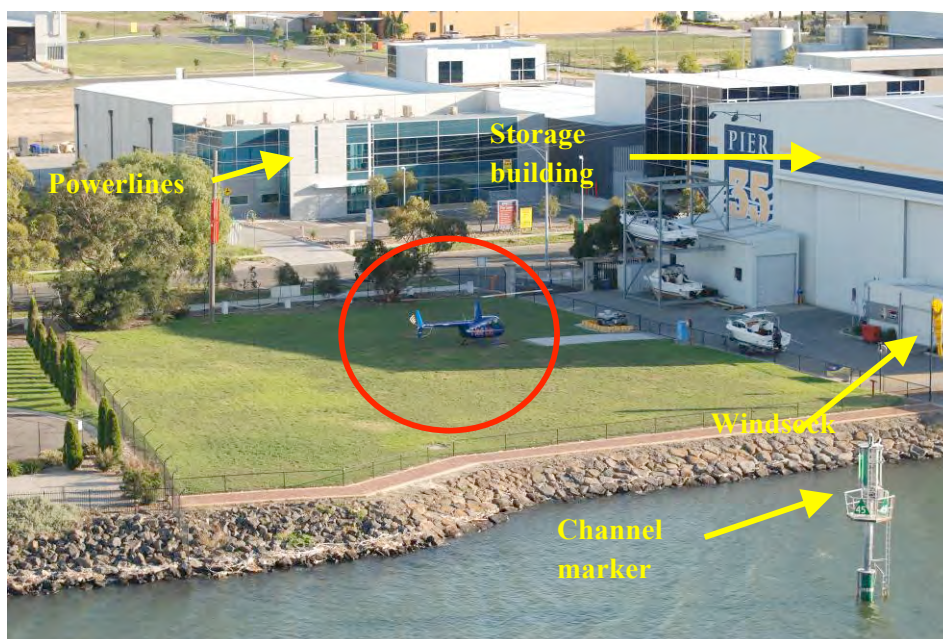
**Figure 10: VH-MEB on the Pier 35 helipad**

The photograph below was taken by a crewmember on board a container ship *Maersk Josephine*, which was entering the port, just prior to the helicopter's takeoff on the accident flight. The control/surveillance tower is located to the left and out of view of the photograph. Note that the windsock was indicating little or nil wind (Figure 10).

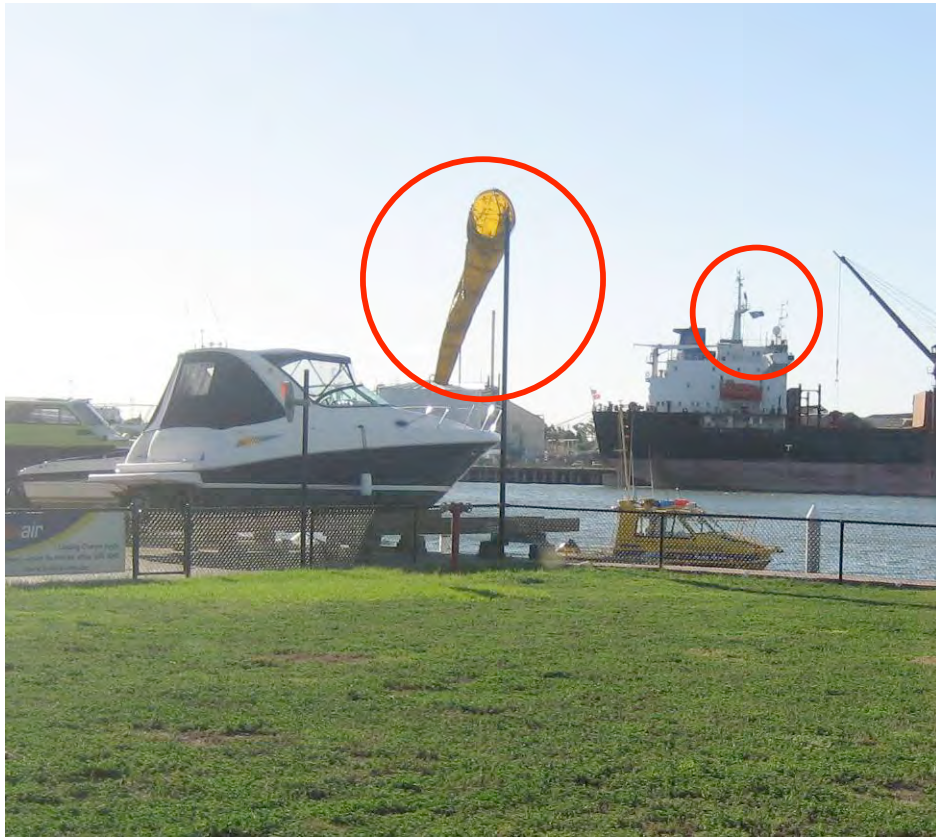
**Figure 11: Photo of windsock from scenic flight**

from the south-south-west and the flag of the container ship docked across the river (also circled in red) shows wind from the south-south-west (Figure 11).

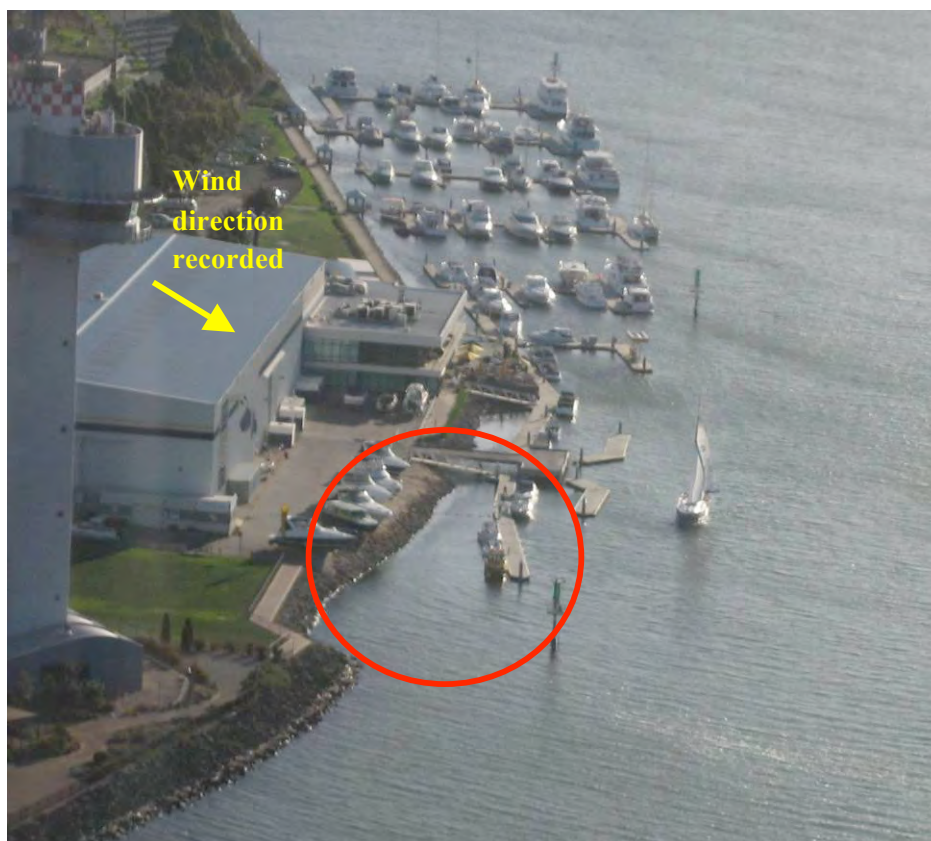
**Figure 12: Marina view during scenic flight**

Another photograph sourced from the scenic flight passengers shows the relatively calm area on the water's surface (circled in red) directly downwind from the boat storage shed and next to a floating dock and ripples in the river showing wind from the west (Figure 12).

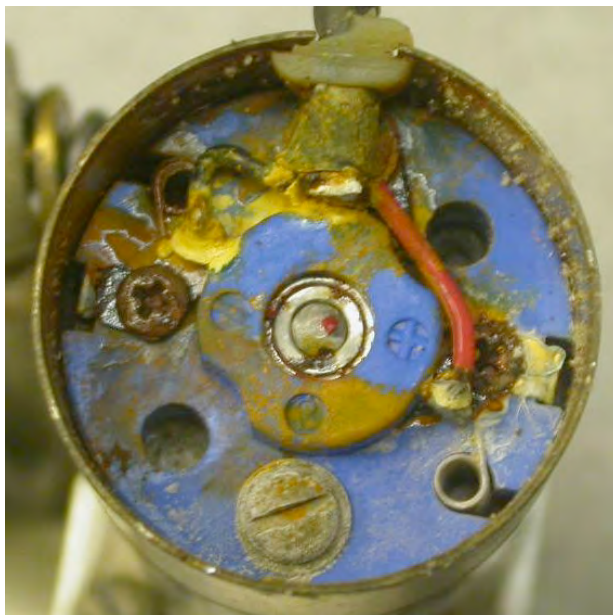
**Figure 13: Governor assembly gear motor**

- no water ingress of the controller
- a bias shift of the controller during testing causing a loss of symmetry at the dead band edge. The functional result of this would be the controller keeping the engine at 101.913% RPM during dynamic loading, and 102.058% during static loading. The bias shift was not present during production testing of the unit on 11 March 2006.
- water ingress of the governor assembly gear motor resulting in seizure
- no gear damage or metal contamination of the governor assembly gear motor (Figure 13).

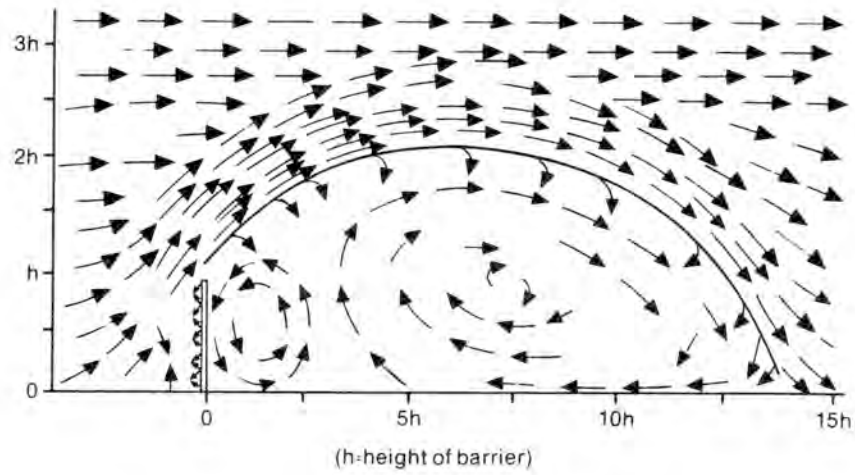
**Figure 14: Turbulent flow over impermeable barrier**

Based on the above information and the fact that the height of the boat storage building was 15.5 m ( $h$ ), the investigation calculated turbulence from the structure could extend to 230 m downwind of the south wall of the building.
