ATSB TRANSPORT SAFETY REPORT

Aviation Occurrence Investigation – AO-2007-034

Fuel system event
Near Rockhampton aerodrome, Qld
13 Aug 2007
VH-VBR
Boeing Company 737-7BX

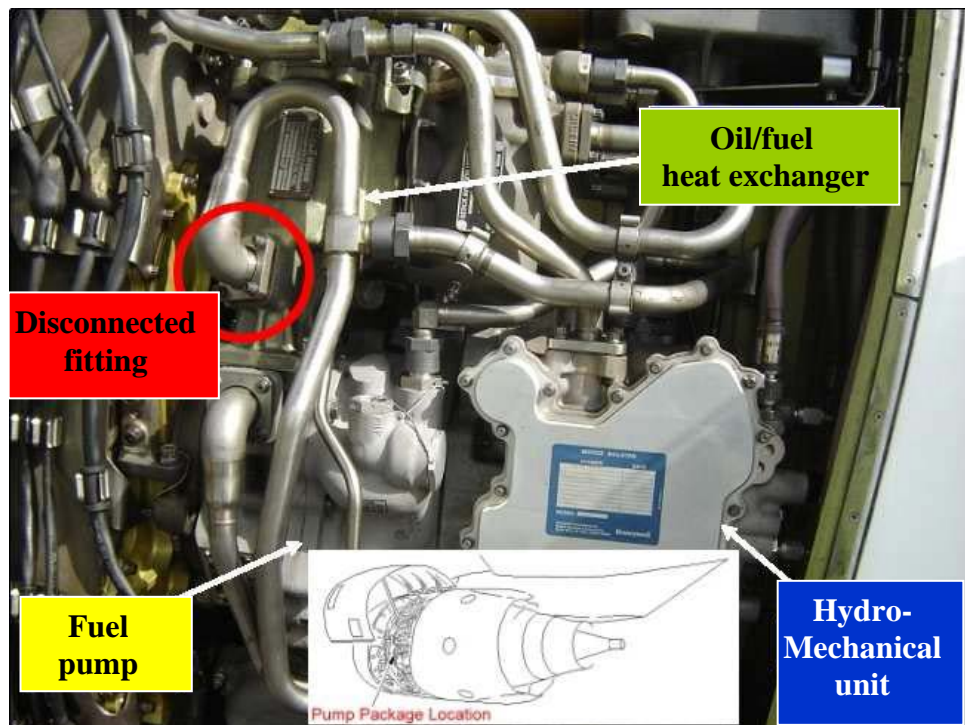
A subsequent examination of the number-2 engine during an engine ground run revealed that fuel was leaking from the engine 'fuel pump package' area. The fuel pump package incorporated the fuel pump, the hydro-mechanical unit (HMU) and an oil/fuel heat exchanger. The leak was identified as being from the main fuel return pipe where it connected into the oil/fuel heat exchanger. The pipe connection had partially disconnected from the oil/fuel heat exchanger (Figure 1).

Figure 1: Fuel return pipe to oil/fuel heat exchanger fitting

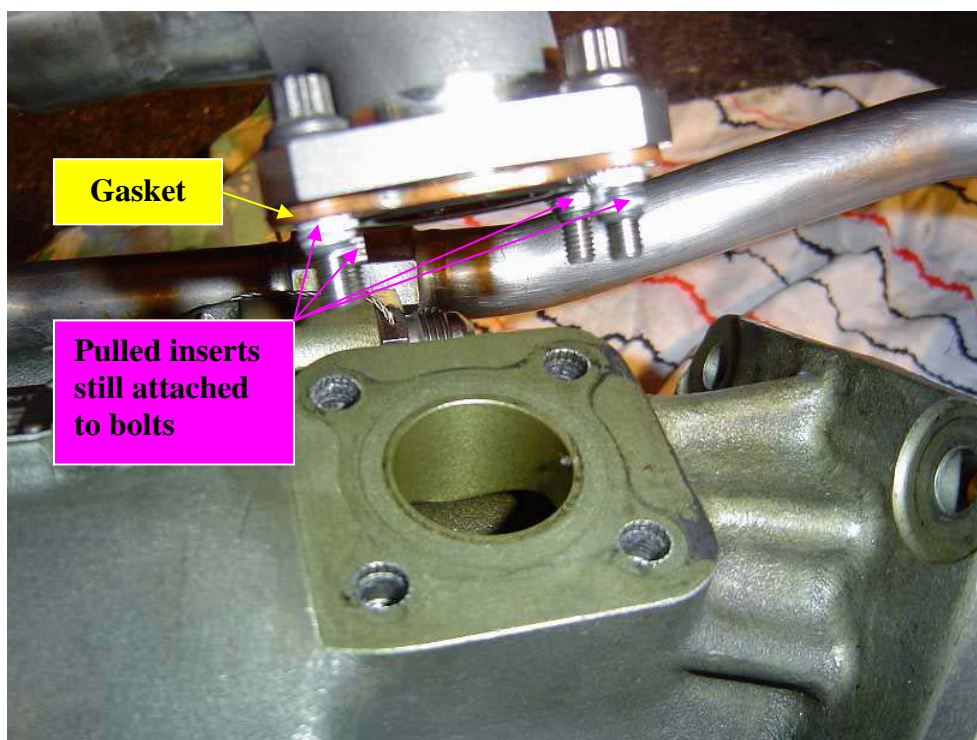
All four of the pipe attachment bolts were accounted for, being tightly connected to the fuel pipe flange plate. However, the corresponding steel-threaded inserts within the heat exchanger had failed and pulled free of the heat exchanger body, and were still attached to the bolts (Figure 2).

Figure 2: Fuel pipe flange plate and gasket showing pulled inserts

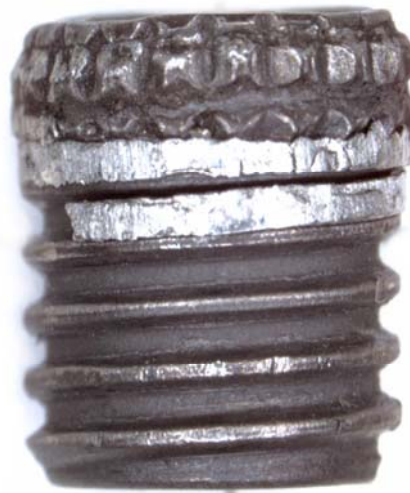
Examination by the ATSB of the supplied components showed that sufficient force had been applied to all four of the threaded inserts to pull them away from the body of the oil/fuel heat exchanger complete with thread material. An examination of the four blind holes in which the inserts had been tapped, revealed that the internal threads had been stripped (Figure 3).

Figure 3: Close view of one of the threaded inserts showing 'stripped' thread material from the heat exchanger

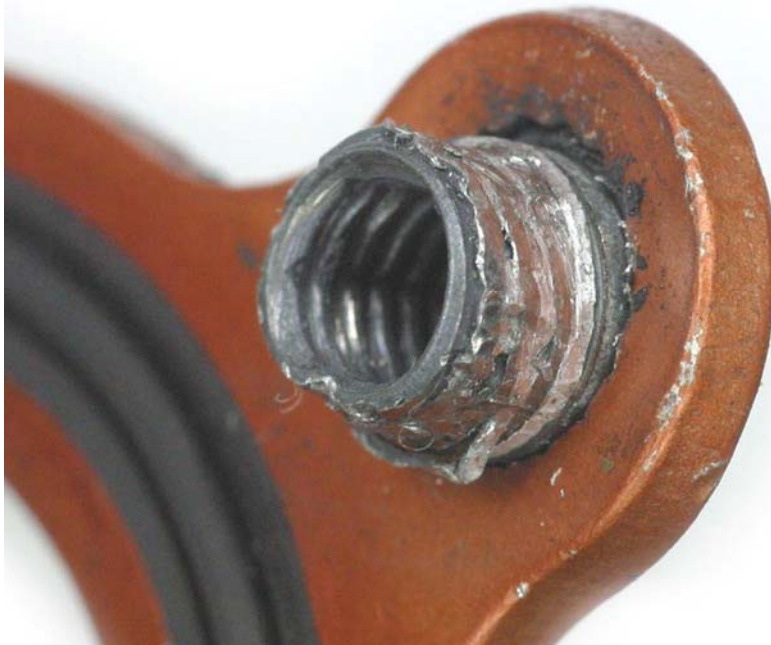
The examination also revealed that all four of the inserts had been pulled into the aluminium alloy substrate of the gasket. Three of the inserts had been completely pulled through the gasket (Figures 4 and 5), while the fourth had been pulled partially into the gasket.

Figure 4: Close-up of a threaded insert from the gasket assembly

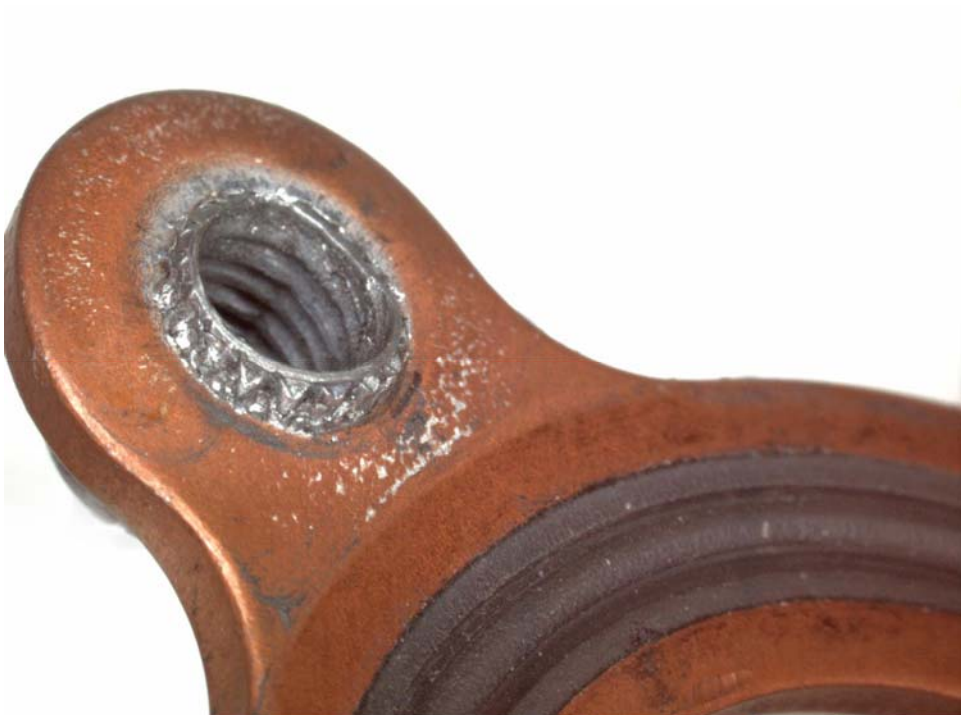
Figure 5: Opposite view of the insert from Figure 4, showing it had been pulled completely through the gasket

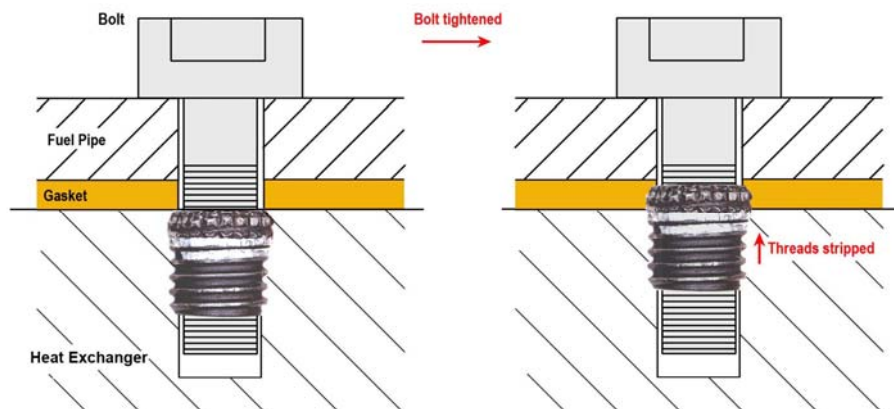
Thread material from the oil/fuel heat exchanger was still located within the thread of the inserts, indicating that exposure to excessive shear stress had occurred. The thread failure was a direct result of over-torque of the attachment bolts. The drawing of the inserts through the gasket material (Figure 7) indicated that the failure of the inlet flange threads would have occurred during the bolt tightening sequence during the previous maintenance activity to install the fuel pump package, 2 days earlier. Had the inserts failed due to flexing/vibration of the return fuel line during service subsequent to the fuel pump package fitment, the inserts would not have penetrated the gasket material. The lack of damage to the gasket and flange surface, as reported by the aircraft maintenance engineer (AME), indicated that the inserts had not commenced migration prior to the fitment of the fuel pipe.

Figure 7: Bolt tightening sequence showing thread stripping and insert migration into the gasket

The AME reported tightening the four attachment bolts to 60 pound-inches. The maintenance manual indicated that, for the modification status of the oil/fuel heat exchanger, the maximum torque applied to the bolts should have been 53 pound-inches. The AME's lack of awareness of the different modification states applicable to the oil/fuel heat exchanger and the differing torque values to be used, may explain the incorrect torque value applied to the attachment bolts.
