ATSB TRANSPORT SAFETY INVESTIGATION REPORT

Aviation Occurrence Report – 200600851

Aircraft loss of control - 20 km SSW Cootamundra, NSW

PZL M-18A, Dromader

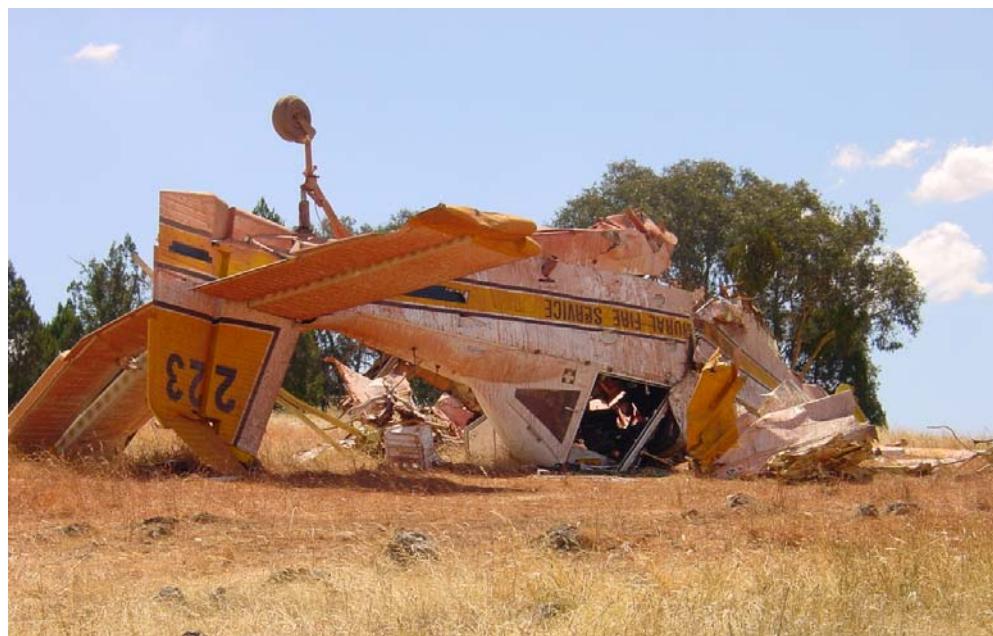
Figure 1: Accident site

The sound of an impact alerted the firemen to the accident. They looked up to see the aircraft moments after its collision with the ground and immediately went to render assistance. The aircraft was destroyed by impact forces (Figure 1).

The aircraft was destroyed by impact with the ground.

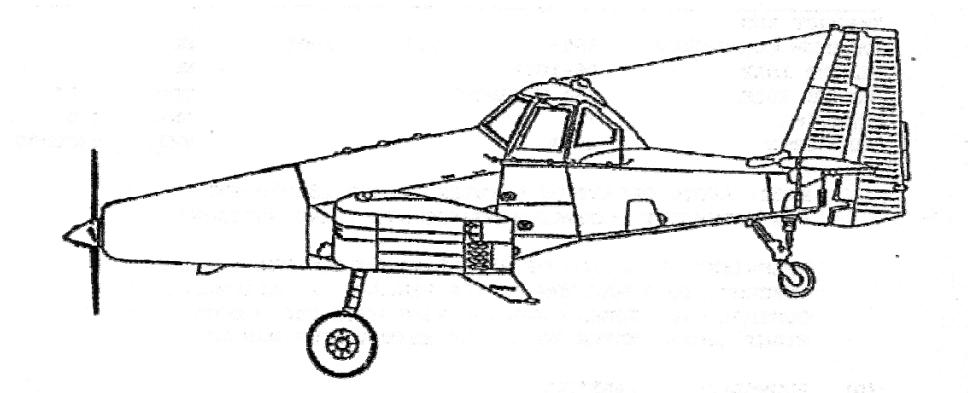
Figure 2: Side view of the modified Dromader

In November 2003, the aircraft was modified from the original type certificated design in accordance with a US Federal Aviation Administration (FAA) approved Supplemental Type Certificate (STC) and Australian engineering orders. The original radial engine was removed and a Honeywell turbine engine, capable of developing 1100 SHP, was installed. A Hartzell 5-blade constant speed propeller, driven through the engine's reduction gear box, replaced the original 4-blade propeller.

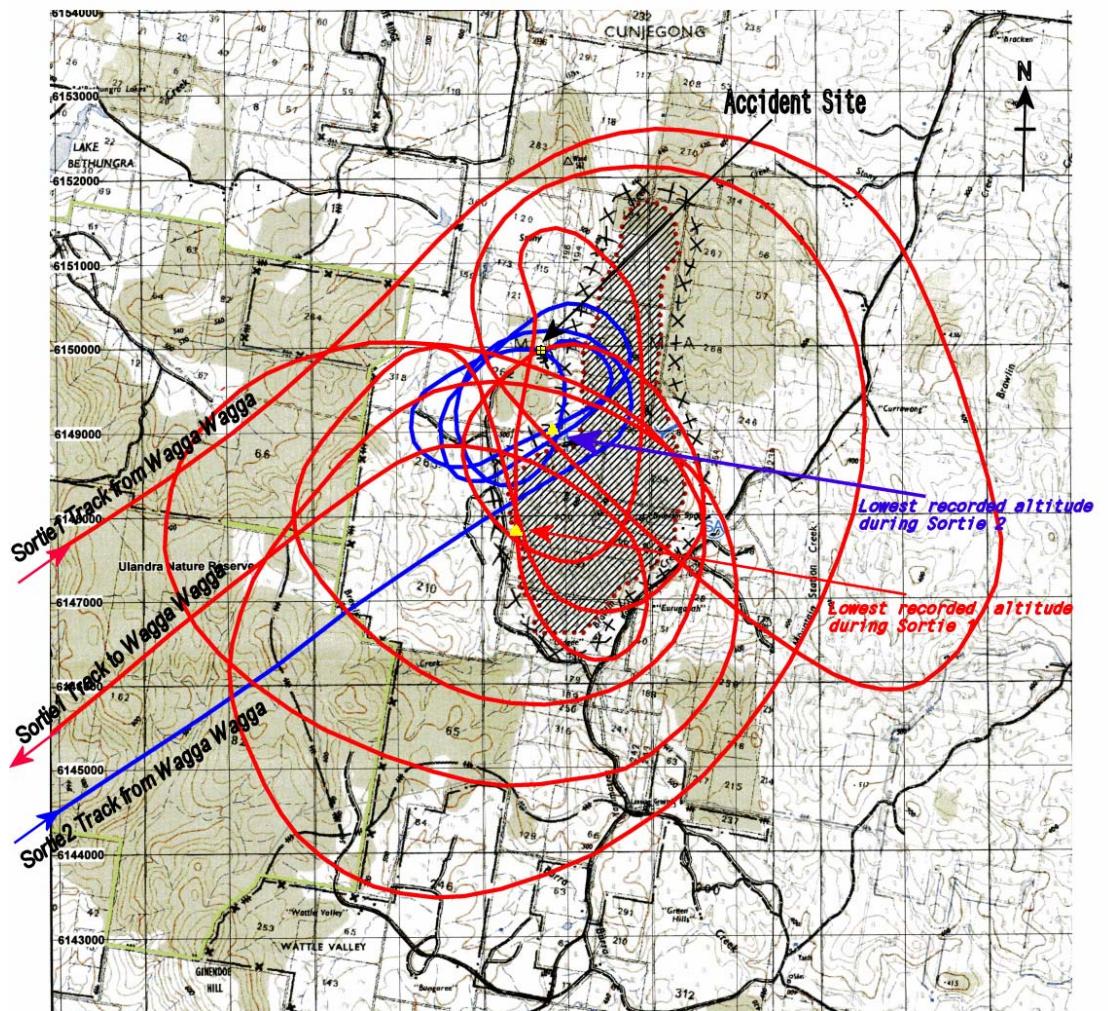
Figure 3: GPS tracks of FVF on 16 February 2006 (hatching shows fire area)

The GPS data for the first flight on 16 February 2006 (depicted in red at Figure 3), when the Dromader pilot followed the other fire bomber, showed the aircraft's flight to the fire area and a series of four, wide, right circles flown around the fire area, followed by three smaller left orbits. These were made as the pilot of the lead aircraft coordinated the best location for the retardant drop with fire fighters on the ground and with the pilot of a fire-bucket helicopter. During the last orbit, the turns were of a much smaller radius. The retardant drop was made in a southerly direction on the south-western perimeter of the fire area.

The second flight over the fire area (depicted in blue at Figure 3) was characterised by a series of left orbits over the fire area, with turns of generally smaller radius than those on the first flight. The aircraft had completed four orbits and was commencing its fifth when the accident occurred. During the third orbit, the aircraft descended briefly to a GPS altitude of 1,700 ft above mean sea level (AMSL) before climbing to approximately 2,000 ft AMSL. That low pass was made on a north-easterly heading and coincided with a swathe of retardant on the western perimeter of the fire area, north of the previous drop.

It was not possible to determine from the characteristics of the flight path if any retardant had been dropped on the fire area. A comparison with drops made on the previous flight and on the day before, showed some differences in that:

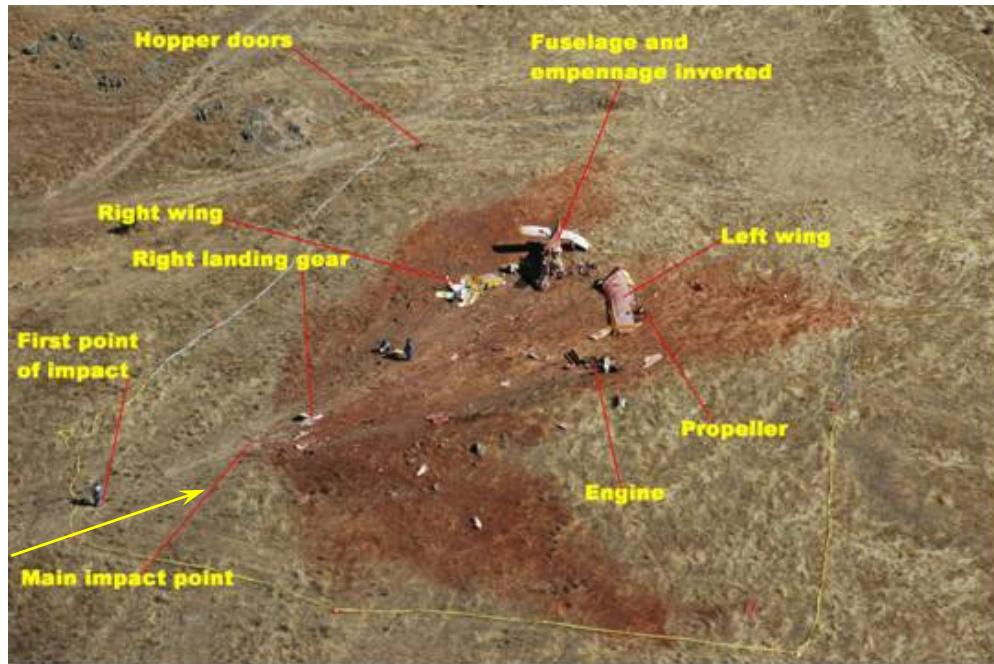
Figure 4: Aerial view of the wreckage showing direction of flight

The impact damage was consistent with the aircraft having impacted the ground heavily in a nose-down, right wing-low attitude, with a high rate of descent and at a low to moderate forward speed.

The first impact mark was made by the right wingtip. A further 10 m beyond this point was the main impact ground scar, where the engine and lower fuselage, including the hopper fire-door, had impacted the ground. A further 3 m along the wreckage trail were two of the propeller blades embedded in the ground. At this point, the engine mounts appeared to have broken away and the fibre glass hopper disintegrated as the aircraft break-up sequence commenced.

About 1 m further along the wreckage trail was the right main landing gear, which had separated from the wing. At this point the aircraft started to tumble and both main wings had separated from the fuselage. The damaged right wing lay to the east of the fuselage and exhibited considerable damage to the wing primary structure, consistent with having struck the ground. The left wing was lying on the other side of the fuselage and had separated as the aircraft tumbled. The left gear leg was attached to the wing structure but bent aft at 90°.

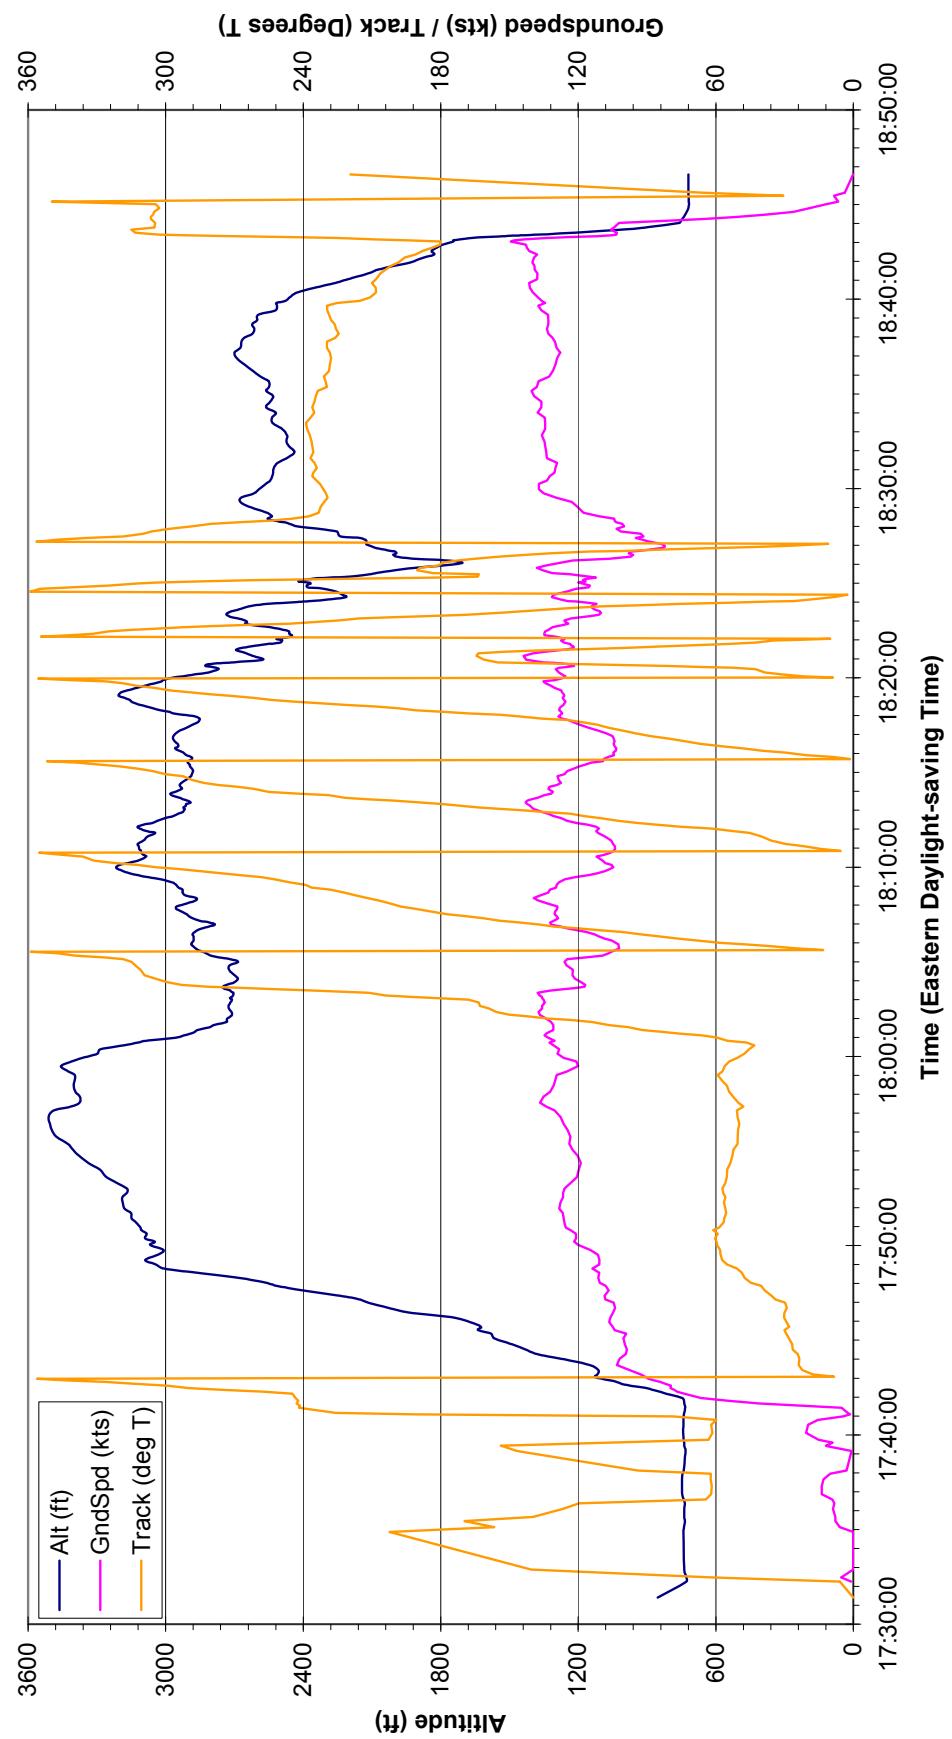
VH-FVF 16 Feb 2006 Sortie 1

Recovered GPS data from the aircraft's receiver for the flight on 15 February 2006 and for both flights made on 16 February 2006 was downloaded and the parameters for track, groundspeed and GPS altitude was plotted and is presented on the following charts.
