**ATSB TRANSPORT SAFETY INVESTIGATION REPORT**

Aviation Safety Occurrence Report – 200506266

**In-flight breakup**  
**28 km north of Condobolin, NSW**  
**2 December 2005**  
**VH-PYN**  
**Piper Aircraft Corporation PA-31-350**

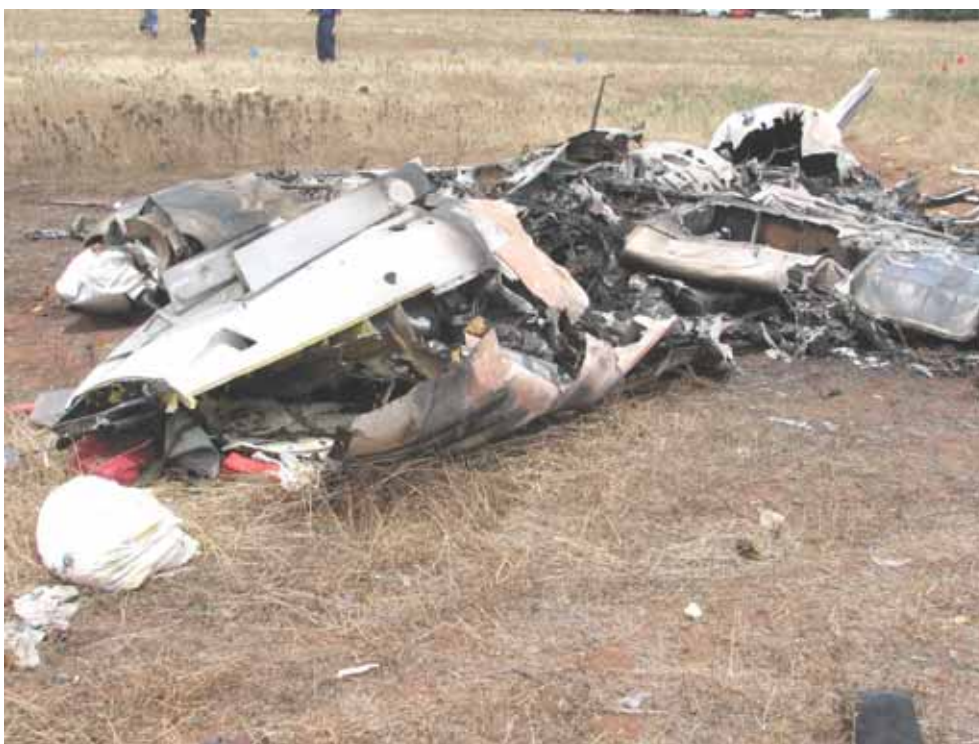
Sections of the aircraft's extremities and control surfaces, along with the right engine, had separated during flight. The fuselage and remaining wing sections, with the left engine still attached, impacted the ground inverted and were destroyed by a post-impact fuel-fed fire (Figure 2).

**Figure 2: Burnt, inverted fuselage and inner wing sections**

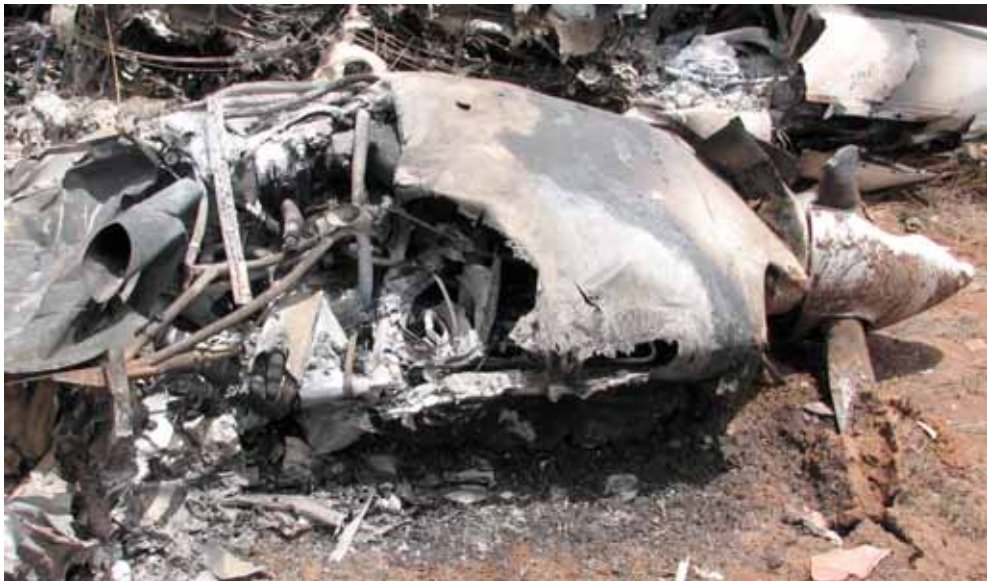
- The position of the engine controls at impact could not be determined.
- The left engine remained attached to the aircraft and had received significant fire damage (Figure 6).
- The left propeller had no indications of rotation at ground impact. One left propeller blade had broken off approximately 10 cm from the blade root. The separated blade section was not found. That blade had failed in overload, possibly when struck by a part of the aircraft during the break-up sequence.
- The right engine showed no evidence of fire damage (Figure 7).
- The right propeller blades were in the feathered position at impact.
- There was evidence on the propeller flange that the propeller was rotating at the time the engine was torn from the wing.

**Figure 6: Left engine showing broken propeller blade**

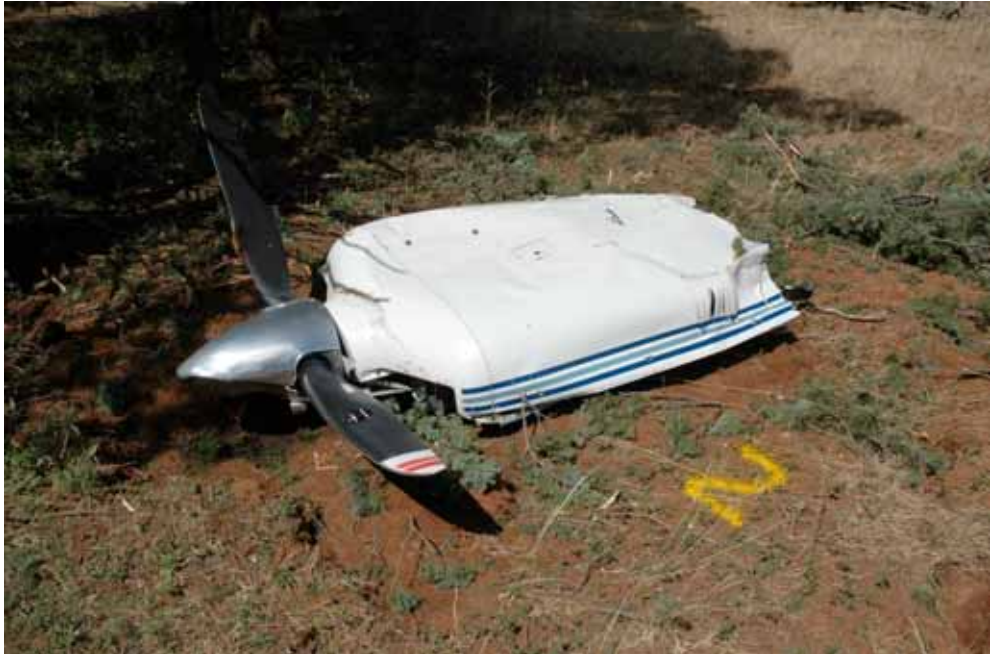
**Figure 7: Separated right engine**

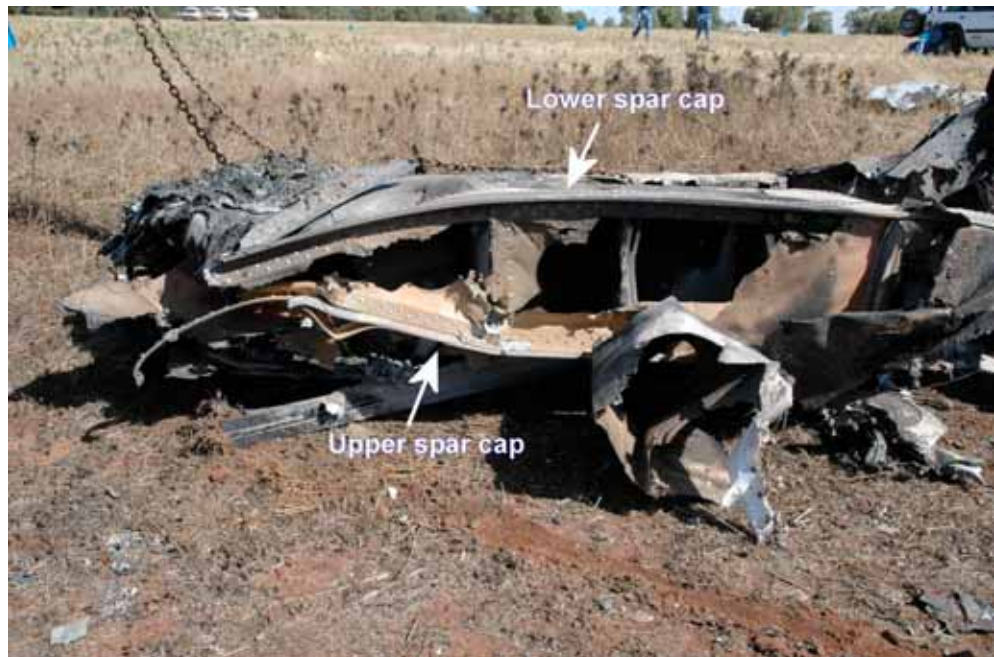
The fuselage impacted the ground inverted, with low forward speed. Both wings had failed outboard of the engine nacelles (Figure 8). The right engine had separated from the aircraft and was found about 300 m from the fuselage. The left engine remained attached to the wing.

**Figure 8: Failed left wing main spar (inverted) outboard of engine nacelle**

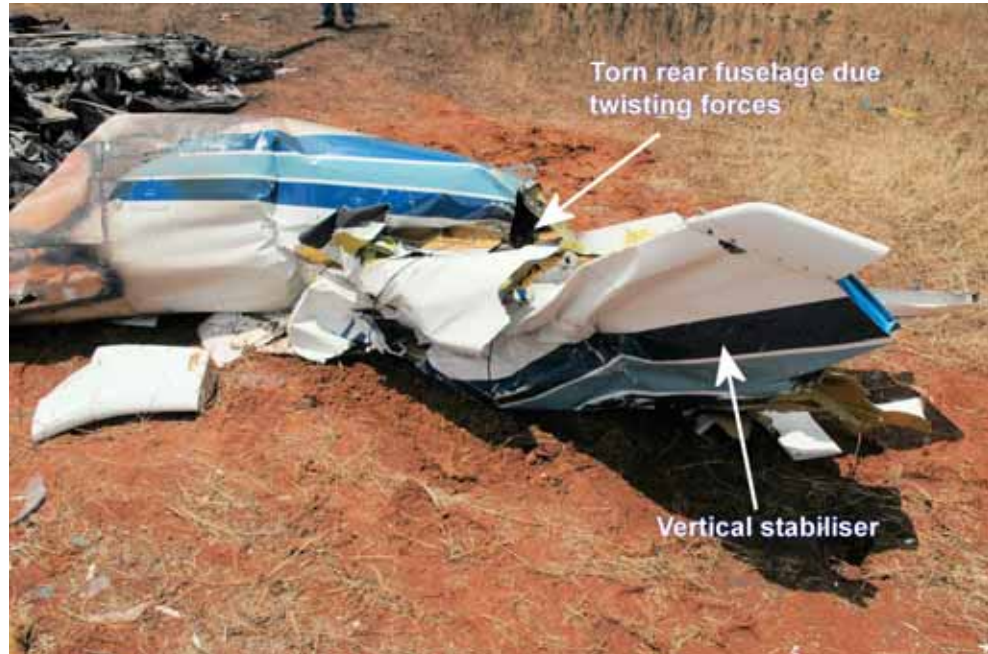
The rear fuselage and empennage showed evidence of severe torsional twisting to the right, typically incurred by an extreme rate of roll in the opposite direction (Figure 9).

**Figure 9: Torsional twisting to rear fuselage and empennage**

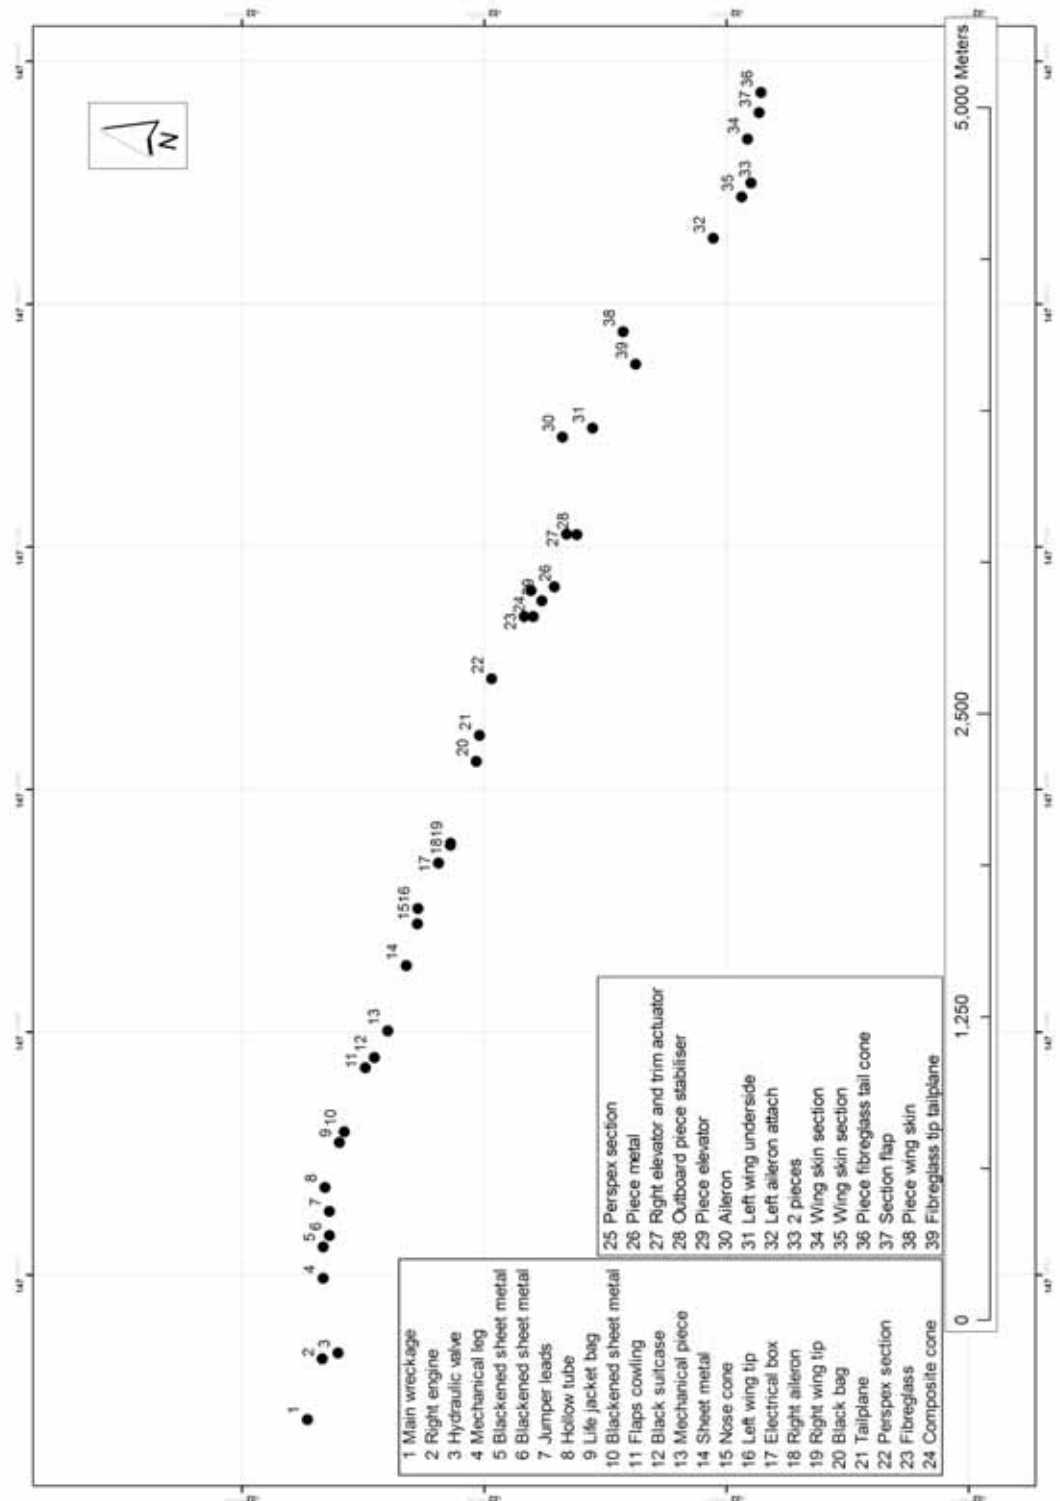
**Figure 10: Location and identity of recovered wreckage**

There was no evidence of heat, smoke, or fire damage to items 11 to 39 inclusive (Figure 10, see also 1.14 Fire). No evidence was found of hail or lightning strike damage to any section of the aircraft found along the wreckage trail.

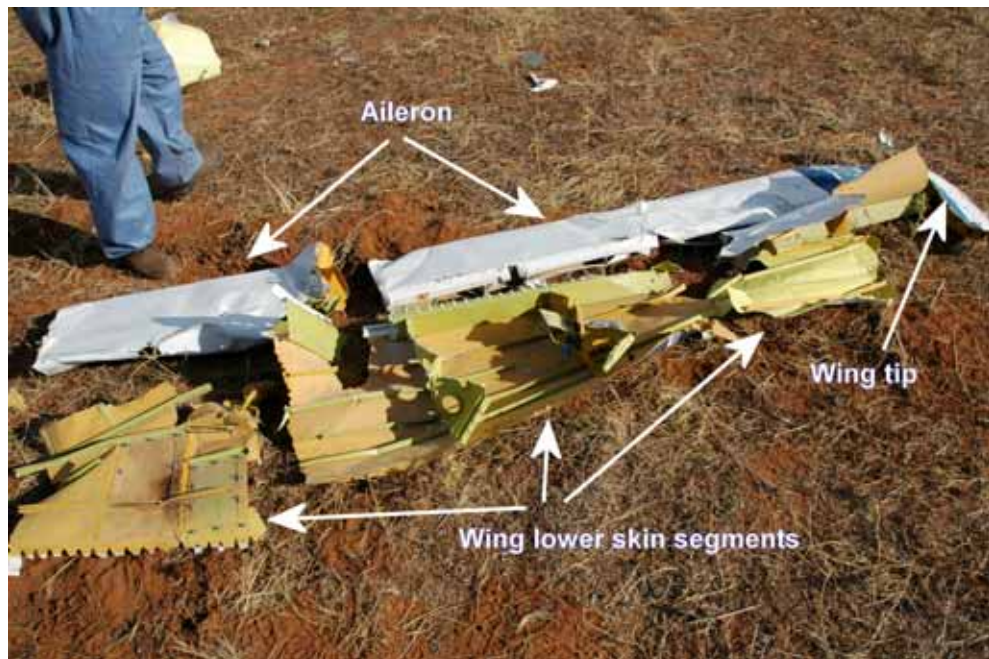
An example of the nature of the disruption that occurred to the outer wing structures is demonstrated by the recovered left wing pieces shown in Figure 11, roughly reassembled. The outer right wing sustained similar damage.

**Figure 11: Recovered outer left wing pieces showing extent of destruction**

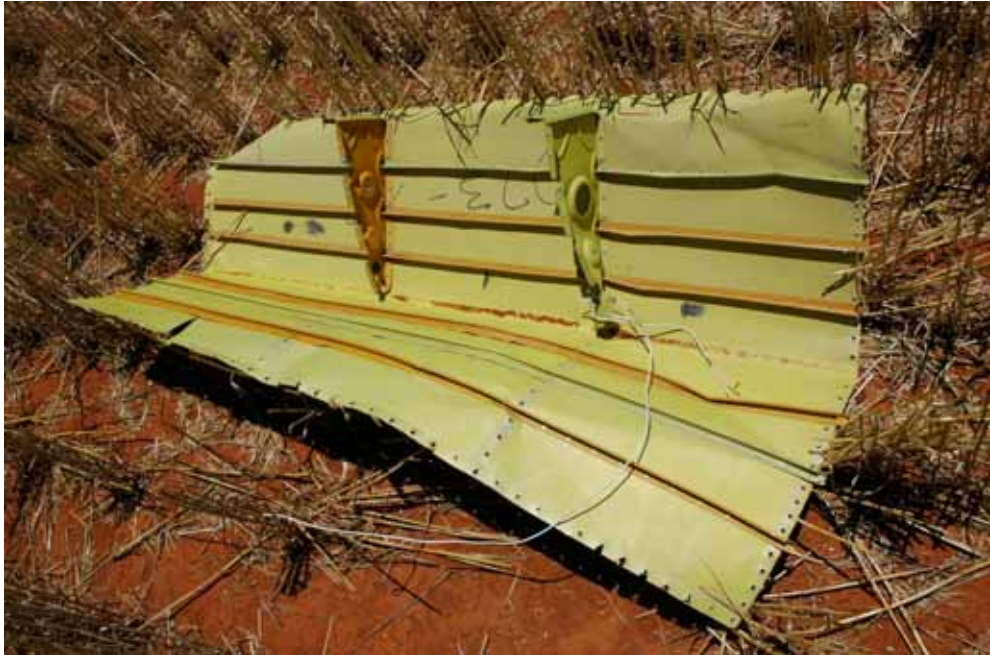
- The shape and edge profile of a section of the right wing leading edge indicated that the section was torn off towards the leading edge of the wing. That damage implied that the wing was not moving in the conventional forward flight direction when the section separated (Figure 12).

**Figure 12: Section of right wing leading edge**

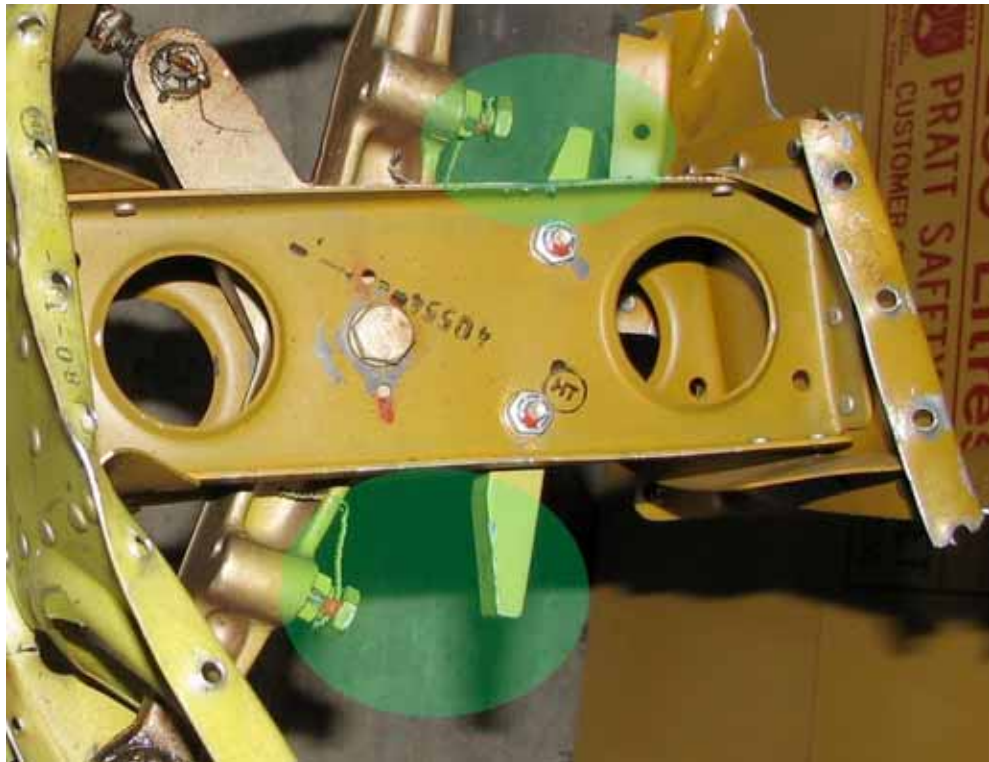
**Figure 13: Showing right aileron stops (shaded)**

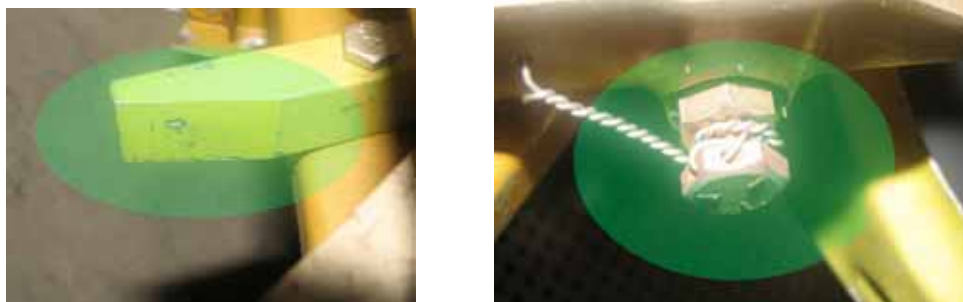
- The right aileron, at about its mid-span position, had been bent upwards at least 60 degrees at some point during the breakup sequence. The condition of the hinges and their surrounds suggested that the aileron was forced in a span-wise direction during the break-up.
- The right aileron trim tab remained attached, and the trim tab control rod was firmly attached to the trim and its control mechanism screw jack. Both trim cables were attached to the drum but had failed in overload. The aileron stops and the aileron bell crank travel stops were in place and showed no discernable deformation (Figure 13). There was no evidence of repetitive, hard contacts on any of the stops (Figure 14).

**Figure 14: Right aileron stops showing absence of repetitive contact**
