**ATSB TRANSPORT SAFETY INVESTIGATION REPORT**

Aviation Occurrence Report – 200403238 / 200404436

**Abnormal airspeed indications  
En route from/to Brisbane Qld  
31 August 2004 / 9 November 2004  
Bombardier Aerospace DHC8-315  
VH-SBJ / VH-SBW**

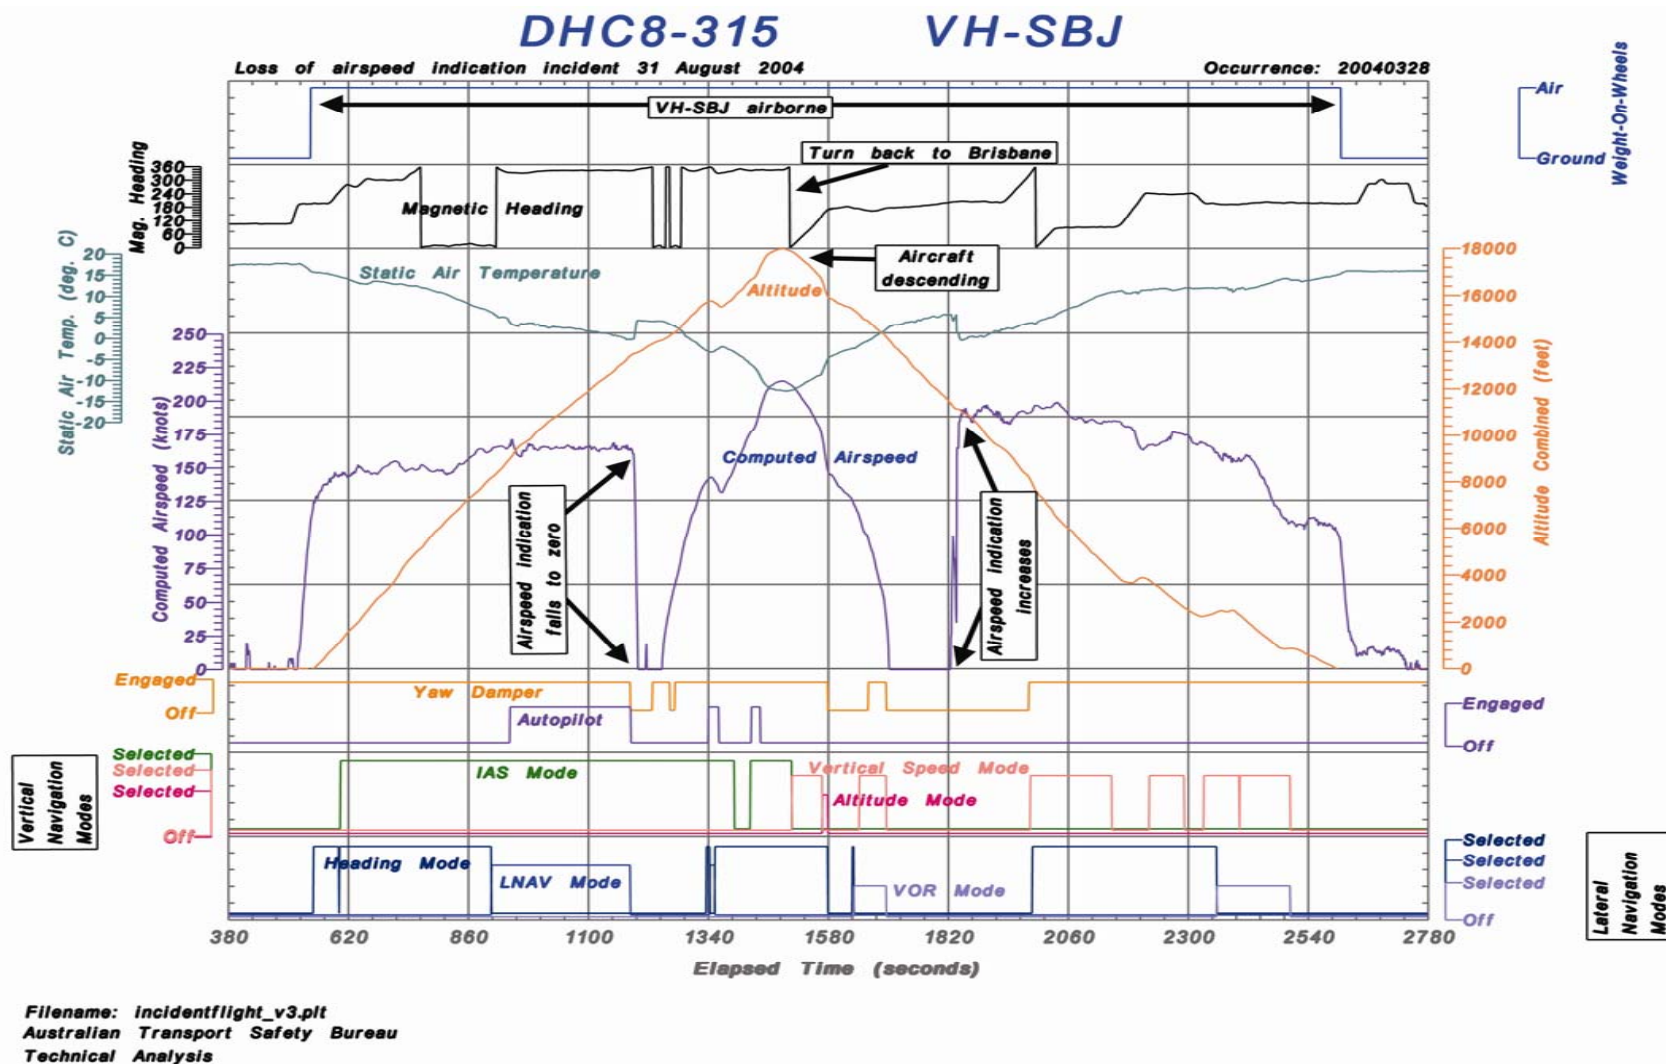
Figure 1: Plot of FDR data showing the incident flight

Figure 2 is a plot of the incident showing a reduced number of parameters and an expanded time scale. Figure 2 shows that between an elapsed time of 1,100 and 1,900, the computed airspeed trace can be seen to drop to zero for a short period then, as the aircraft continues to climb, increases until the aircraft begins to descend. As the aircraft descends, the computed airspeed value also decreases, reaching zero for a short period before rising rapidly to a normal value.

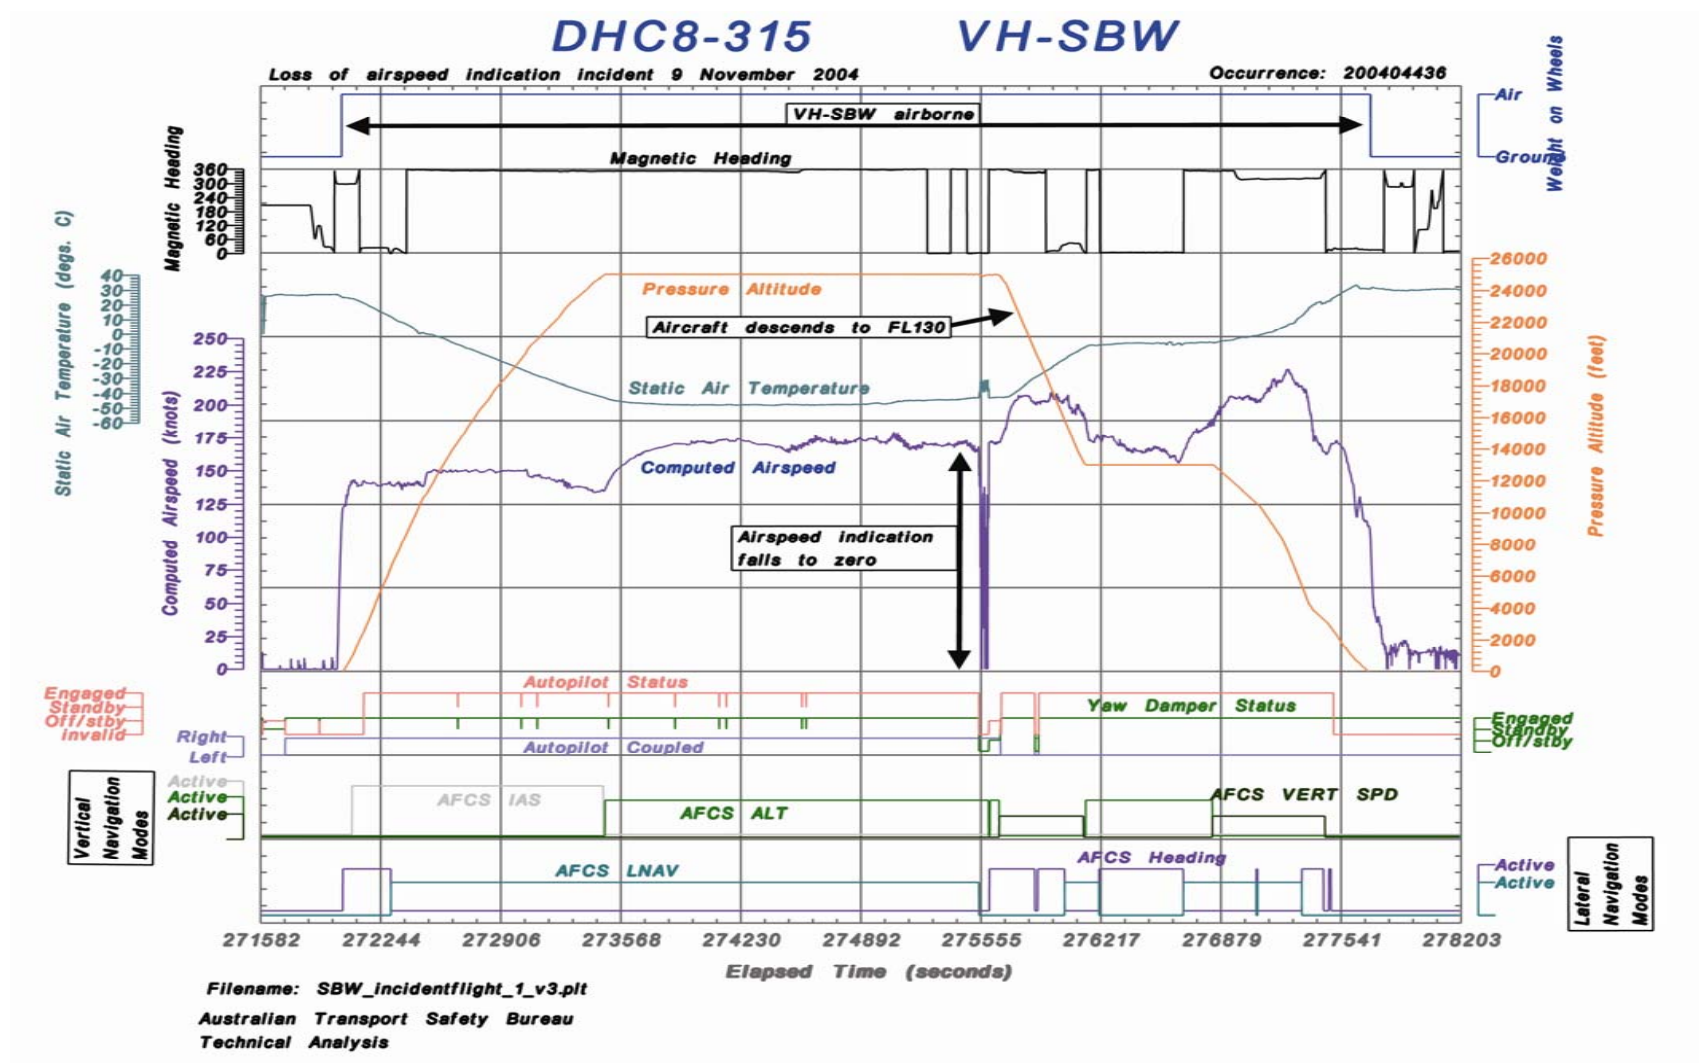
Figure 3: FDR information relating to flight from Williamtown NSW to Brisbane Qld

The recorded FDR information closely correlated with the flight crew report. The comment by the crew that the copilot's airspeed fell to zero, was confirmed by the FDR information. Airspeed values appeared normal after the left horizontal situation indicator (HSI) source was selected; control of the aircraft and systems being transferred to the pilot in command. The selection of the HSI also transfers the source of DADC information that is recorded by the FDR.

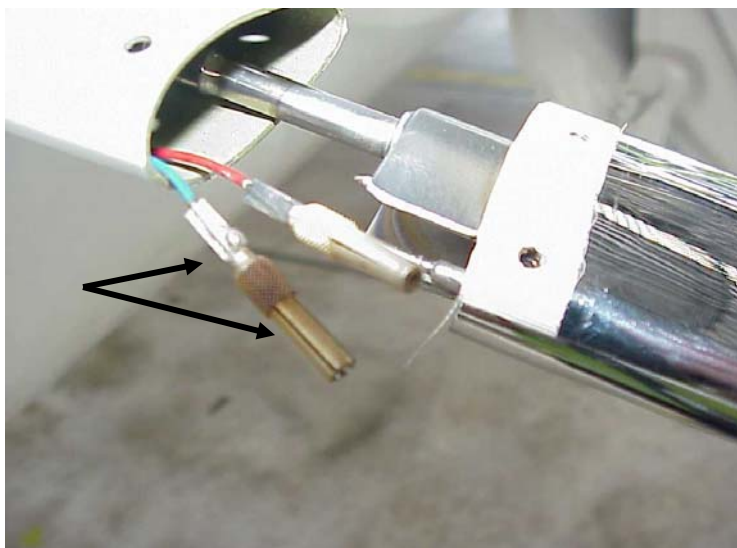
On 8 November 2004, DHC8-315, VH-SBI, which had been recently delivered to the operator, developed abnormal indications of the pitot heat system. Evidence was found that solder had been melting and re-solidifying in the solder joint between the wiring and the heater element electrical sockets, see figure 8 and 9.

**Figure 8: Photograph of electrical sockets fitted to VH-SBI (note - globule of solder and discolouration seen on socket attached to blue wire)**

An examination of the solder present on the electrical sockets showed that it was a tin-lead alloy with no silver present.

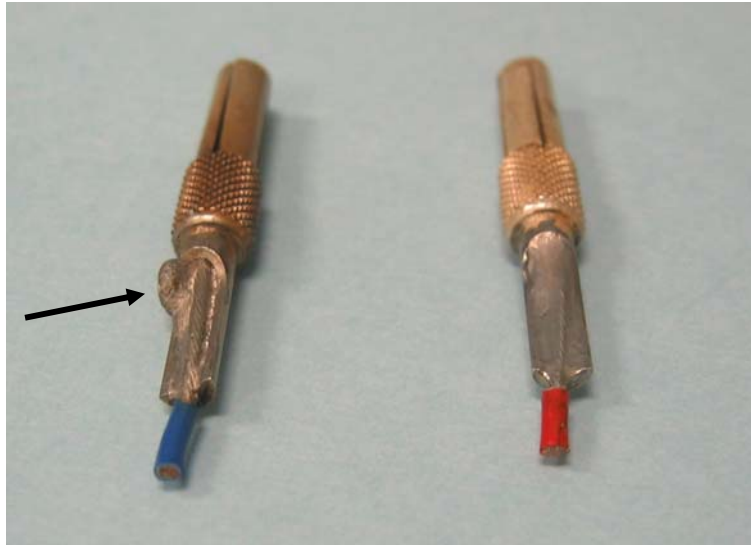
**Figure 9**     **Photograph of connector pins solder joint**

The use of solder alloy containing 60% tin and 40% lead, rather than the recommended 63% silver and 37% lead, lowers the tolerance to elevated temperatures by the soldered joint at the pitot head heater connections. *[Safety issue]*

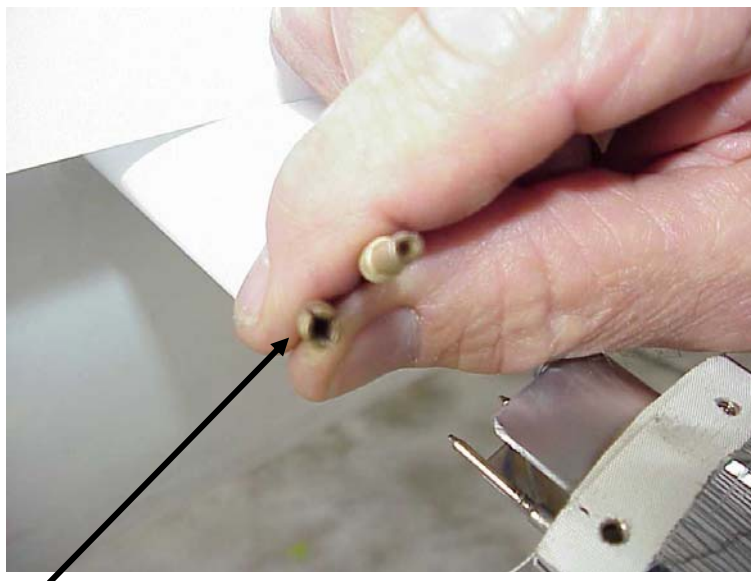
The tines on the electrical heater element socket connected to the blue wire had become discoloured and splayed, preventing them from gripping the mating pin firmly, see figure 10.

**Figure 10: Photograph of tines of electrical socket fitted to VH-SBI.**
