Aviation Occurrence Report – 200604949

**Flight control system event  
120 km north of Brisbane Airport, QLD**

**VH-VBN**

**Boeing Company 737-76N**

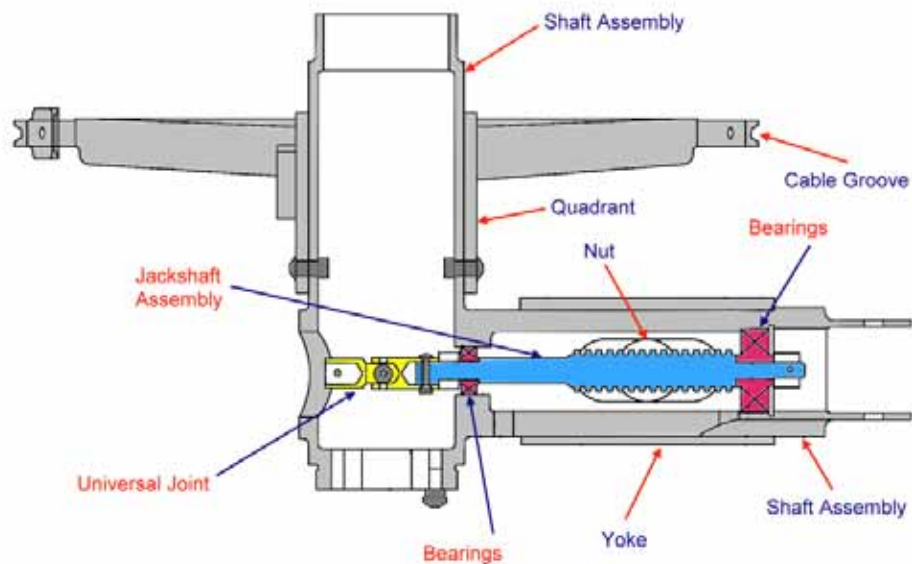
**Figure 1: Jack shaft assembly cross-section**

Further detailed examination of the jackshaft assembly by the component manufacturer indicated that the bearings and the universal joint of the shaft assembly were worn excessively (figure 1). The bearings and universal joint were replaced and the jackshaft returned to service.

The anomaly with the rudder control system as reported by the flight crew was the result of excessive wear of the bearings and universal joint of the jackshaft assembly.

With the knowledge of past rudder safety related advisories involving uncommanded inputs on this model of aircraft, the rudder anomaly may have led the flight crew to believe that there was a problem with the rudder control system. The wear of the components of the jackshaft assembly, although not desirable, was not an immediate safety of flight concern for the operation of the aircraft.

As a result of the occurrence, the aircraft operator has issued a flight crew operations notice to caution their pilots on applying force to the rudder pedals while adjusting the pedal length. They have also issued an engineering notice highlighting this occurrence.
