ATSB TRANSPORT SAFETY INVESTIGATION REPORT  
Marine Occurrence Investigation No. 234  
Final

Independent investigation into the engine room fire on board the  
French Antarctic supply ship

# L'Astrolabe

11 November 2006

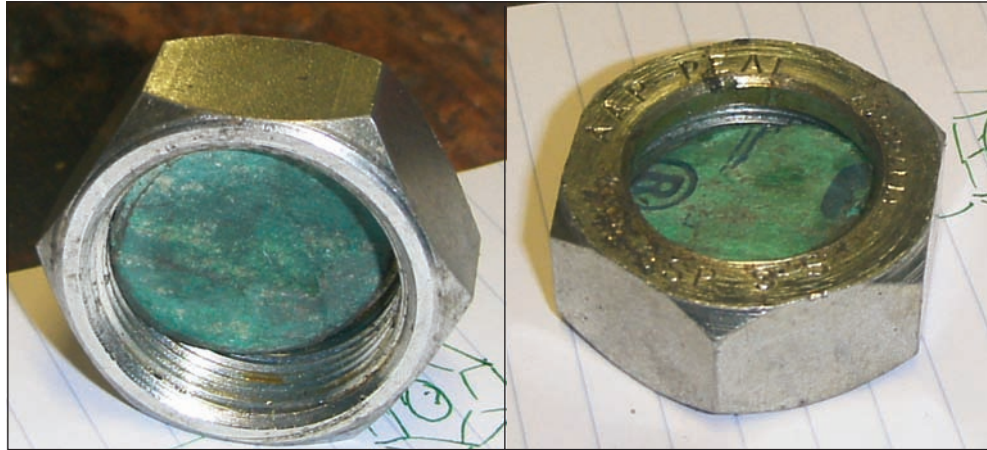
**Figure 3: Similar blanking materials**

Each pipe was blanked off using two discs of flexible gasket material, backed by a copper disc, held against the pipe end by an open ended, threaded pipe union fitting (Figures 3 and 4). At 2100, the starboard main engine was re-started. There were no leaks from the blank so the engine was clutched in and returned to service.

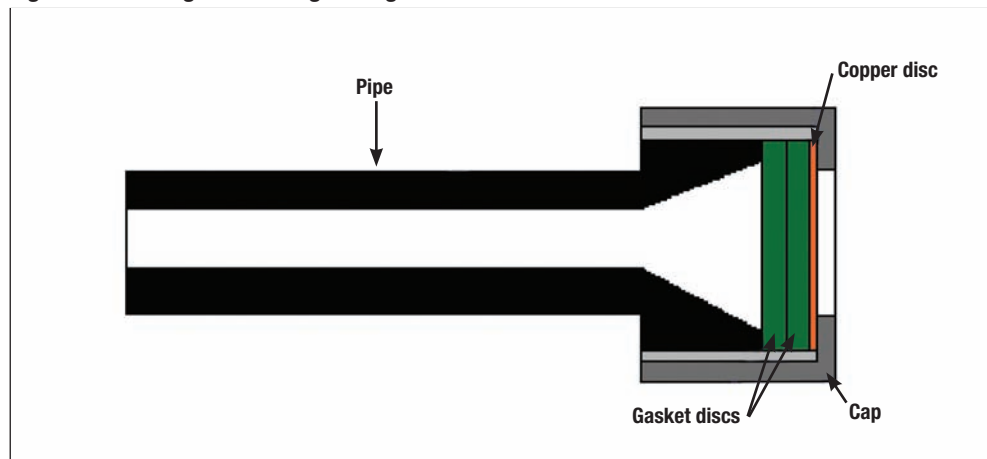
**Figure 4: Drawing of blanking arrangement**

In the case of the blank fitted to the main fuel pump discharge line by *L'Astrolabe's* engineers, as the pressure pulses occurred within the fuel rail, the gasket and the thin copper discs fitted between the pipe taper and the open ended cap (Figure 4) would have flexed like a diaphragm. The flexing of the discs would have allowed them to deform and become progressively looser within the cap. Ultimately, it is probable that the discs became loose enough to allow a fuel leak to develop.

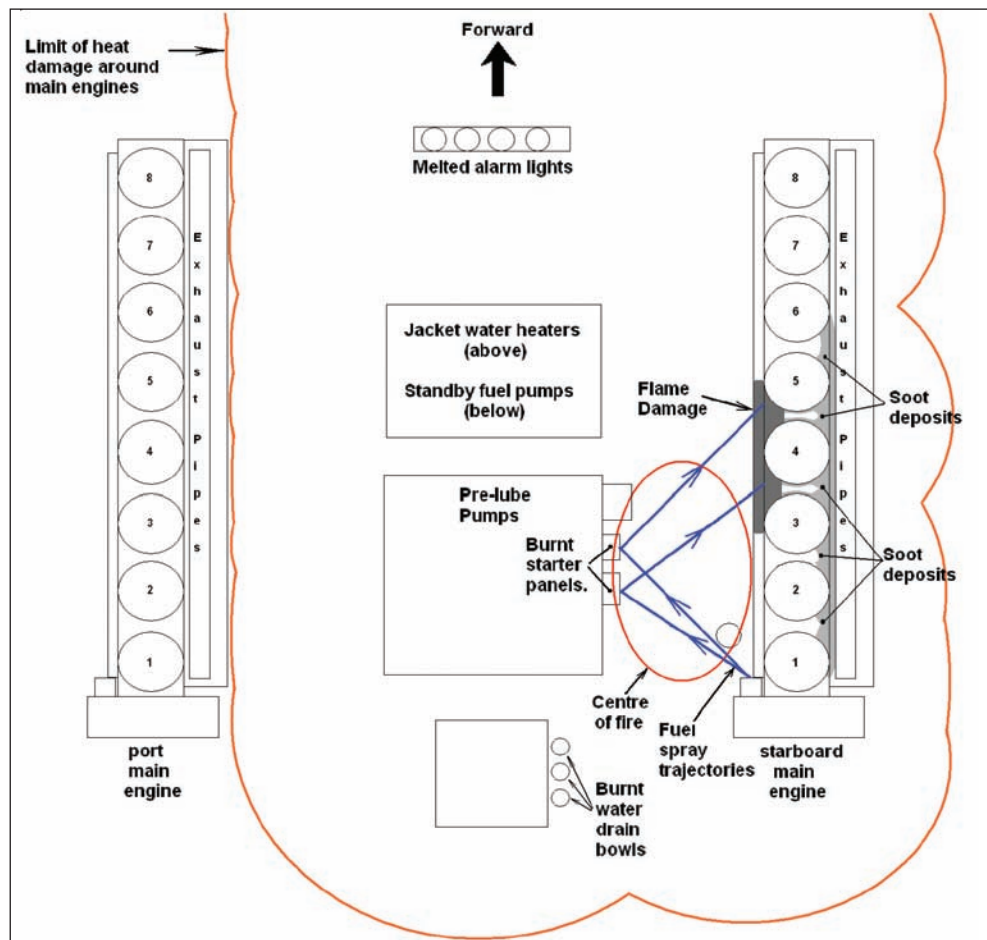
Figure 7: Fire damage and spray path diagram

An examination of the fire scene revealed that the area that was affected by heat extended along the deck head to about 3 m aft of the electrical starter panels between the engines and forward to the control room bulkhead. The direction of travel of the heat was from the seat of the fire and forward towards the funnels (Figure 7), as directed by the ventilation within the engine room. The worst damage was limited to the inboard side of the starboard engine, the electrical panels adjacent to it and the deck head above this area.

The fuel leaking past the discs would probably have been in the form of a fine spray which was directed away from the engine and towards the electrical starter panels and pumps located between the engines. The spray was then probably deflected off the electrical panels and back towards the starboard main engine (Figure 7).

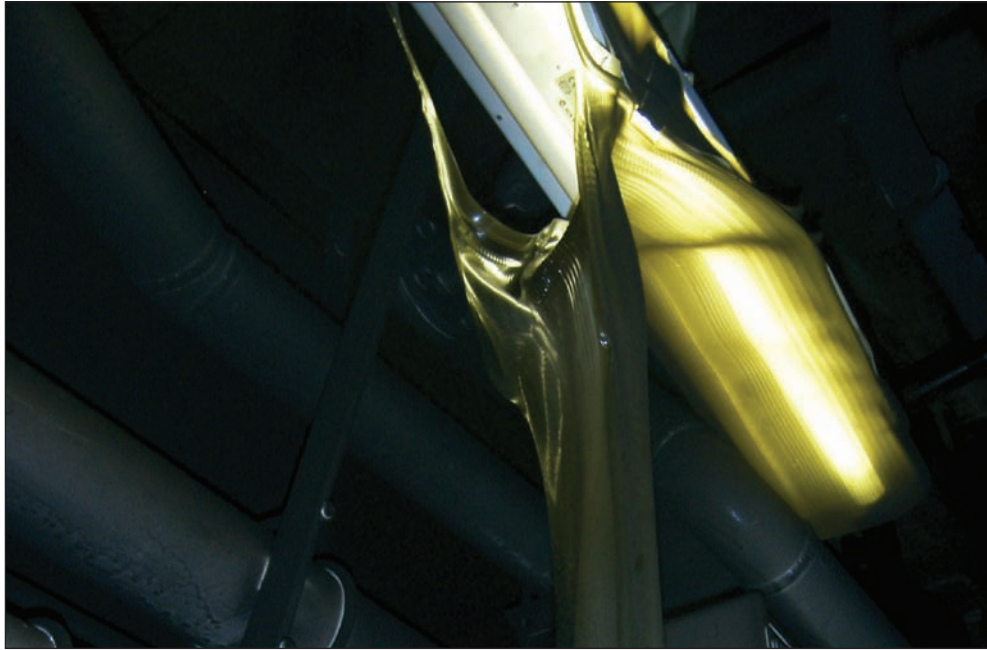
**Figure 8: Melted light diffuser**

All of the fluorescent lights in the heat affected area were either damaged or destroyed. The fluorescent light fitting mounted forward of the starboard main engine, and about one metre below the deck head, had melted (Figure 8). This indicated that the temperature reached in this area was in excess of 240°C, the melting point of the polycarbonate diffuser.

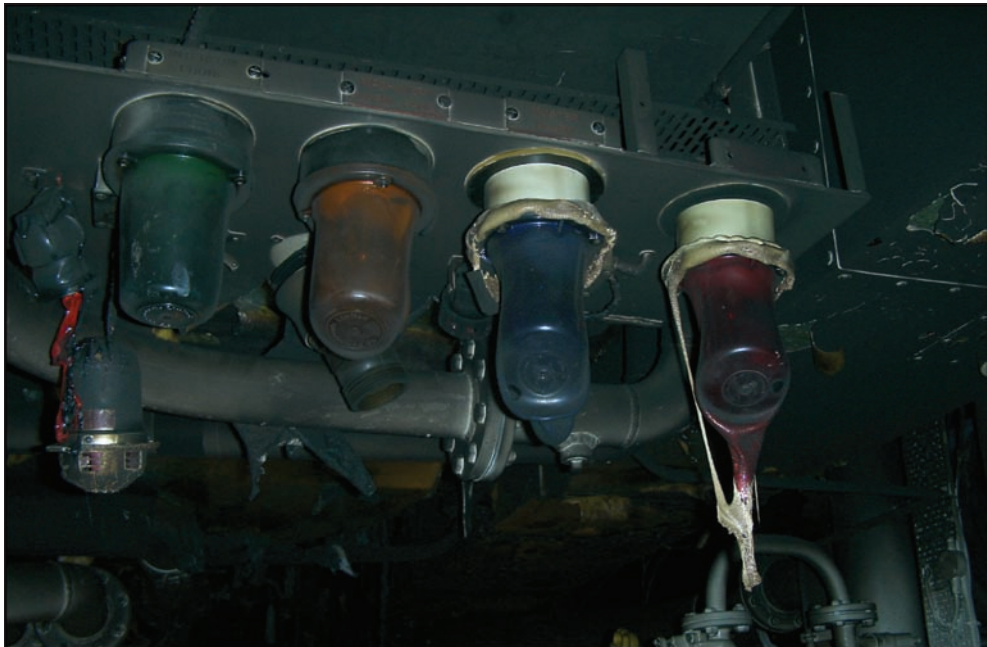
**Figure 9: Melted alarm lights**

A bank of alarm lights mounted about 1.5 m below the deck head forward of the engines was also damaged (Figures 7 and 9). The lower degree of heat damage to the covers indicates that these lights were exposed to less heat.

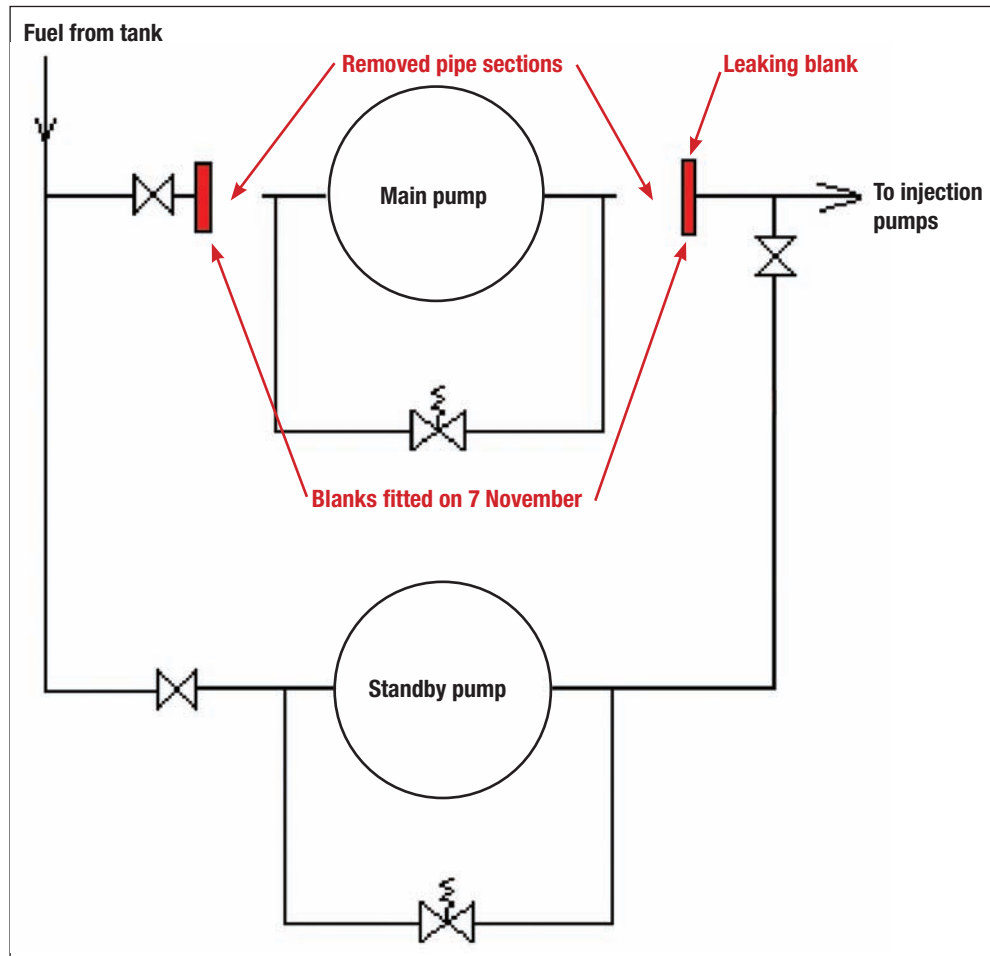
**Figure 10: Section of fuel system schematic showing location of blanks**

On 7 November, the engineers needed to stop fuel leaking from the damaged shaft seal of the main fuel pump. They fitted blanks to the supply and discharge pipes (Figure 10) so that they could run the engine using the stand by pump and stop the main pump from becoming pressurised. If a valve had been fitted in the main fuel pump's discharge pipe, the blanks would not have been necessary. The act of closing the isolating valves would have prevented the pump's body from becoming pressurised while running the stand-by pump and the integrity of the fuel system would have remained intact.

By using a set of gasket and copper discs held against a tapered pipe by an open ended cap, the engineers fabricated a blank, on 7 November, for the fuel rail on the starboard main engine that was unsuitable for the task because of the pressure pulses within the fuel system. The failure of the blanking arrangement resulted in the fuel leak which ultimately led to the fire.

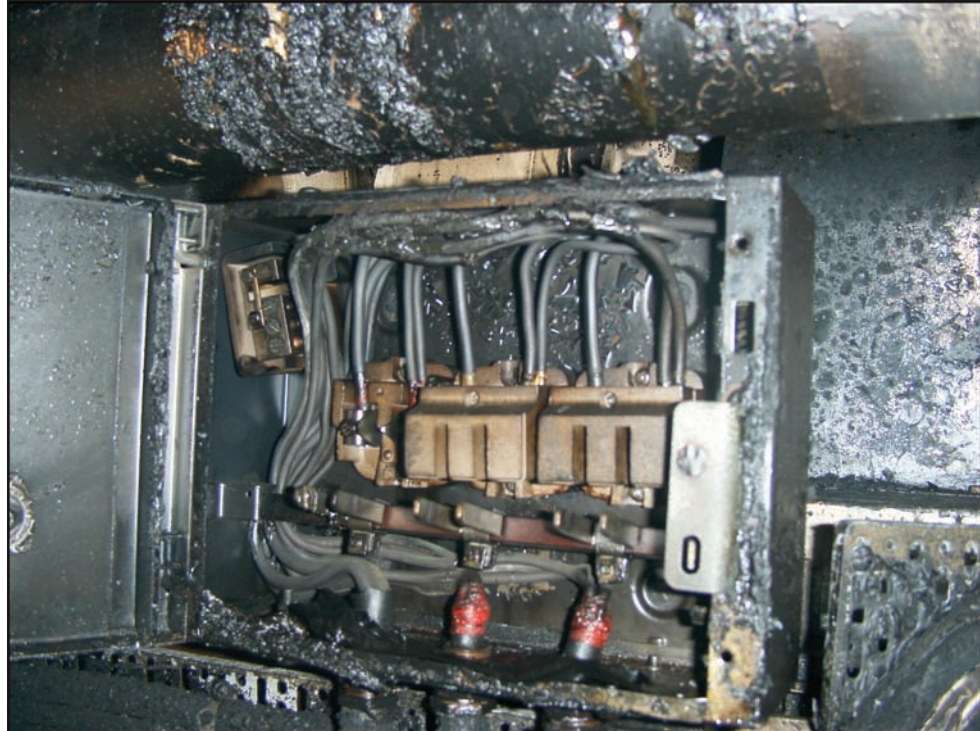
**Figure 11: Jacket water heater starter panel**

The electrical starter panels for the jacket water heaters were in line with the spray of leaking fuel (Figure 7) but these panels had rubber seals on the panel's covers. Furthermore, power to the starter panels was isolated by pulling out the circuit

breakers (Figure 11) so it is extremely unlikely that ignition could have occurred inside the panel. The outside of the starter panels and the wiring inside the panels was burnt by the heat from the burning spray of fuel that impinged on them but there was no evidence of burnt fuel inside the panels. This indicates that the starter panels almost certainly did not provide the ignition source for the fire.

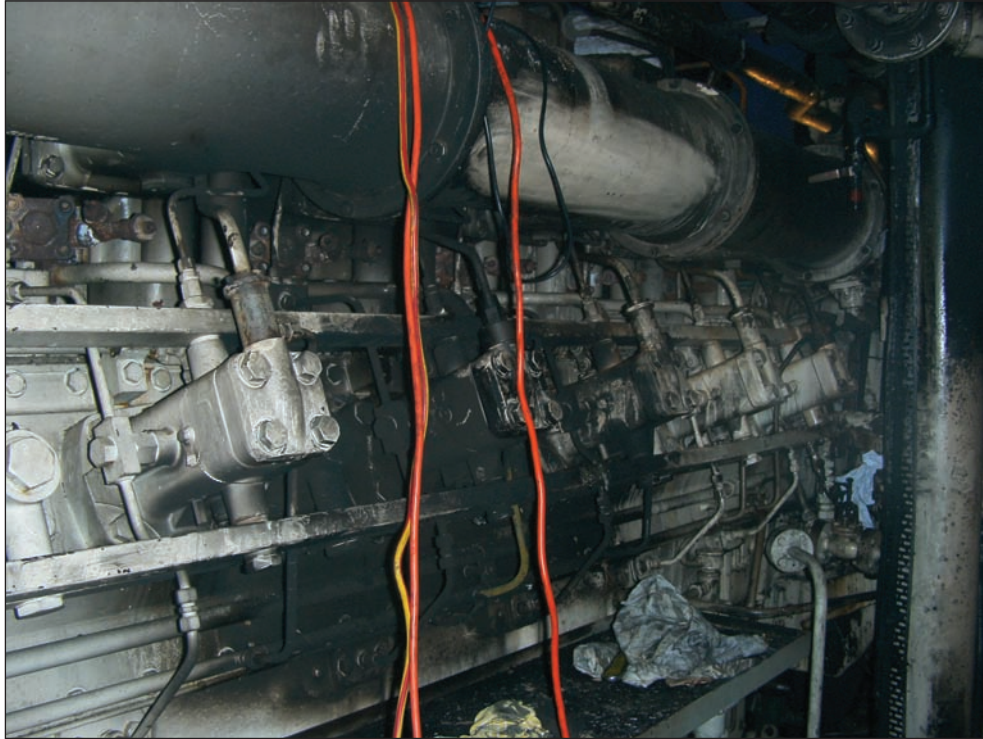
**Figure 12: Flame damage on starboard engine**

A detailed inspection of the starboard main engine revealed a layer of fine soot between the cylinder heads and inside the heat shield around the exhaust pipes between number two and number six cylinders. There were also signs of flame impingement between number three and number five cylinders on the inboard side of the engine (Figure 12).

The evidence suggests that the fuel spray from the leaking pipe probably ignited on contact with the hot starboard main engine exhaust pipes or indicator cocks.
