ATSB TRANSPORT SAFETY INVESTIGATION REPORT  
Marine Occurrence Investigation No. 208  
Final

Independent investigation into the lifeboat accident and  
fatalities aboard the Hong Kong registered bulk carrier

# Lowlands Grace

at anchor off Port Hedland, Western Australia on  
7 October 2004

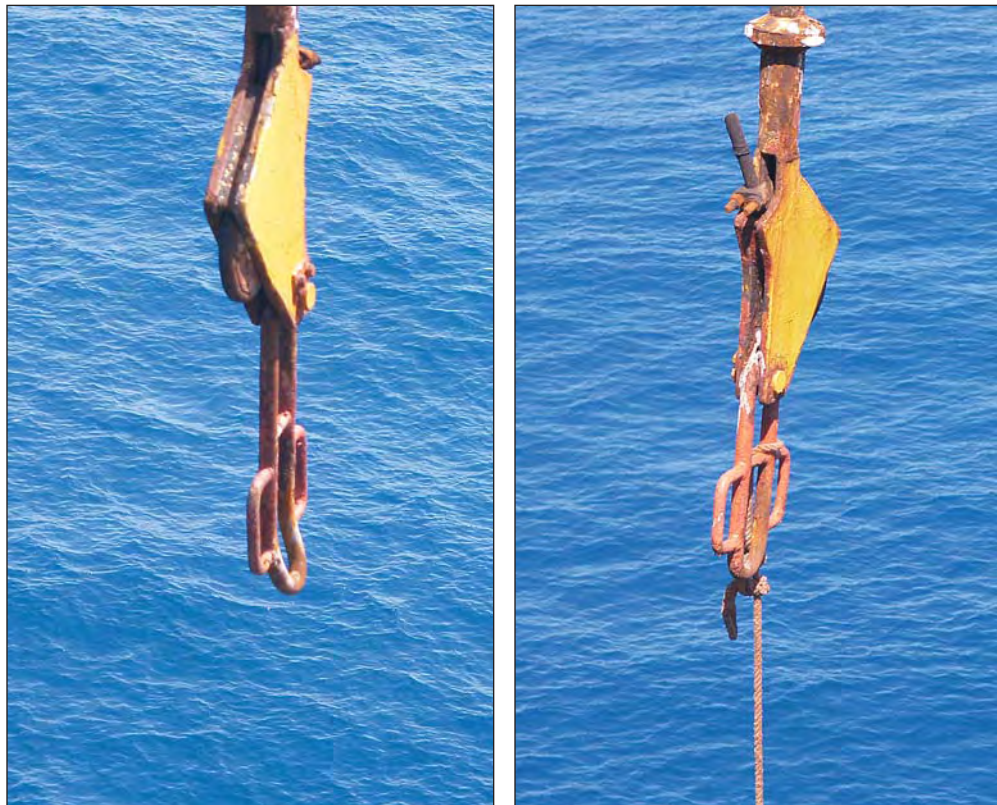
**Figures 12: Lifeboat forward and after hook suspension rings after the accident**

While on board *Lowlands Grace*, investigators inspected the port lifeboat's falls. The suspension ring (long link) attached to the end of the lifeboat's forward fall was slightly bent on the end normally attached to the hook. The after suspension ring was also still attached to its fall and did not exhibit any apparent damage or marks (Figure 12). The davit and falls did not reveal anything else of significance.

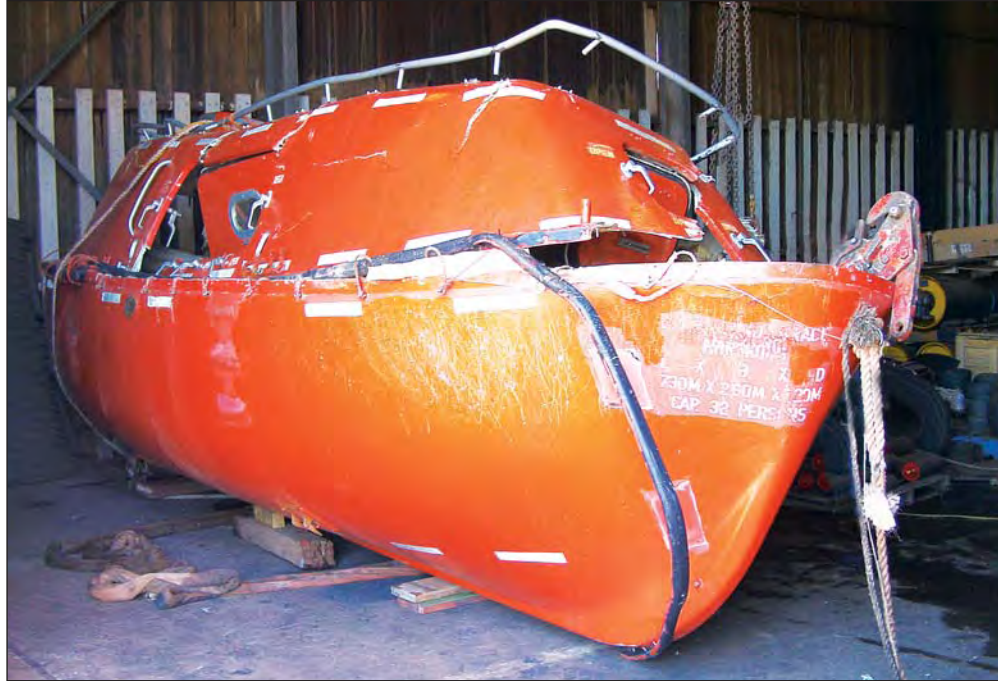
**Figure 13: Port lifeboat after recovery**

The port lifeboat was inspected in Port Hedland after it had been recovered and transported to a facility ashore. The boat had sustained extensive damage, in particular to its canopy, which exhibited numerous cracks, pieces missing etc. and had been almost completely detached from the hull (Figure 13). The foredeck in way of the forward hook mechanism was completely missing. Inside, the lifeboat was filled with debris, buoyancy foam and equipment which had broken free when the lifeboat impacted the water (Figure 14).

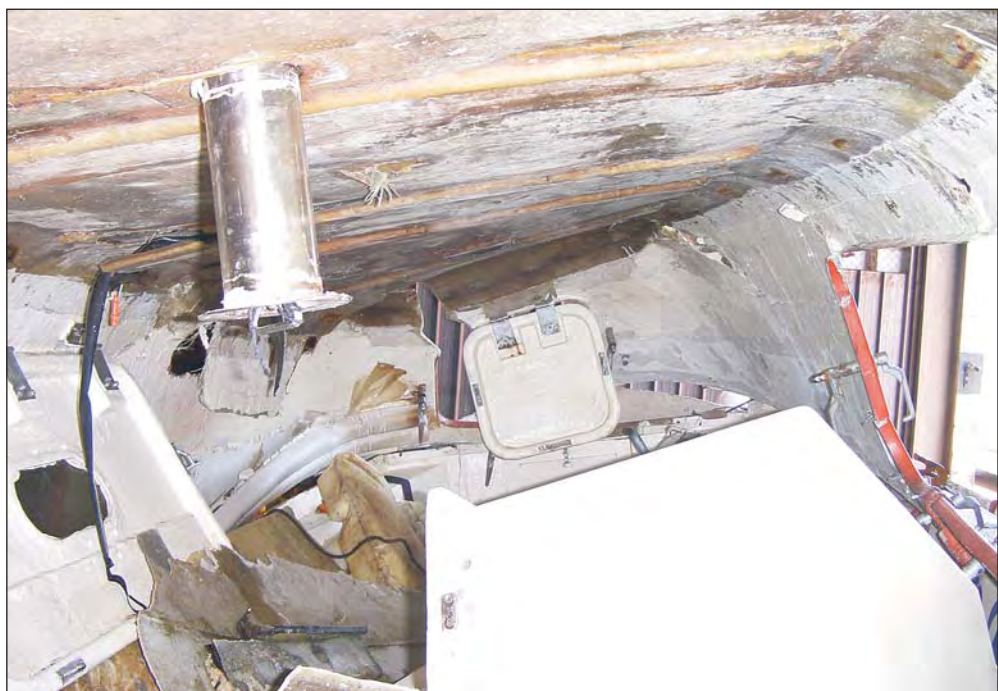
**Figure 14: Port lifeboat interior after recovery**

The on-load release system was inspected in its 'as found' condition. The operating mechanism for the on-load release system was found to be in the fully reset position. The safety pin was in place and hydrostatic locking lever was in the locked position with the operating quadrants for both hooks locked in the reset position below it. The forward hook was found to be in a tripped condition with the clevis fitting between the operating cable and the operating lever and the housing covering the operating lever missing (Figure 14).

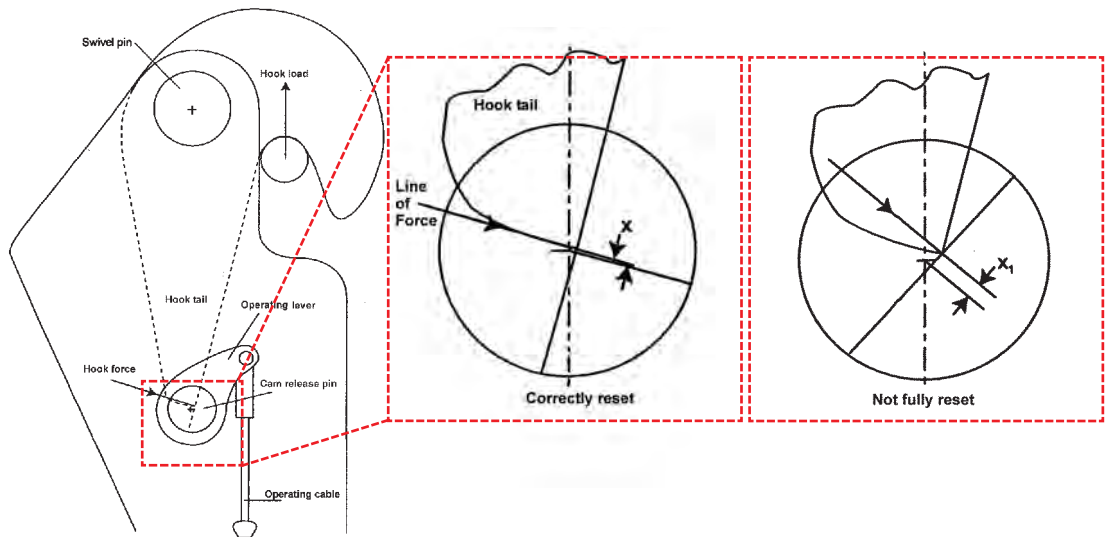
**Figure 23: Hook locking mechanism with detail of cam release pin and hook tail contact**

When the operating cable for the forward hook on *Lowlands Grace*'s port lifeboat was bent at the time the foredeck failed, the cam release pin holding the hook closed was slightly rotated to the effect that  $X$  increased to  $X_1$ . This dramatically increased the turning moment on the cam release pin. The remaining stiffness in the operating cable (as the operating system at the other end of the cable remained locked) was insufficient to carry the additional force being transmitted from the heavily loaded hook. The cam release pin rotated further and allowed the hook to open.

The way in which the hook is locked by the cam release pin makes this type of system particularly prone to spontaneous release when not fully reset and/or when parts of the mechanism are worn. For these reasons this type of system has been implicated in a number of other lifeboat accidents and thus there is a compelling need to make the system as fail safe as possible throughout its service life. While good maintenance practices and correct operation by competent crew mitigate these risks, it is almost certain that during their service life many of these systems will not be operated or maintained in the fashion that the manufacturer stipulates.
