MARINE SAFETY INVESTIGATION

REPORT 178

Independent investigation into the contact with the
number two coal loader at Port Kembla, NSW,
by the Bahamas flag bulk carrier

SA Fortius

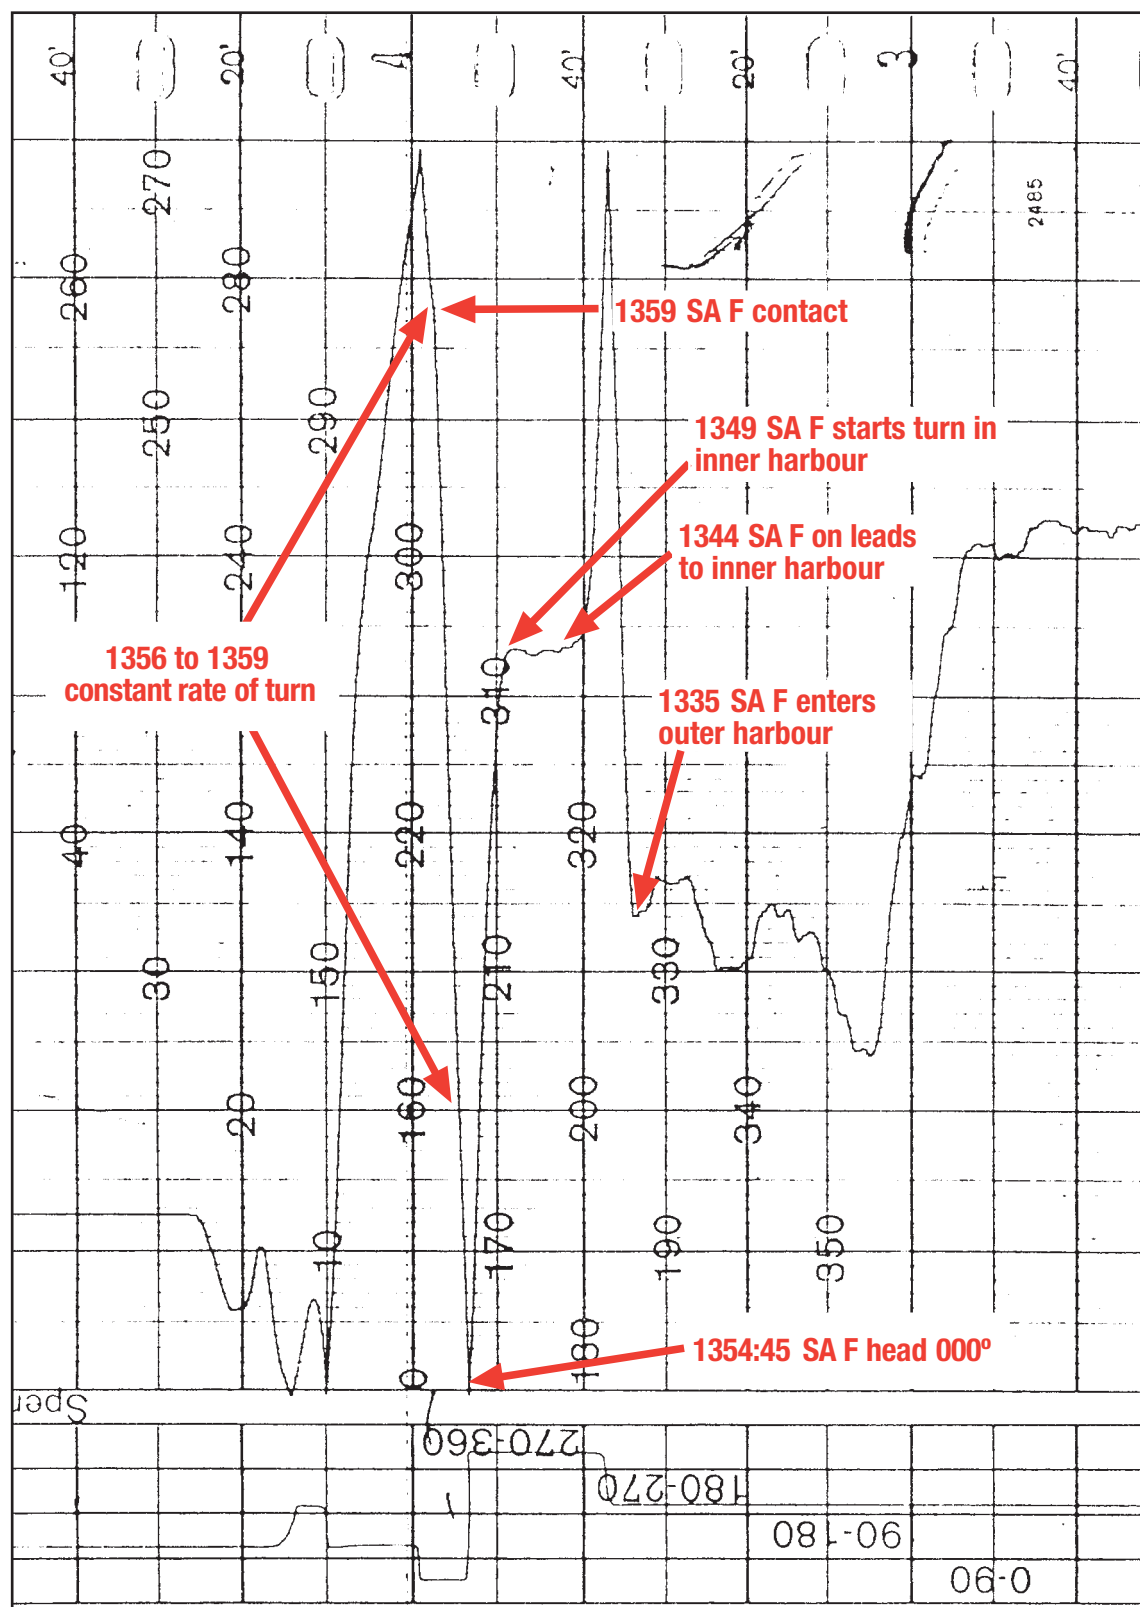
FIGURE 3:
Course recorder trace for entry to Port Kembla

Note: Recorder time 1 1/2 minutes slow and 1° low.

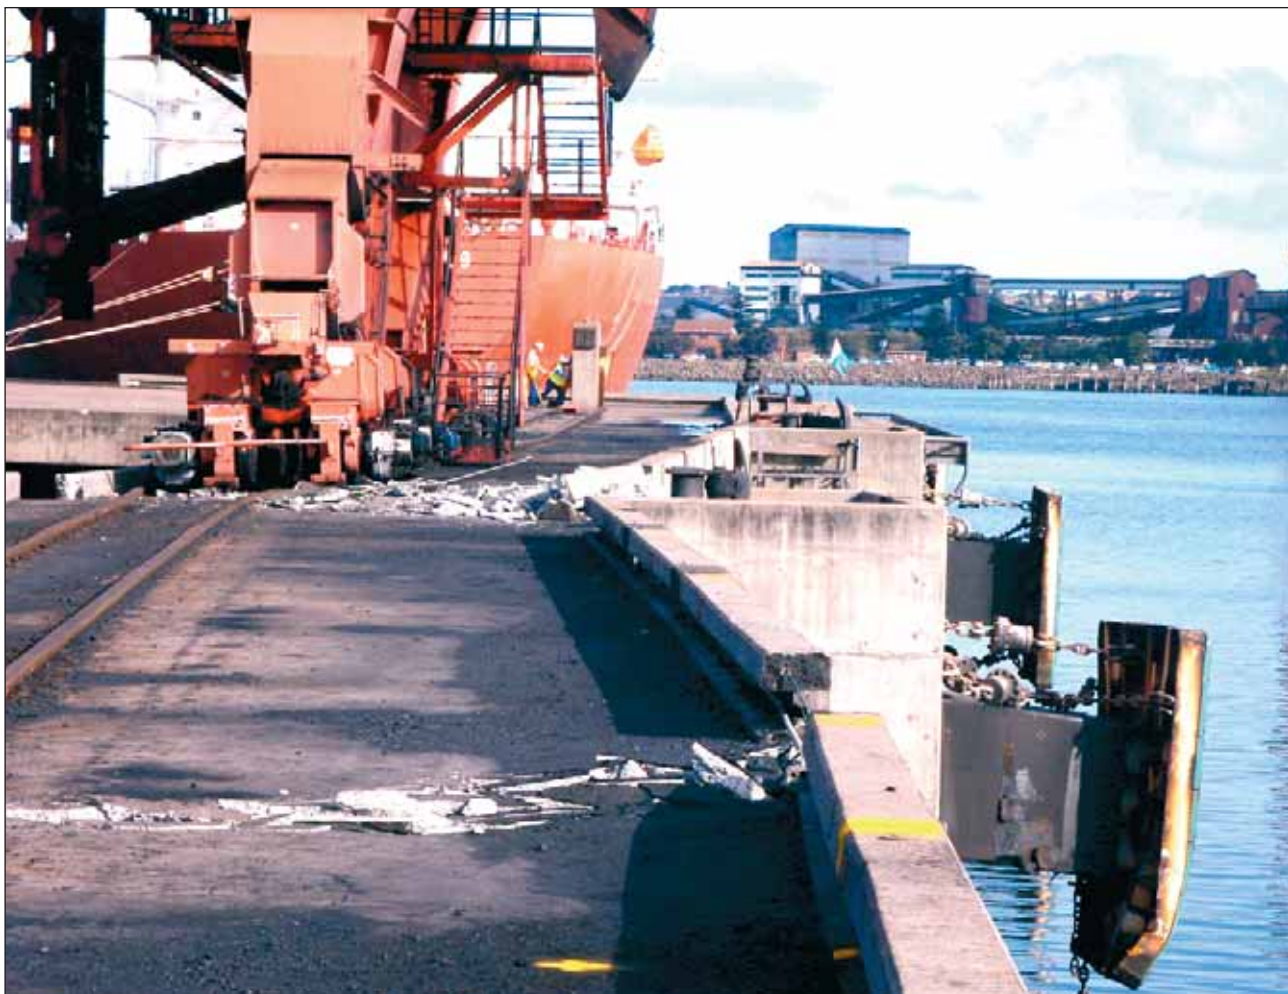
FIGURE 4:
Damage to coal berth

The incident had resulted in significant damage to number two coal berth. The fender struck by *SA Fortius* was badly deformed, as was the steel reinforcing strut from the fender to the shore. A section of the wharf's reinforced concrete decking had been broken away and set back and

the walkway connecting the wharf to the shore was buckled. The coal loader had been derailed by the impact and had suffered some damage as a result.

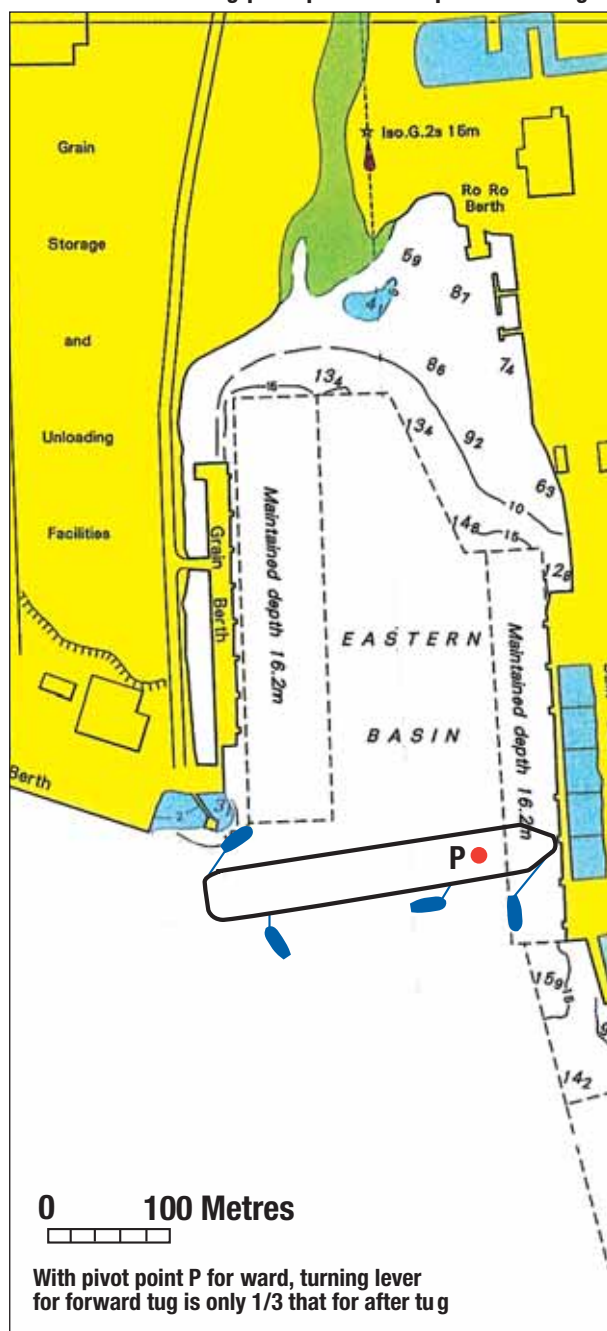
FIGURE 6:
SA Fortius showing pivot point P and position of tugs

The pilot intended to use the two forward tugs, *Kembla* in towing the ship's bow to starboard and *Bullara* to create a braking effect, to arrest any excessive forward motion imparted by the

main engine ahead revolutions. Once the ship's stern was clear of the general-purpose berth, the two after tugs would assist in manoeuvring the stern to port and complete the berthing operation.
