MARINE SAFETY INVESTIGATION  
REPORT 155

Independent investigation into the collision  
involving the Chinese bulk carrier

**Hai Teng**  
and the Australian recreational vessel  
**Chester**

east of Mooloolaba, Queensland  
on 19 March 2000

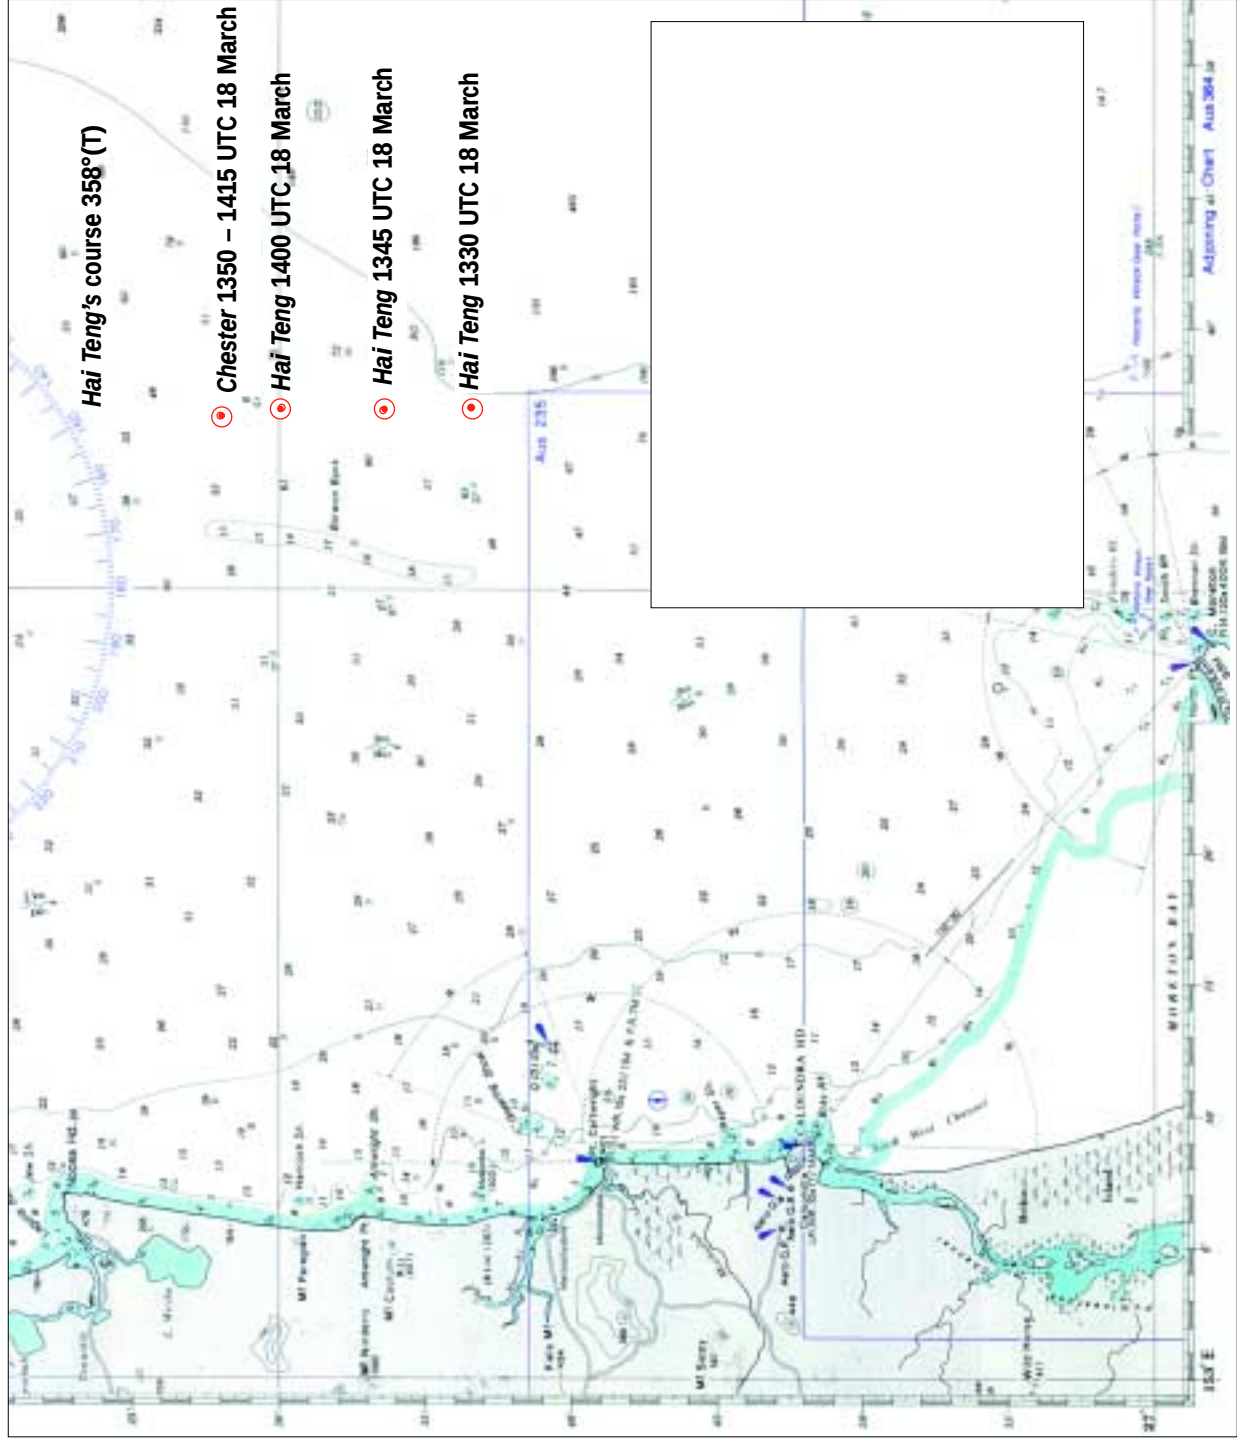
**FIGURE 3:**  
Portion of chart Aus 365 showing positions of Hai Teng and Chester

In a statement to the water police, the deckhand said that he had been asleep on the boat, which was anchored at 26° 28.02' S, 153° 35.63' E, when the collision occurred at 2350 local time, 1350 UTC on 18 March. He also said that the owner and he had seen a large ship with a black hull close to their boat, heading north.

All ships except the Chinese bulk carrier *Hai Teng* were eliminated. The vessel was on a voyage from Newcastle to China at the time of the incident and one of the positions, at 1400 UTC, reported by the master was about

two miles south of the position of the collision involving *Chester*.

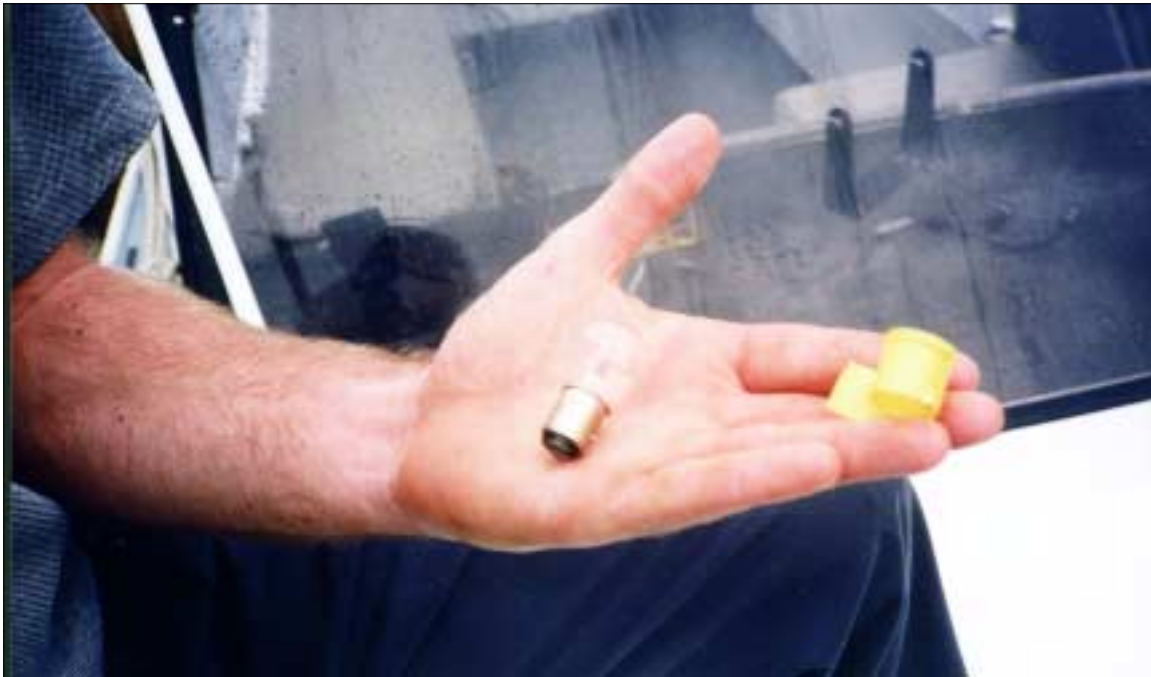
**FIGURE 4:**  
**Narva bulb used in anchor light aboard *Chester***

In *Chester's* case, the skipper was using a bulb with half the power of a 10 watt bulb. Use of an incorrect bulb would affect the distance at which a light becomes visible. The condition of the battery and wiring could also affect the output from the light. Additionally, the position and orientation of the filament is critical for the lens elements to function effectively.

On board *Chester*, the use of an automotive bulb with the navigation lamp would have led to the following conditions affecting the visibility of the anchor light;

- a wattage only half that required by the manufacturer of the fitting and
- a location for the centre of the filament that was, almost certainly, incorrectly positioned for the lens in use.

The existing socket was not designed for the Narva bulb, which had to be jammed into the socket using insulating tape around the cap (see photograph, page 11). This would have caused the bulb to be seated at an angle to the vertical, instead of it being upright, in order to illuminate the filament.

In addition, the 5 watt filament is positioned off centre in the bulb. This could result in a varied intensity in azimuth.

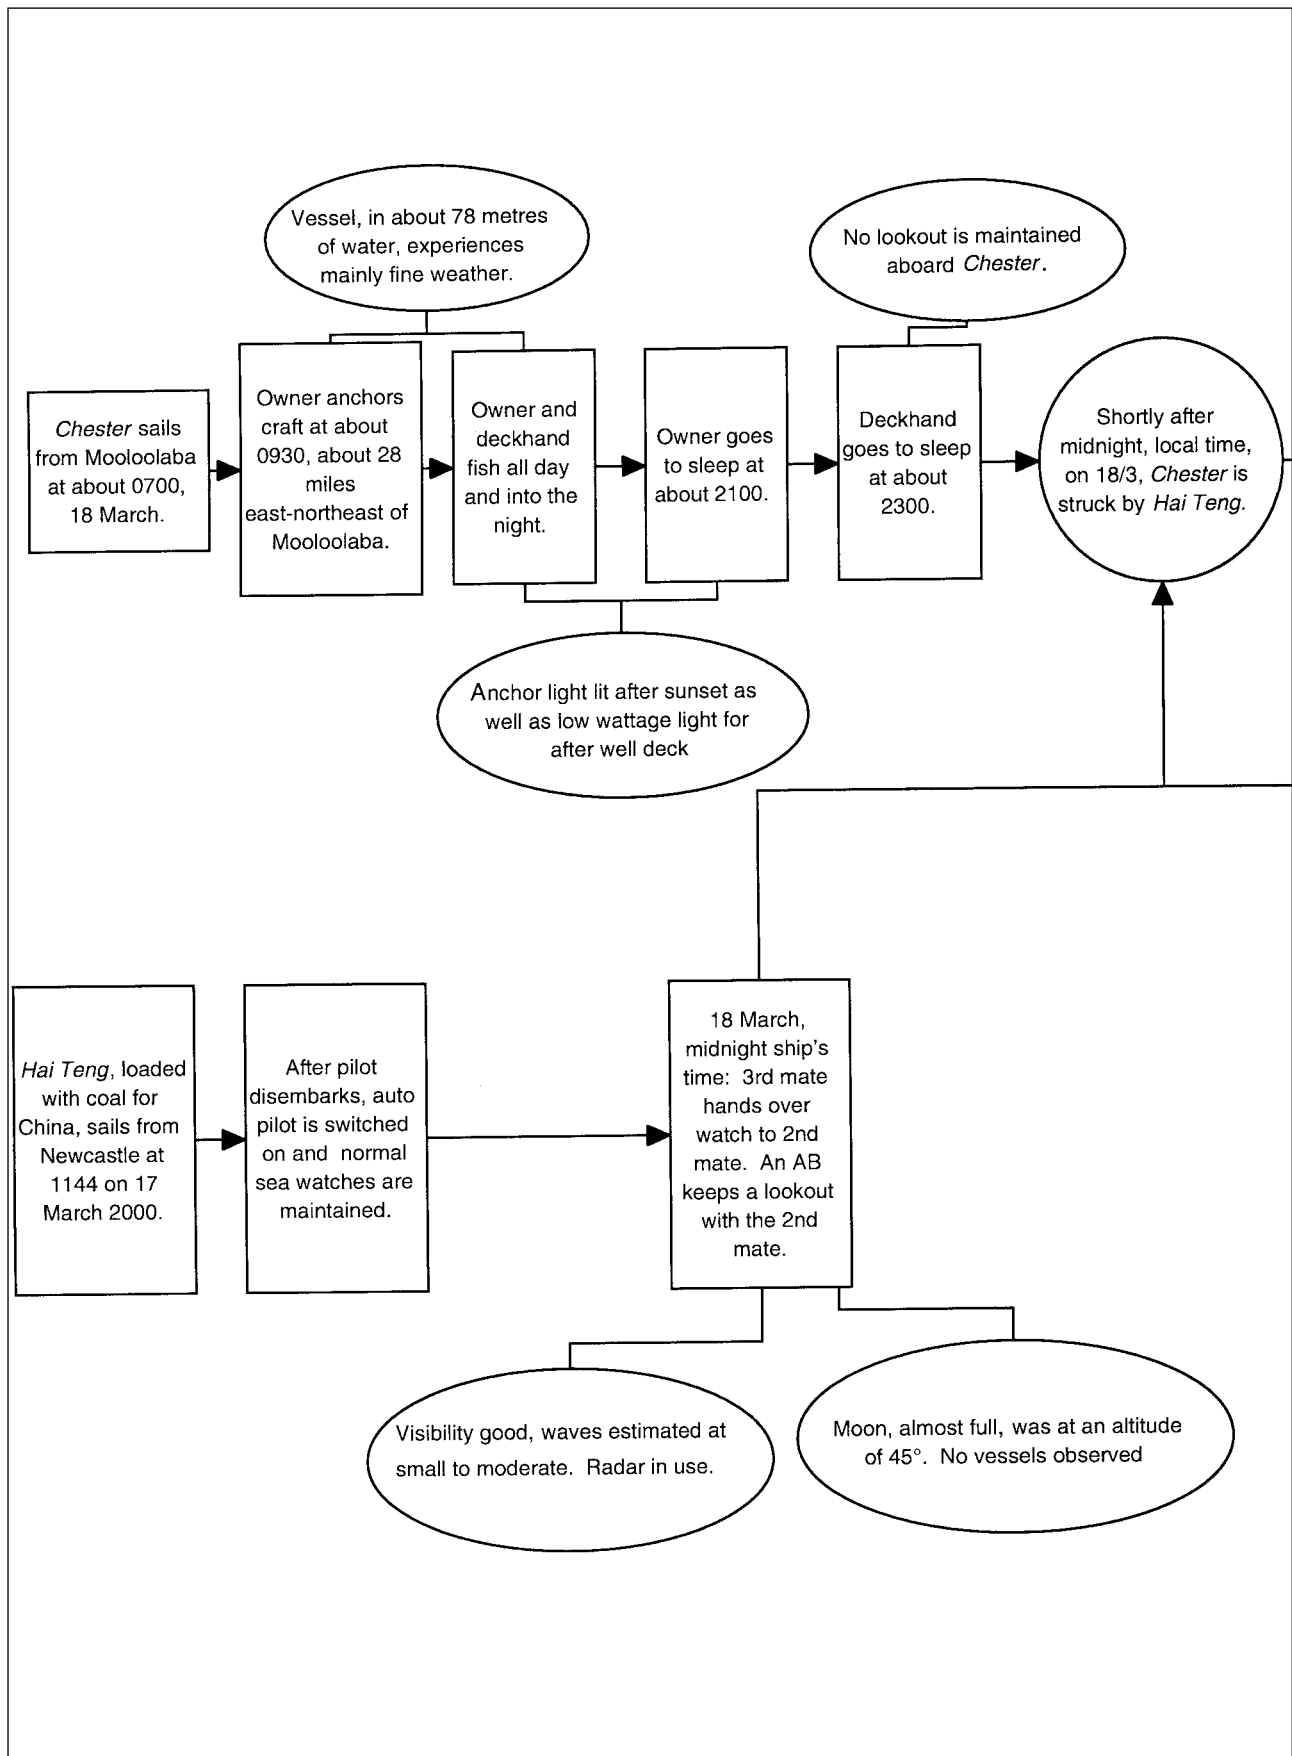
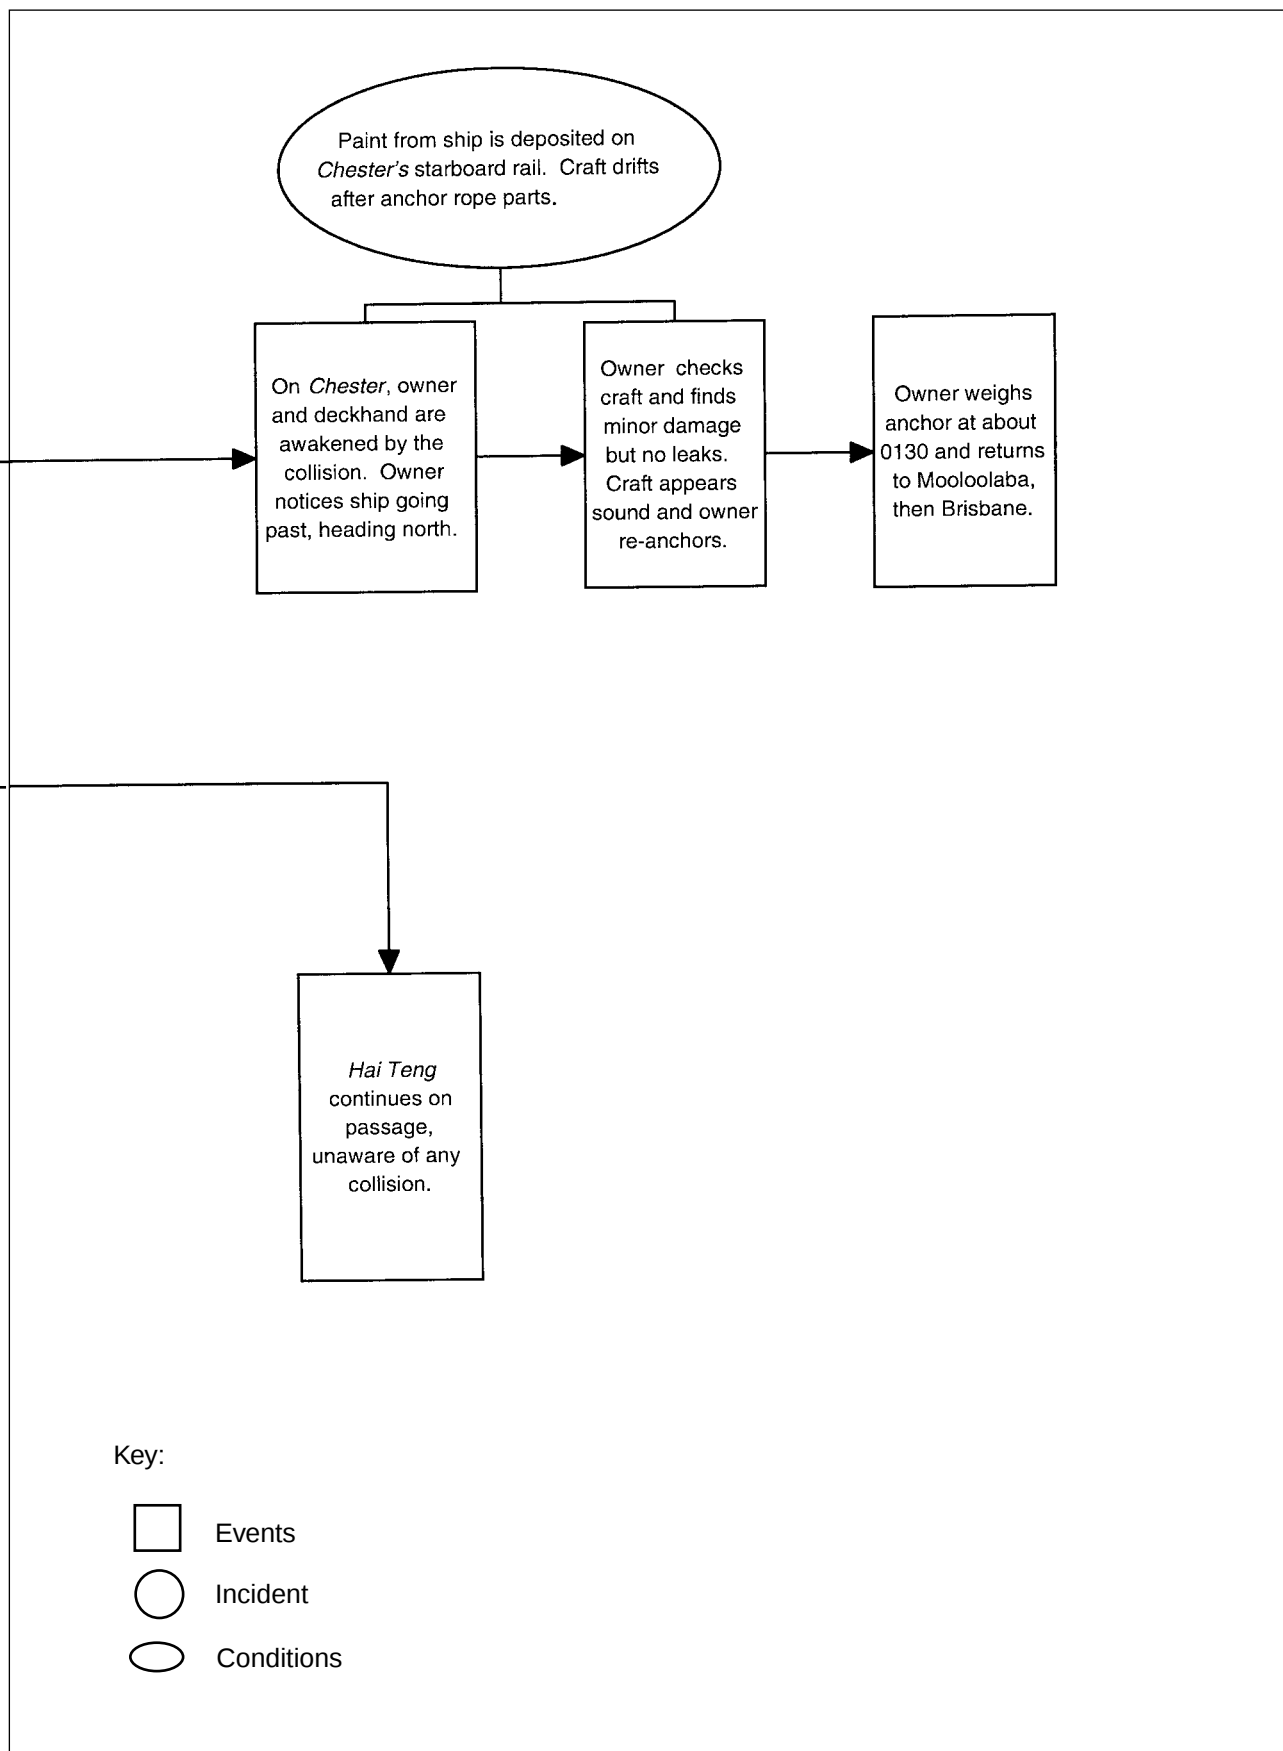
**FIGURE 5:**  
**Collision: *Hai Teng* and *Chester*, Events and causal factors chart**

- It is probable that visual detection of the light on *Chester* was affected by the reflection of moonlight from the water.
- *Chester*, a small craft with limited visual and radar conspicuousness, was anchored about 28 miles off the coast in shipping lanes.
- The size and, possibly, the aspect of *Chester* as well as existing sea conditions led to the craft not being observed on the ship's radar.

The ATSB recommends that training establishments and authorities issuing certificates of competency, or boating or similar licences, place greater emphasis on training and examining candidates for full knowledge and proper understanding of the International Regulations for Preventing Collisions at Sea, 1972, as amended and in force for Australia.

The ATSB also recommends that Australian shipowners, managers, pilots and agents take note of Safety Bulletin 02 attached to this report and available on the ATSB website, bringing it to the attention of as many vessels as possible. The bulletin points out that the only explanations for most collisions are the lack of a proper visual lookout, or an over-reliance on radar detection when the radar set has not been correctly set-up, or has not been maintained properly.
