MARINE SAFETY INVESTIGATION

REPORT 152

Independent investigation into the
steering gear failure
on the Australian flag motor vessel

Warden Point

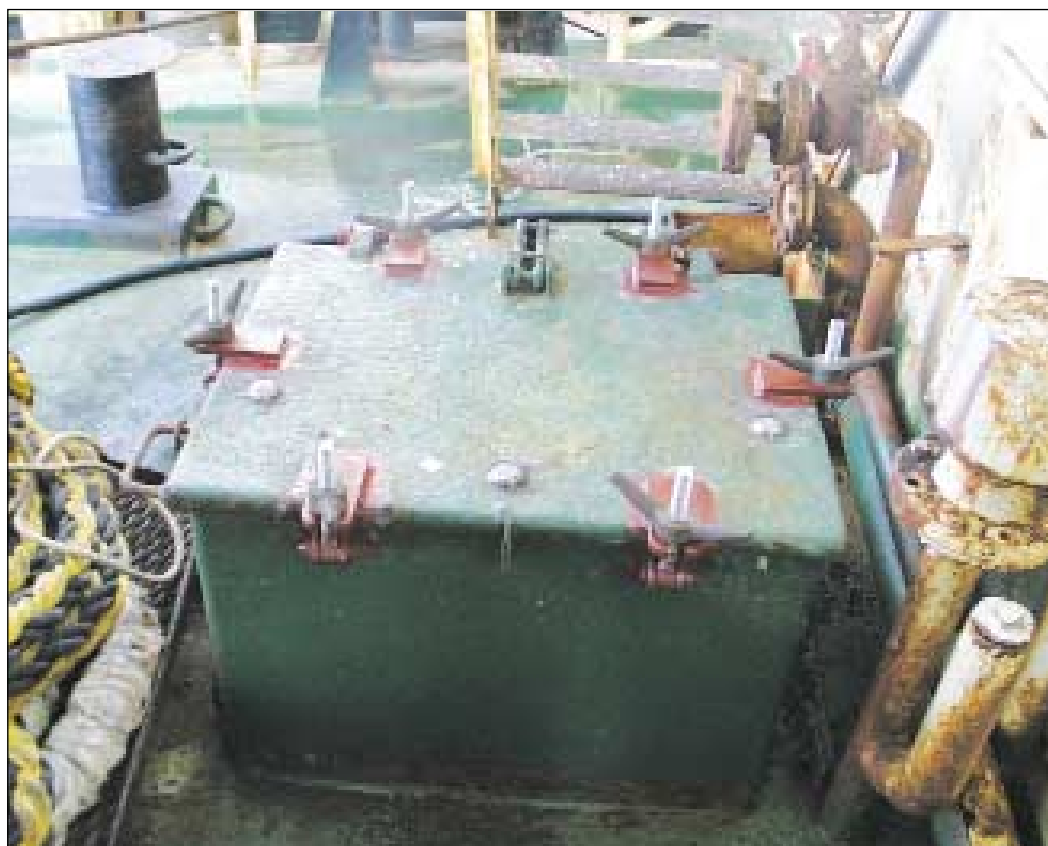
FIGURE 6:
Rope locker hatch after new dogs were fitted

The flooding of *Warden Point's* steering flat was the result of the leaking hatch lid on the adjoining rope locker. Once sufficient seawater had entered the rope locker, it overflowed through the ports in the division bulkhead into the steering flat.

The initial leak through the rope locker hatch was caused by a combination of the seawater running over and around the hatch and an ineffective seal between the hatch lid and the coaming. The three dogs on the hatch lid exerted insufficient clamping pressure to maintain a positive seal between the hatch lid and the hatch coaming.

The lever and wedge dogs fitted to the rope locker hatch lid, when new, would have provided the weathertight seal required by the class rules. Over the course of the vessel's lifetime the dogs, wedges and seal had worn to the point where a satisfactory 'weathertight' seal was not maintained.

When the crew placed the tarpaulin over the rope locker hatch, after the steering flat had been flooded, they noted that the three hatch dogs were slack but still engaged on the coaming wedges. Under the circumstances the most likely conclusion is that, in the 2 hours between 2230 and 0030, the rope locker hatch lid dogs were loosened by the action of the waves over the lower poop deck. Once the dogs were slack the rope locker would have taken water with every wave over the poop deck.

Contractors attended the vessel to modify the rope locker hatch lid. Six new screw-down dogs were fitted. The crew and cargo insurance assessors inspected the cargo holds after arrival. The cargo in no.1 hold was found to have shifted both to port and forward. The cargo in this hold was subsequently re-trimmed using the cargo discharge equipment. The fly ash in no.2 hold was found to have shifted and submerged the cargo discharge equipment. The discharge equipment could not be lifted clear to re-trim the cargo in this hold as a result of the weight of the fly ash. There was also found to be a small amount of water ingress into the holds through leaks in the hatch covers.

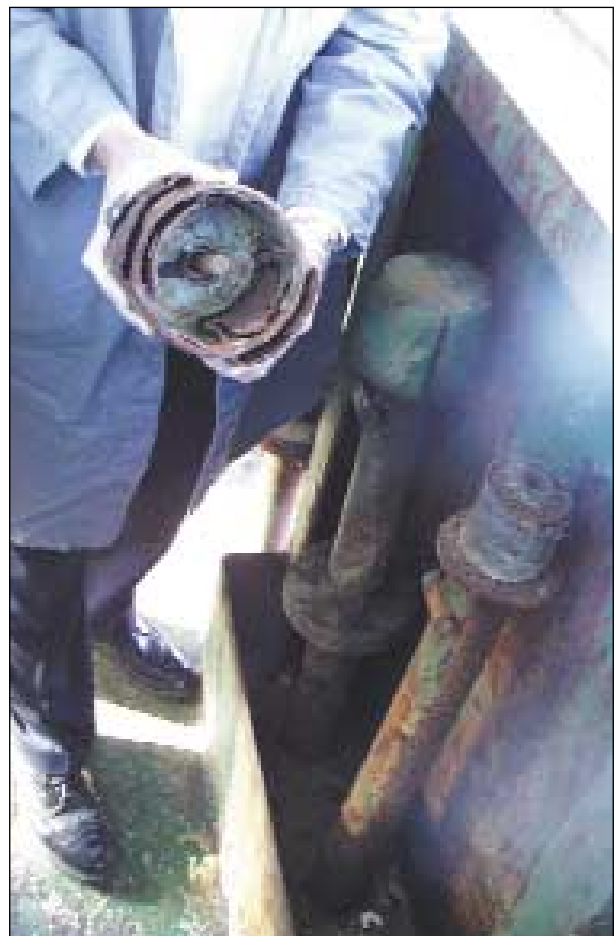
FIGURE 7:
Fuel service tank breathers

Compounding the failure of the steering motors was the contamination of the fuel by sea water. The diesel and heavy fuel service tank breathers were inspected after *Warden Point* had arrived in Port Kembla. The service tank breathers are fitted beside each other adjacent to the bulwark on the starboard side, after end, of the main deck (fig. 7). The breathers consist of steel standpipes, approximately 800 mm high,

mounted above the deck level with the tank vent at the top. The vents consist of a cylindrical air inlet/outlet, fitted with gauze, which is enclosed by a screw down fabricated steel cap with an integral 'tortuous path' to prevent water ingress. The diesel tank breather was found to be in a particularly poor state of repair with the vent cap's screw-down thread stripped and the fabricated tortuous path galleries badly corroded. The heavy fuel breather was in a better state of repair. Both tank breathers had not been maintained for a considerable period of time.

In view of the condition of the service tank breathers, there is little doubt that they were the point of entry for the seawater drained from the tanks. For such a large amount of water to be taken, particularly into the diesel service tank, the breathers must have spent a considerable time submerged. This verifies the observations of the crew concerning the sea conditions they experienced at the time of the incident.
