MARINE SAFETY INVESTIGATION

REPORT 162

Independent investigation into the grounding
of the Malaysian flag container ship

Bunga Teratai Satu

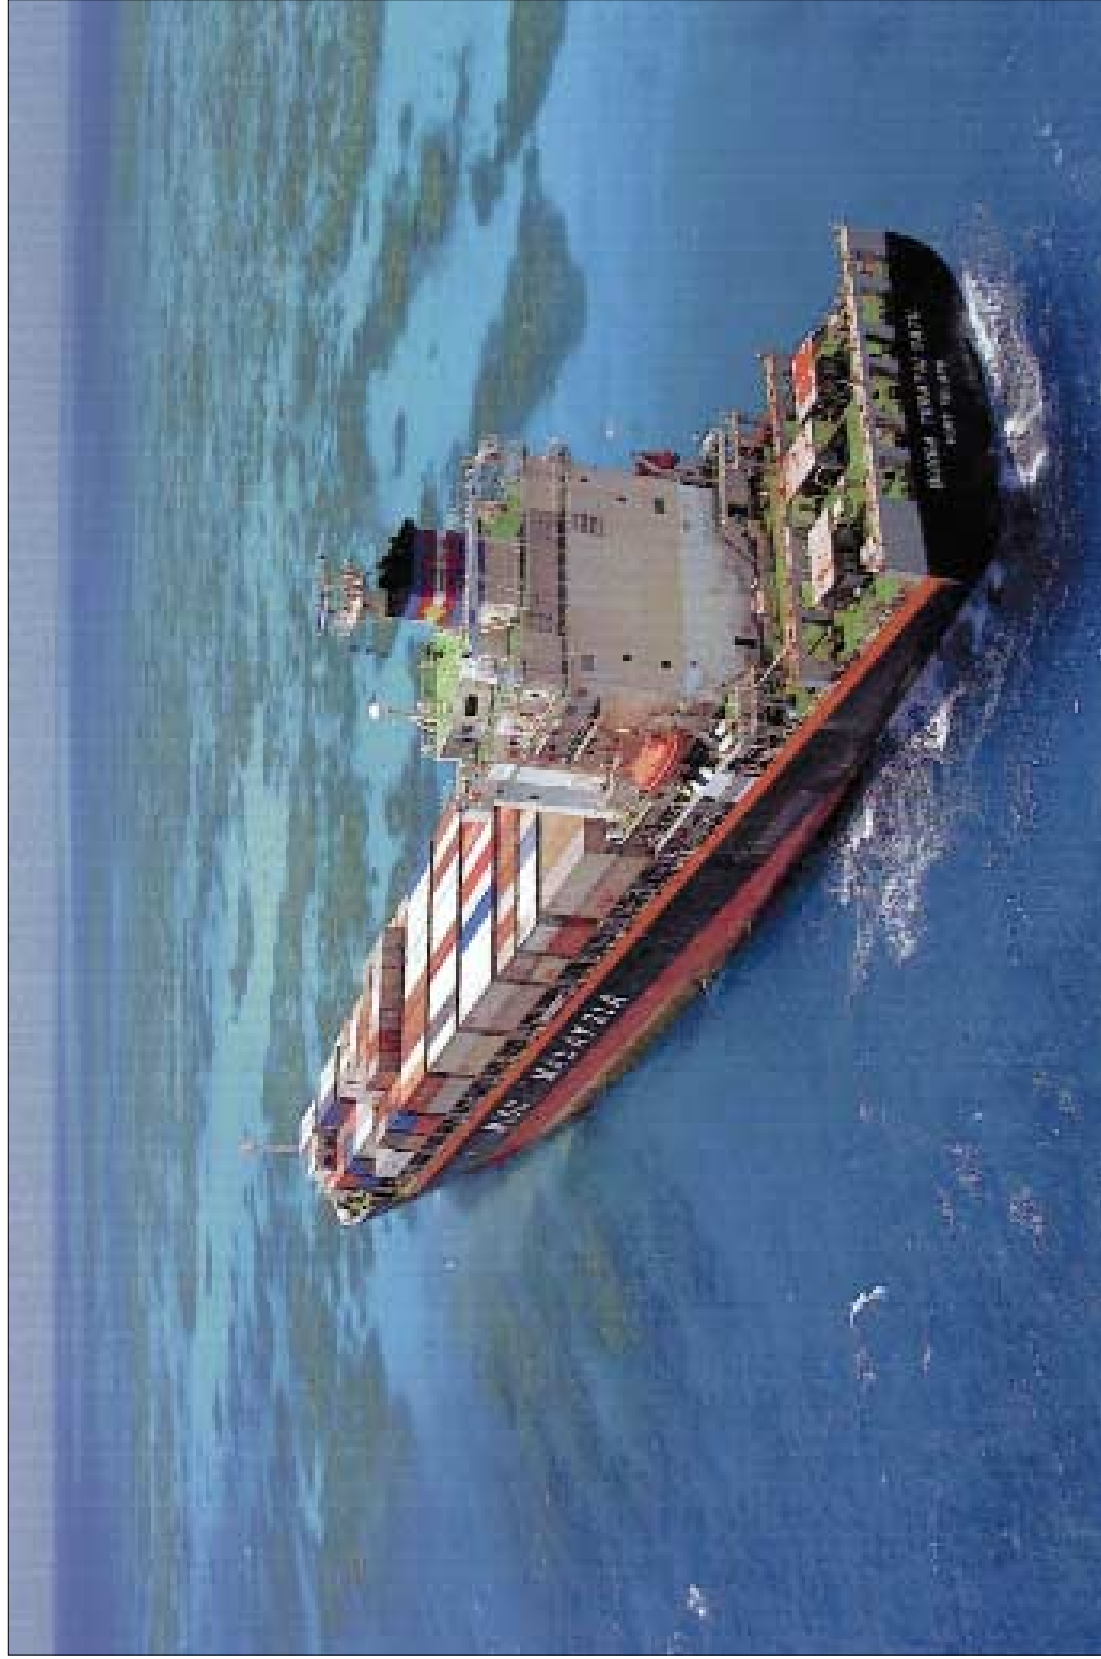
Figure 1:
Bunga Teratai Satu aground on Sudbury Reef

At about 0723, the ship struck the north end of Sudbury Reef at a speed of over 20 knots on a heading of 120°. It was about 1³/₄ hours after low water and the vessel's bow rode some 100 metres onto the reef leaving the stern in approximately 12 metres of water.

Nobody was hurt as a result of the grounding and no oil or other pollutant escaped from the ship. The grounding resulted in mechanical damage to the reef and the yet-to-be assessed effects of the ship's anti-fouling paint.

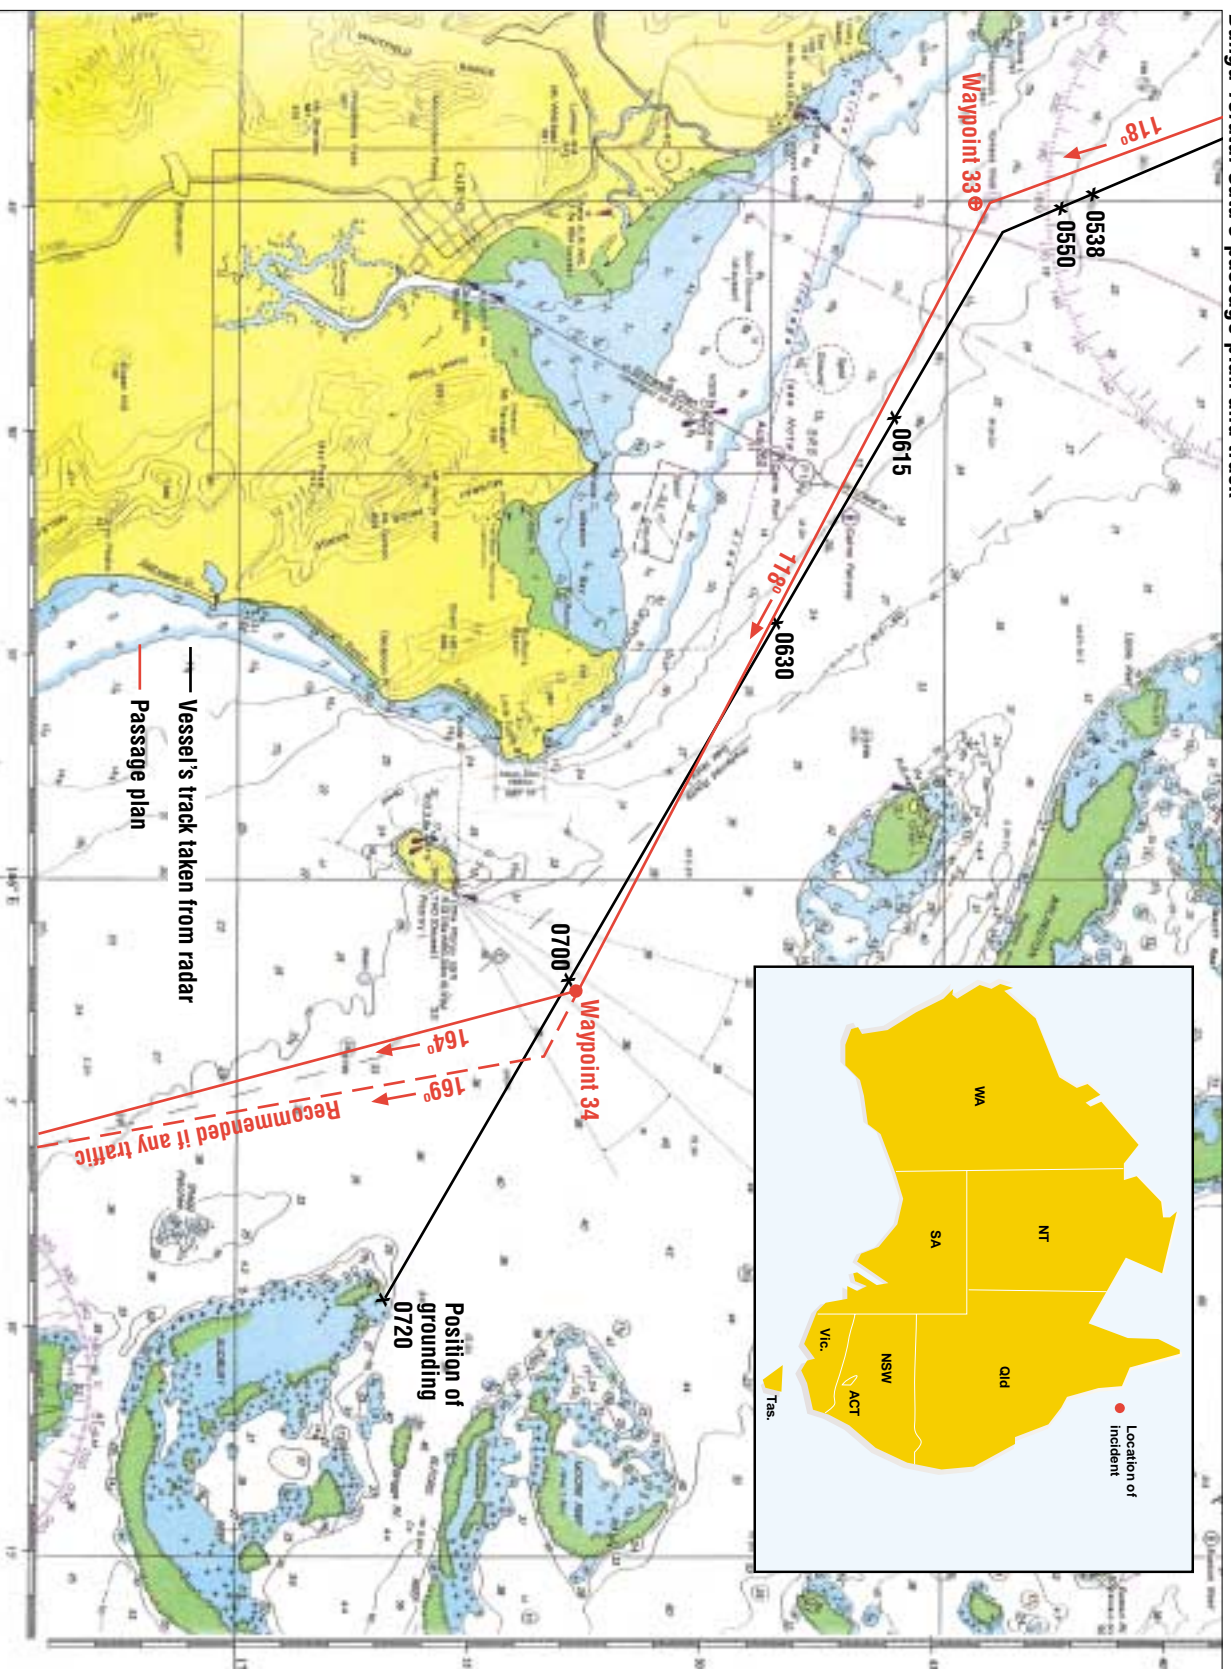
Figure 2:
Bunga Teratai Satu's passage plan and track

At 0600, 'full away' was rung and the vessel resumed its passage to Sydney on a course of 120° (true). A programmed way-point, at position 16° 52.8' S, 146° 02.3' E, was reached at 0700. At this way-point, the course was supposed to be altered to 164° (true) to round Fitzroy Island and take the vessel to the west of Sudbury Reef. However, no course alteration was made.

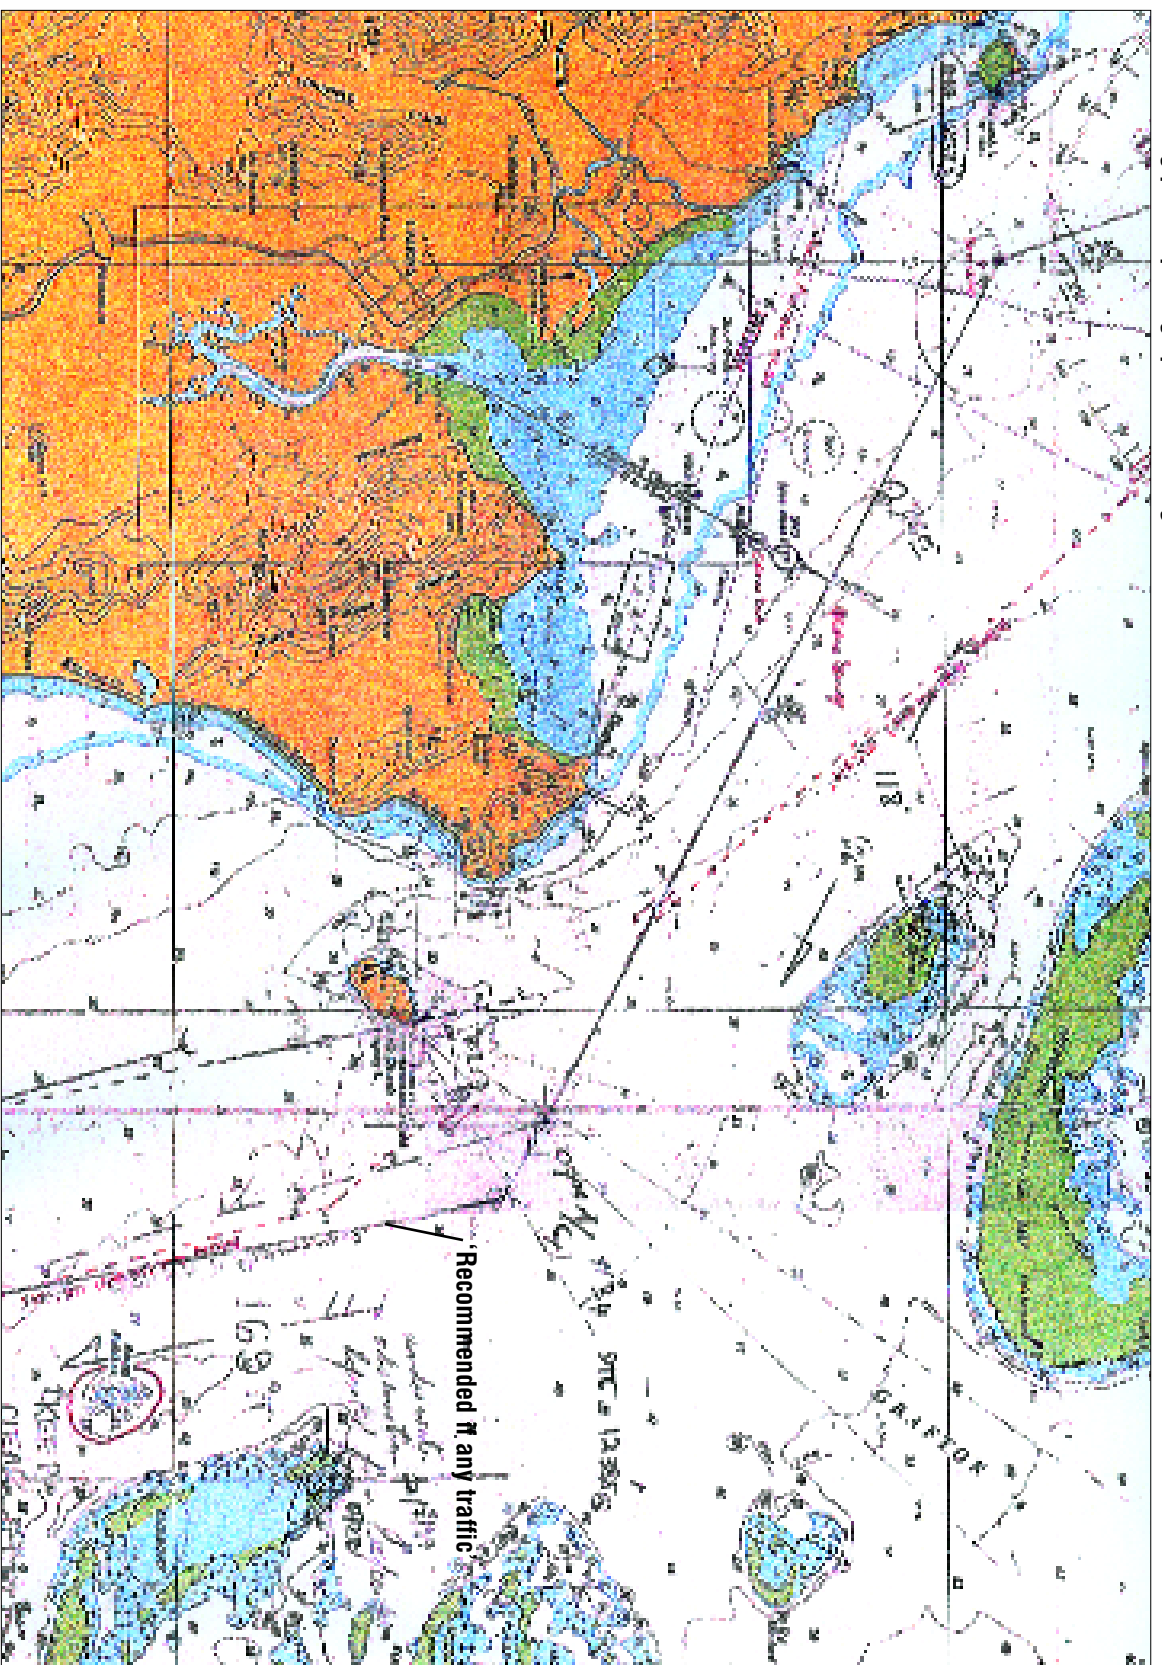
Figure 3:
Chart showing plotted passage plan from Bunga Teratai Satu

course line of 164° was drawn and this was noted in the voyage plan as the course alteration point. The second alteration point required an alteration to a heading of 169° and beside the course line on the chart was notated:

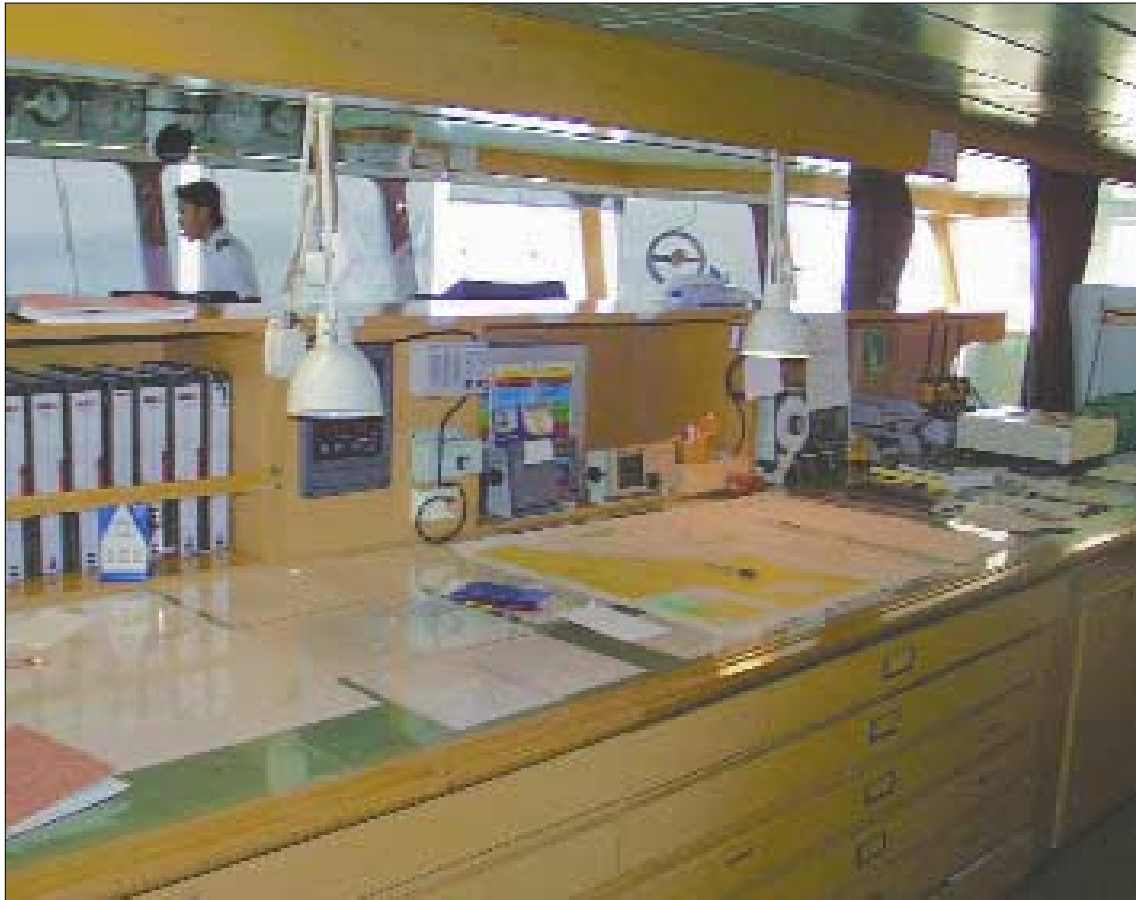
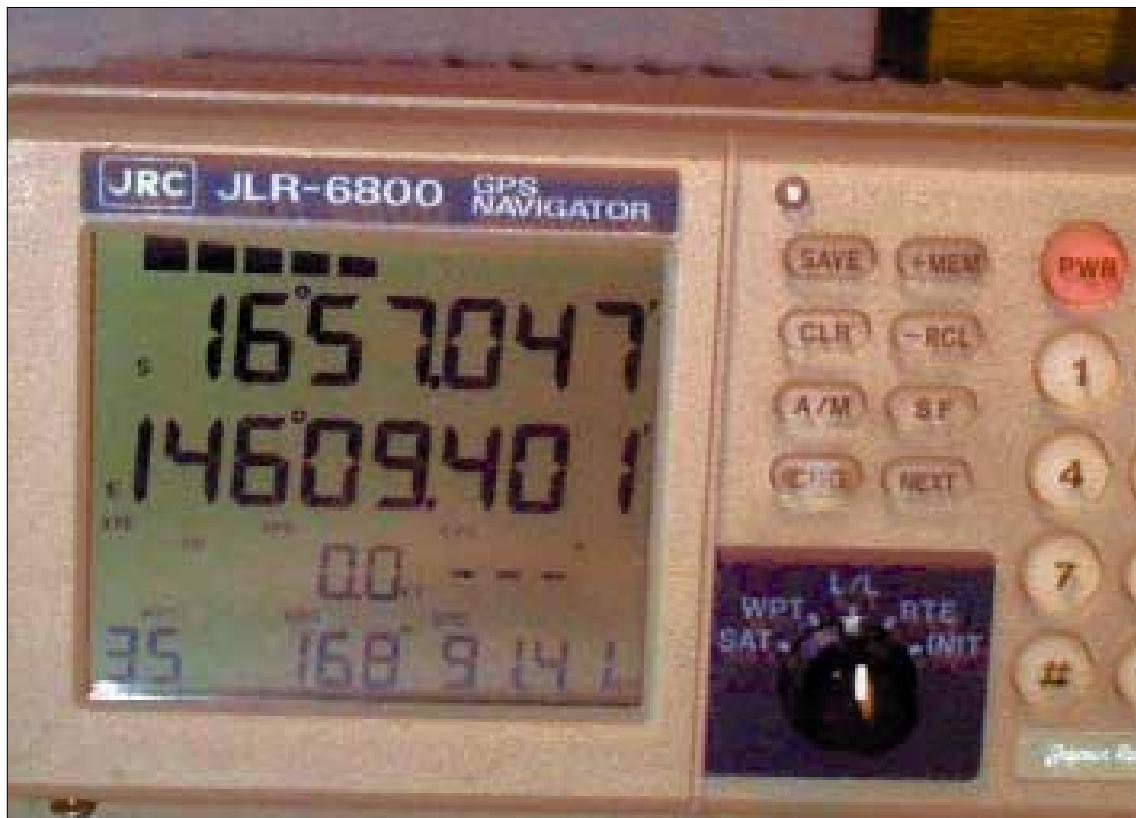
On 21 November, a specialist maintenance engineer examined the ship's GPS on behalf of the Inspector. (Figs. 4 and 5) No fault was found either in the aerial or in the receiver. The ship's staff stated that the GPS was functioning properly both before and after the grounding. It is therefore concluded that the GPS was working properly and there was no fault in the system at the time of the incident.

It should be pointed out that the GPS alarm is not loud and is identical for all alarm conditions. The alarm cannot be heard on the bridge wing, or over the noise of the vacuum cleaner when the bridge is being cleaned. Also it is similar to the Digital Selective Call alarm, part of the GMDSS system, which was located a few metres from the GPS.

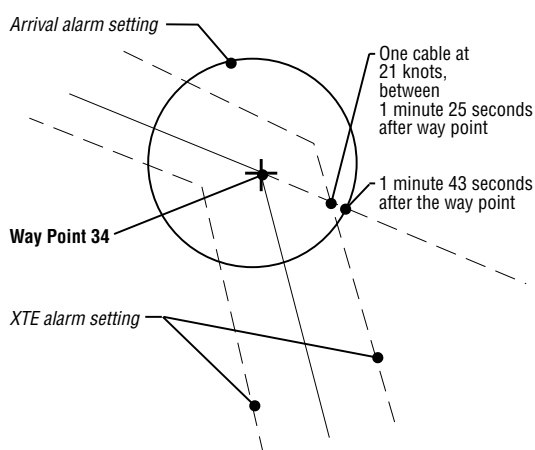
Figure 6:
Diagram showing GPS urgent alarm times

There is no clear evidence as to when any audible alarm was cancelled at, or near waypoint 34. The arrival alarm would have sounded just after 0658 and if it had not been cancelled, would have continued sounding until the XTE alarm was finally cancelled after the grounding. The AB could not recall either the alarm or the mate being inside the wheelhouse after the time his wife arrived on the bridge. The mate stated that he cancelled the alarm, although it is not

clear if this took place at 0700, or after 0715 when he checked the ship's position following the phone calls.

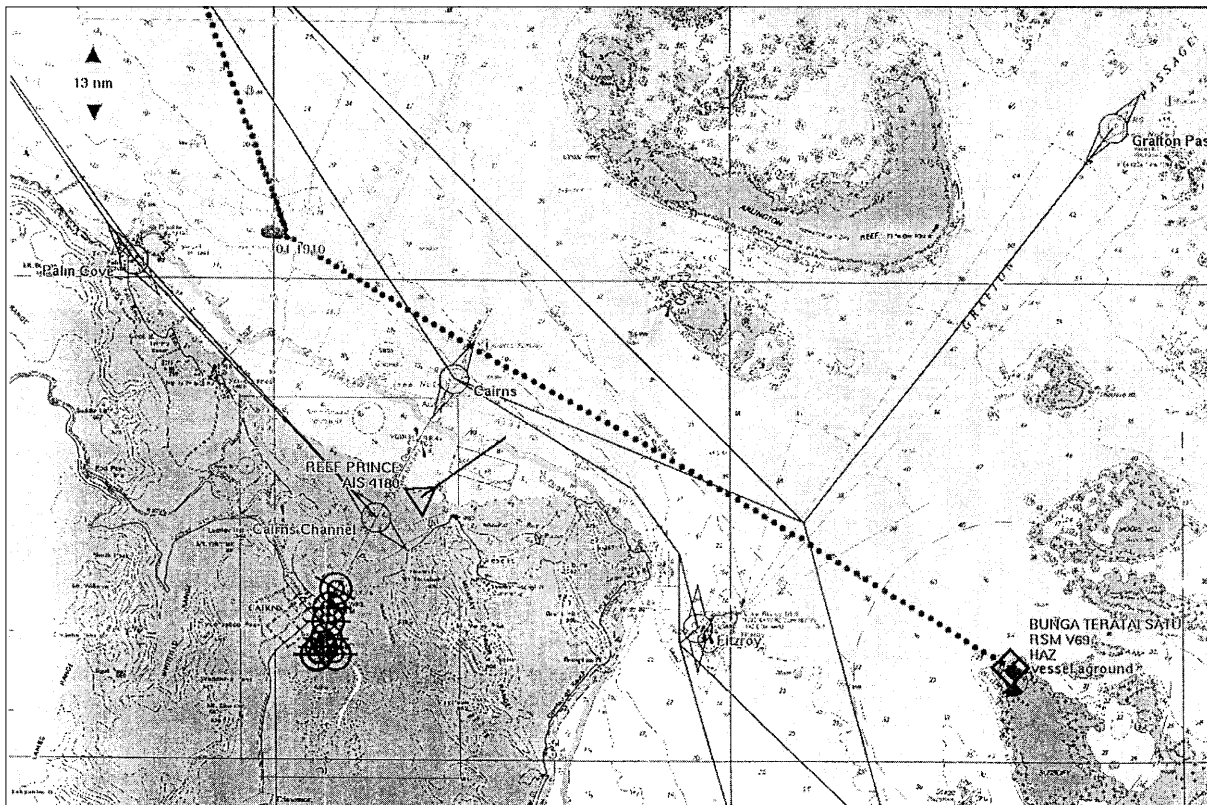
Figure 7:
***Bunga Teratai Satu's* track on Sirius**

However, the system management records show *Bunga Teratai Satu* had passed its waypoint marginally before 0700. There was a period of about 15 minutes, in which the ship maintained a steady course for 5 miles deviating from its planned track before entering the restricted area and triggering the urgent alert message (fig. 7). The circumstances envisaged in 5-3-10 of the

Unless the operator had specifically looked at the Green Island radar display during this time he would not have realised that Bunga Teratai Satu had failed to alter course.

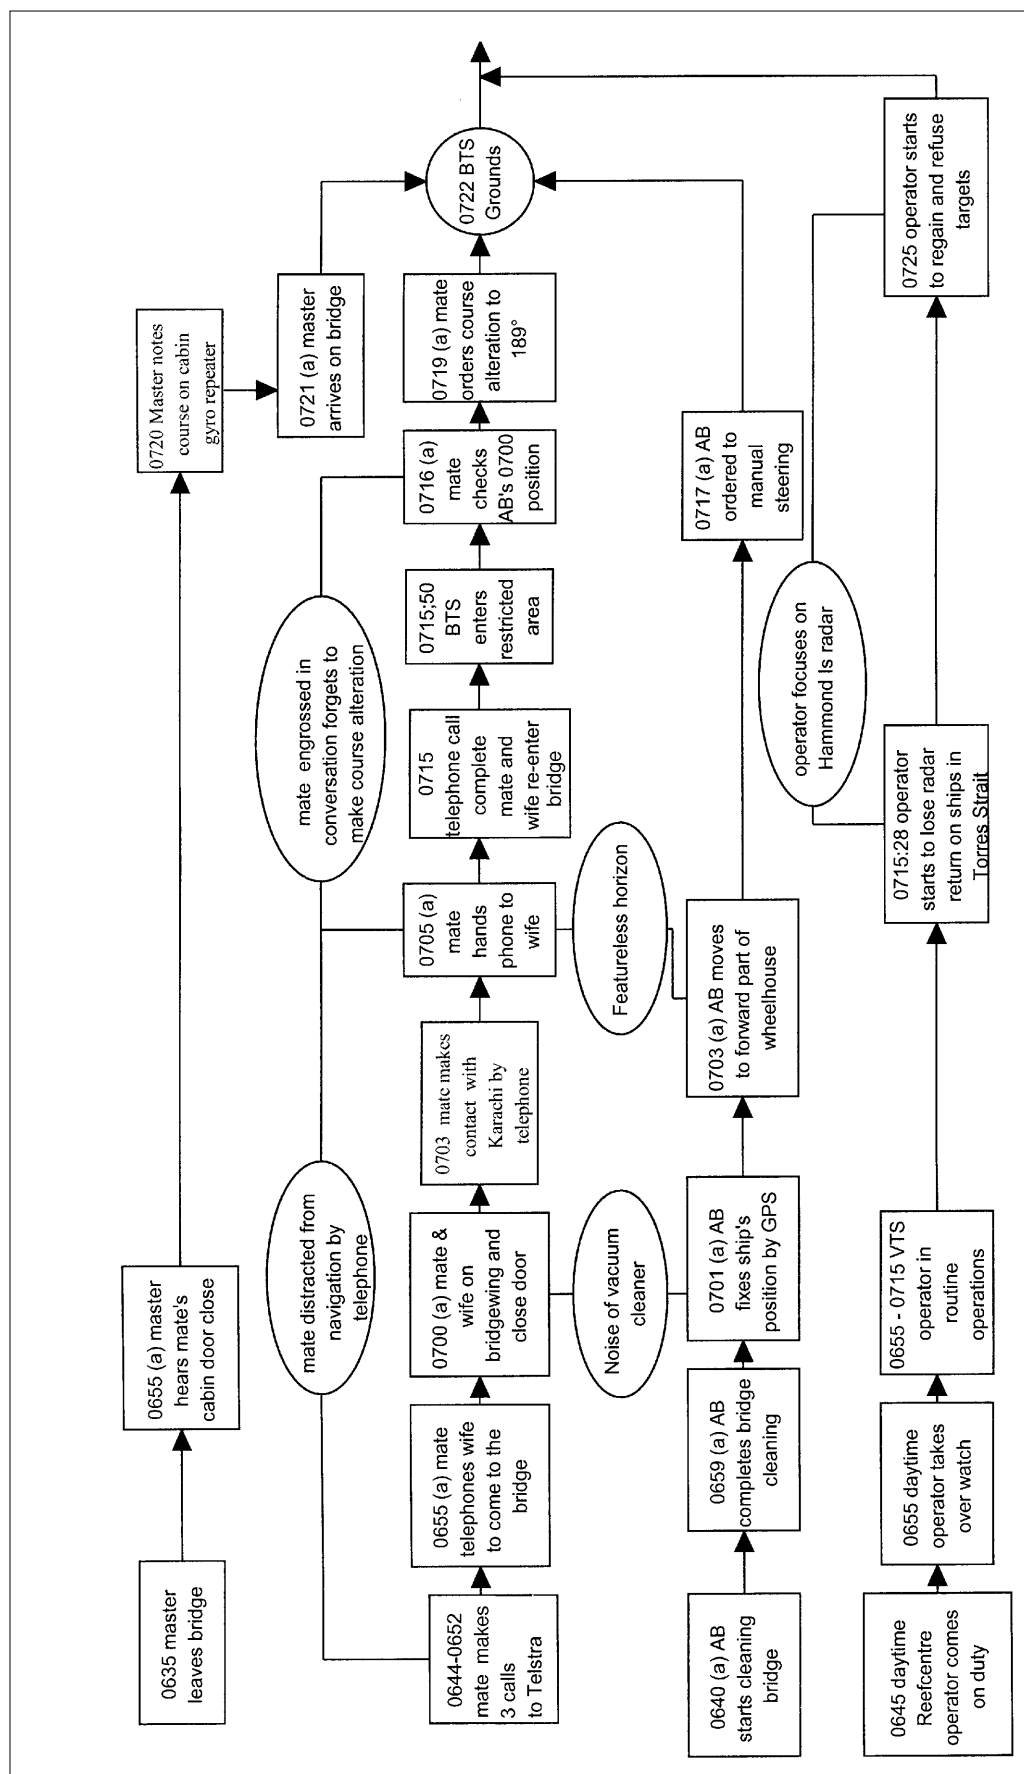
Figure 8:
Bunga Tertai Satu events and causal factor chart

1. The significant unsafe act that resulted in the grounding was that the mate allowed himself to become distracted, for a period of about 15 minutes, from the navigation of the ship by a telephone conversation between his wife, who was on the ship's bridge wing, and his family overseas.
2. From about 0645 to 0715 the mate had become preoccupied with arranging and making private telephone calls while the ship was in cellular phone range of the coast, rather than monitoring the ship's course, speed, position and his other watchkeeping duties.
3. The manner in which the mate maintained his watch on 2 November 2000 lacked appropriate motivation and fell well below proper professional standards.
