**Commonwealth and
New South Wales
joint investigation into
the contact damage sustained
by the Barbados
flag bulk carrier
MV Claudia
at Bass Point,
New South Wales
on 16 December 1998**

Navigation Act 1912
Navigation (Marine Casualty) Regulations
joint investigation into the contact damage sustained
by the Barbados flag bulk carrier
MV Claudia
at Bass Point, New South Wales

Published: July 1999

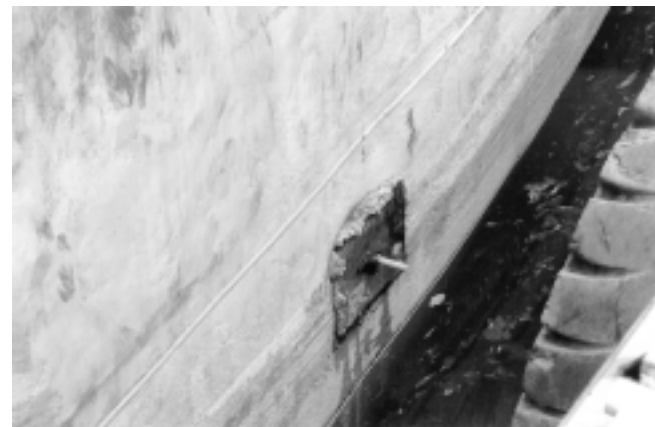
Temporary repairs effected to No 1 void space
Figure 6

The divers from Southern Commercial Divers inspected the hull between 1000 and 1100 and reported that the hull was holed. The hole was about 450 x 100-mm and about 2 metres below the waterline. Temporary underwater repairs were made by bolting a steel plate, on the outside of the hull, to a strongback inside the void space. (See figure 6).

On the 17 December permanent repairs were carried out and surveyed by the vessel's Classification Society surveyor (Lloyd's Register).

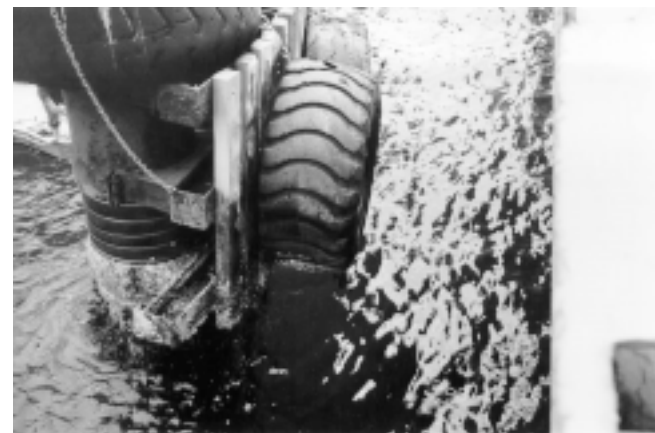
Horizontal girder which caused the hole in No 1 void space
Figure 7

Examinations of the vessel's hull suggested that the damage was effectively a puncture as though the vessel had been pressed against a sharp object. Photographs of No 3 dolphin, taken later in the morning after the tide had fallen, clearly show a section of steel girder extending beyond the facing of the dolphin, between Nos 3 and 4 dolphins. The girder matched the dimensions of the punctured hole. There was no significant scoring to suggest that the vessel had been moving either in a forward or in an astern direction when the hole was made.

From the evidence available and the Master's explanation of the berthing operation, it is reasonable to believe that the vessel's hull was punctured by the steel girder, proud of the piling of No 3 dolphin (See figure 7). The girder, beneath the surface at high tide, formed a pre-existing hazard to any vessel where the bow may down between Nos 3 and 4 dolphins. Neither the Master nor any of the vessel's crew knew of the existence of the section of proud girder.

The Master stated that he had inspected the jetty, together with the personnel from Pioneer Concrete, mainly to formulate the mooring arrangements. The extension of the steel girder was not seen by the Master or brought to his attention. It is not clear whether the proud length of girder was known to Pioneer Concrete and, notwithstanding this, the responsibility is on the owner of the jetty to provide a safe berth.

Inspection of the jetty after the incident by an investigator indicated that the fendering on all four dolphins was generally not in good repair, although work had begun to upgrade the fenders (Recommendation 1). The length of steel girder that protruded from No 3 dolphin and caused the puncture had been cropped.

Immediately after the incident an underwater survey was undertaken. New wooden facing to the dolphins and additional rubber tyre fenders have been fitted. A program of periodic underwater surveys of the berth has been introduced.
