ATSB TRANSPORT SAFETY INVESTIGATION REPORT  
Rail Occurrence Investigation No. 2005/006  
Final

Collision between  
**Shifted Freight Load**  
**on Freight Train 5MA5**  
and  
**Passenger Train 206A**  
Eden Hills, South Australia

30 September 2005

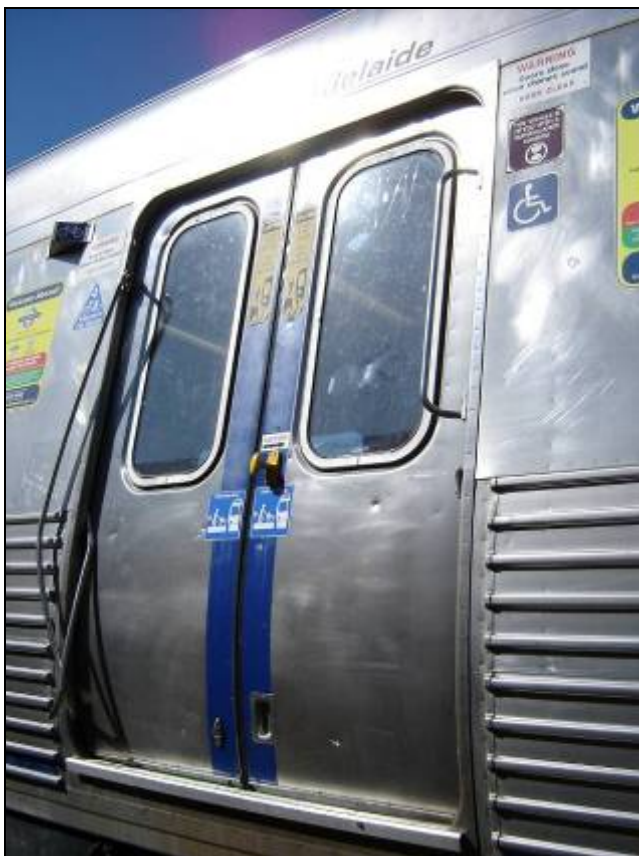
**Figure 3: Photograph of damage to train 206A**

No TransAdelaide track infrastructure was reported damaged as a result of the collision or out-of-gauge loading. There was minor damage to the outer carriage body of the TransAdelaide passenger train, shown in Figure 3.

A number of dents and scratches in the exterior finish were noted, including passenger hand rails that had been dislodged from their mounted position. The damage was minor and the train was able to continue its journey into Adelaide.

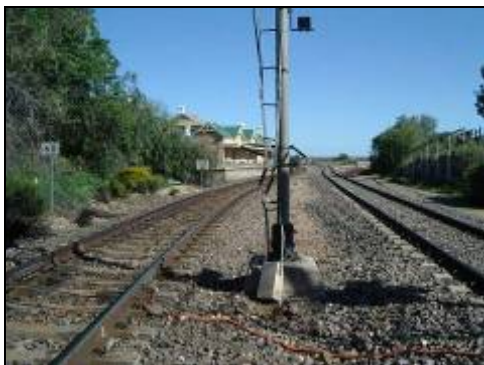
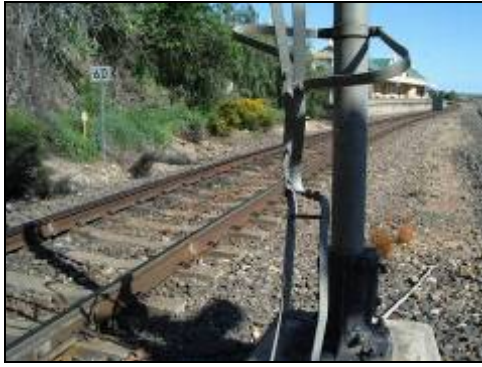
**Figure 4: Photographs of damage to signal 23 at Murray Bridge**

No major damage was recorded by ARTC as a result of the collision or out-of-gauge loading. There was minor strike damage on the Sleeps Hill Tunnel wall, but would not interfere with safe train operations or tunnel integrity. Signal number 23 at Murray Bridge had damage to the access ladder at about the same height as the steel plate protruding from freight train 5MA5, as shown in Figure 4.

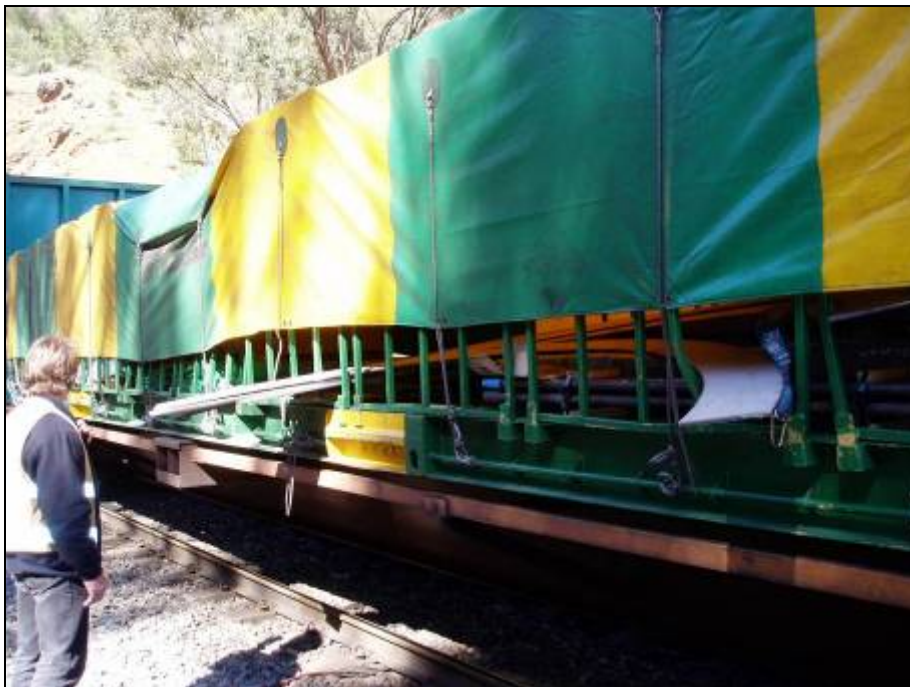
**Figure 5: Photograph of shifted load**

Pacific National had minor damage to the Transi-flat container side cage as a result of the shifted load within.

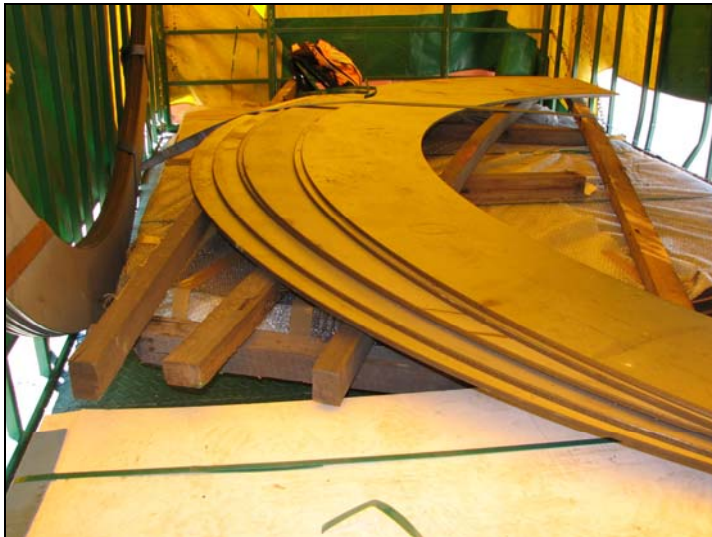
**Figure 6: The Steel Plate Load**

The load which shifted on the freight train was secured using two forms of load restraint. Firstly the load was unitised such that similar items were bound together to form a single unit. Secondly, the unitised load was secured by webbing straps within the caged sides of the Transi-flat. Both the webbing straps and the side cage, however, failed to contain the load within the unit.

The Australian Transport Safety Bureau recommends that Atlas Speciality Metals use appropriate tensile strapping to ensure load security during rail transit in accordance with the Pacific National Freight Loading Manual (or other applicable rail operator instructions).

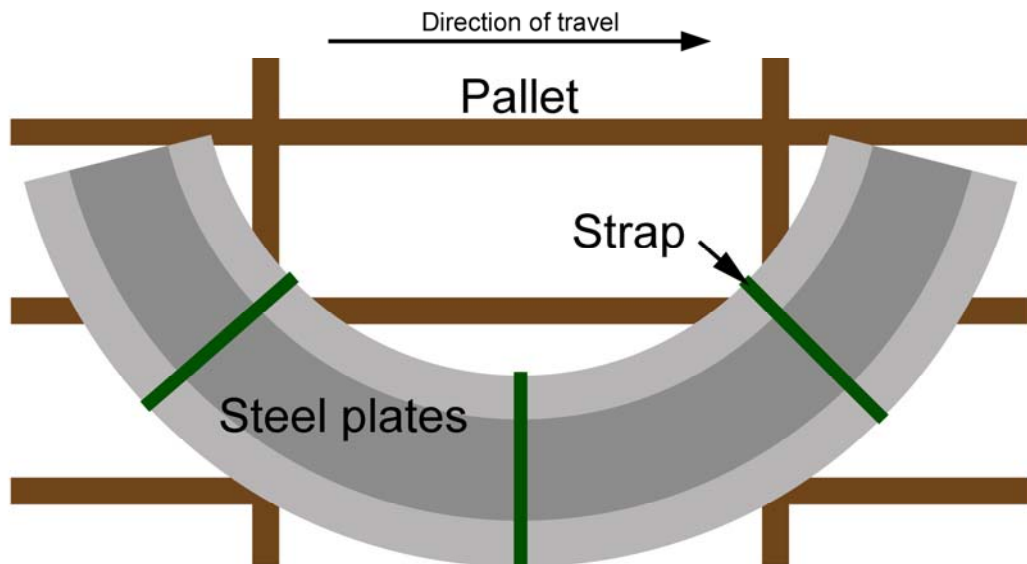
**Figure 7: Unitising strap positions**

Plastic straps were often used by the manufacturer in preference to steel strapping because they did not stain the steel product. The tensile strength of the strapping used in this instance exceeded the Australian standard, but the polyester PET straps did not meet the minimum restraint requirements contained in the PNFLM for such a load.

Two smooth clean stainless steel surfaces placed together have a relatively low coefficient of friction, and can easily slip with respect to each other. This movement may subject the unitising strapping to high levels of abrasion and/or shock loading. To limit this slippage, timber dunnage or load mats are commonly placed in between layers, or the tie down force may be increased. The steel plates which shifted on the freight train were stacked on top on each other with no dunnage or load mats between to increase friction.

It was also evident that the unitising straps were not protected from sharp corners. Consequently, any movement of the load would have led to abrasion of the plastic strapping, reducing its strength and increasing the risk of a strap failure. The load had been inspected by Atlas Speciality Metals prior to despatch and Toll Express inspected the load upon receipt. Toll Express used an acceptance checklist to verify that the load was secure; the correct weight and dimensions were declared on the consignment note; and, whether it was classified as dangerous goods. The checklist did not verify if the load had been packaged to the PNFLM requirements. Pacific National checked the load before the departure of the train. This inspection covered train condition and general load security, it did not ensure unitised loads met the PNFLM requirements.

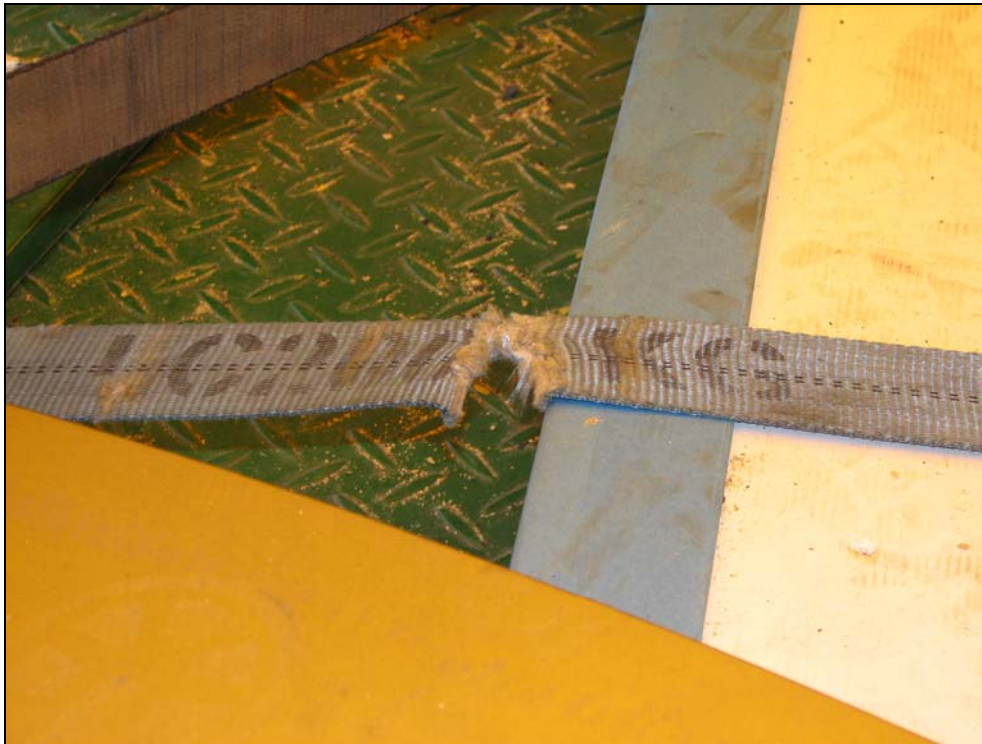
**Figure 8: Damaged webbing strap**

The unitised load was secured to the Transi-flat container using webbing straps. Investigators onsite soon after the incident noticed that the webbing straps were damaged, as shown in Figure 8. The PNFLM specifies that 'whenever securing straps or ropes become frayed by more than 10% of their width (they) must be replaced'. However, it was not clear if this damage was pre-existing, or occurred as a result of the load shifting.

It was also evident that some webbing straps were not protected from sharp corners. As with the unitising straps, any movement of the load would have led to abrasion of the strapping, reducing its strength and increasing the risk of a strap failure.

The Australian Transport Safety Bureau recommends that Toll Express ensure that all securing equipment used such as webbing straps are fit for purpose and protected to ensure load security during rail transit.

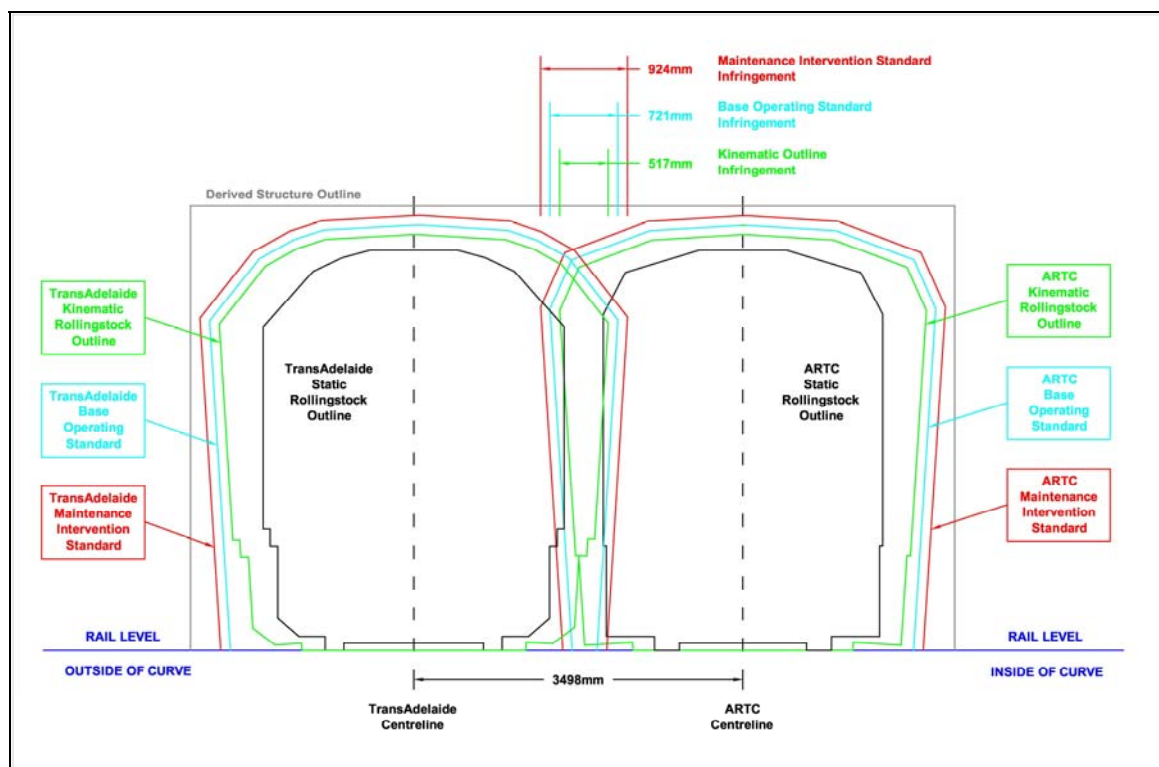
**Figure 9: Clearance outlines at Eden Hills railway station**

Track clearance standards for both ARTC and TransAdelaide specify the minimum kinematic rollingstock outline, and how it is derived. Added to this are the base operating standard, the maintenance intervention standard, and the structure outline. Figure 9 shows the overlaps or infringements of the various standards between the TransAdelaide system and the ARTC network at Eden Hills station platform (14.147 km point).

In certain situations, such as within the confines of a station, preferred track centres may not be able to be physically achieved. Less clearance is allowable in these circumstances in conjunction with more stringent track geometry standards. In this case the ARTC allowable infringement had deviated 140 mm from the design standard without being detected by ARTC or TransAdelaide during routine track inspections. Without intervention, the infringement may have continued to grow, reducing the clearance between the adjacent rail lines and increasing the risk of a collision.

The Australian Transport Safety Bureau recommends that the ARTC review their standards and procedures to mitigate the risk of infringement of the design track centre clearance.

The Australian Transport Safety Bureau recommends that TransAdelaide review their standards and procedures to mitigate the risk of infringement of the design track centre clearance.
