ATSB TRANSPORT SAFETY INVESTIGATION REPORT  
Rail Safety Investigation 2005/003  
Final

**Shunting Accident  
Regency Park, South Australia**

02 February 2005

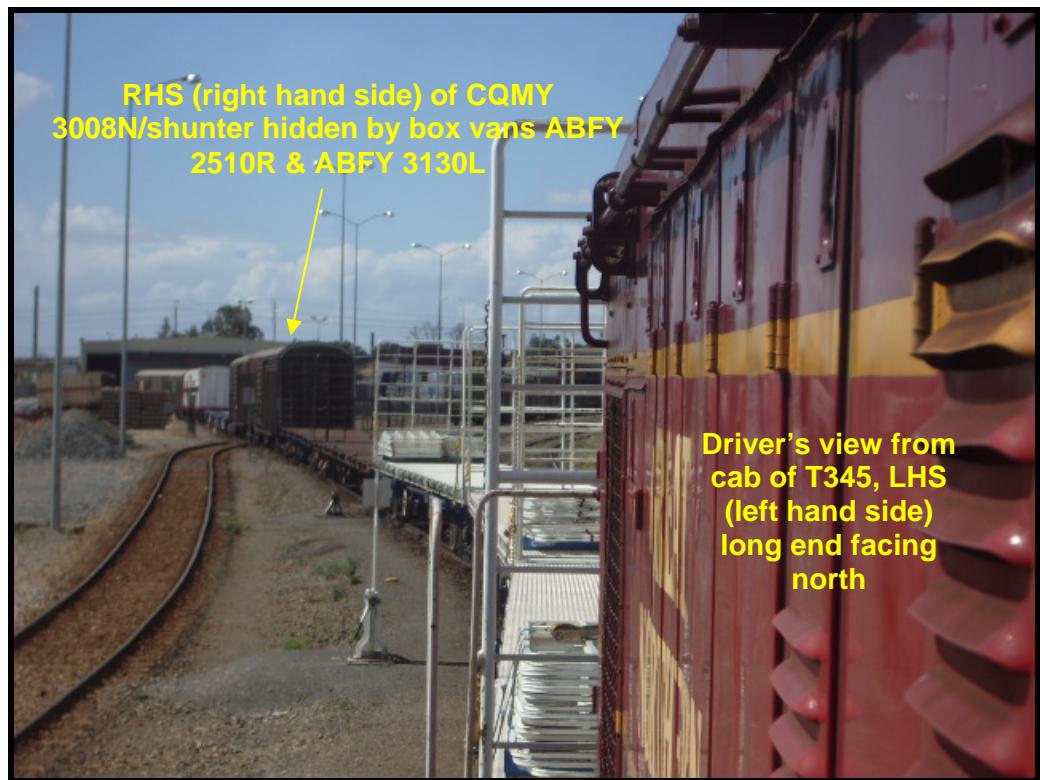
**FIGURE 7. T345 – Driver's view of CQMY 3008N, looking north and as seen while undertaking a propelling move.**

At approximately 1317, (Fig. 8, 17 & 19) unbeknown to the driver, whilst undertaking this final shunt move, CQMY 3008N and all remaining wagons including the locomotive ran over the shunter. During this entire move, the shunter would have been hidden from the driver by the box van.

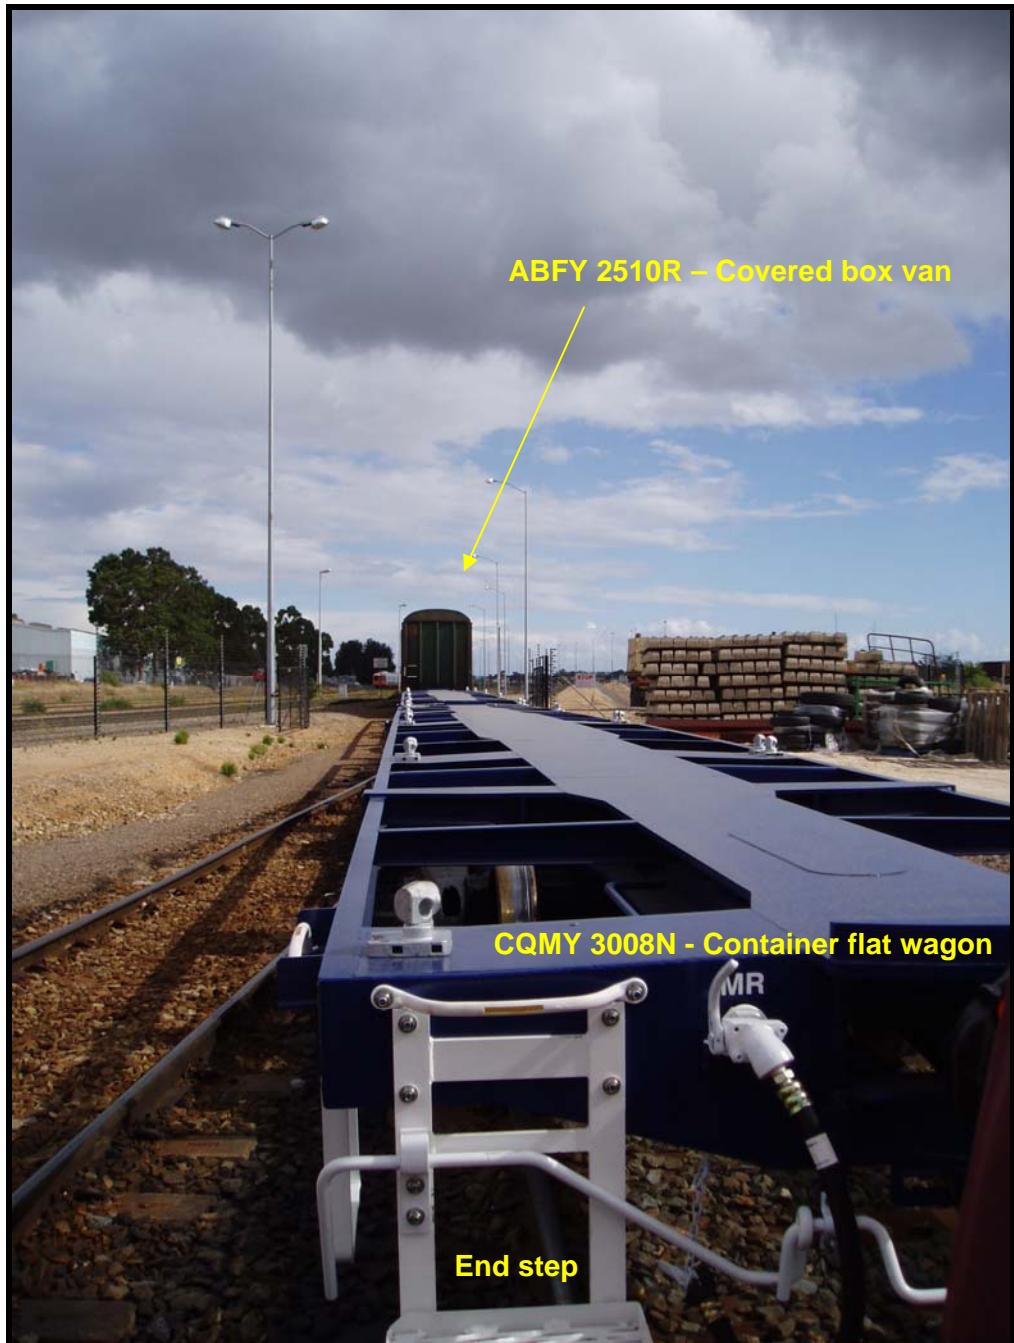
**FIGURE 9. Container flat, CQMY 3008N – As stopped at 1318:35, looking south.**

As the train proceeded northwards, the driver noticed that the train was moving too deep into the SCT yard. The driver stopped the train, at approximately 1319, (Fig. 18 & 20) and endeavoured to contact the shunter using his hand held radio for a 'situation report' and to establish the shunter's wellbeing/whereabouts.

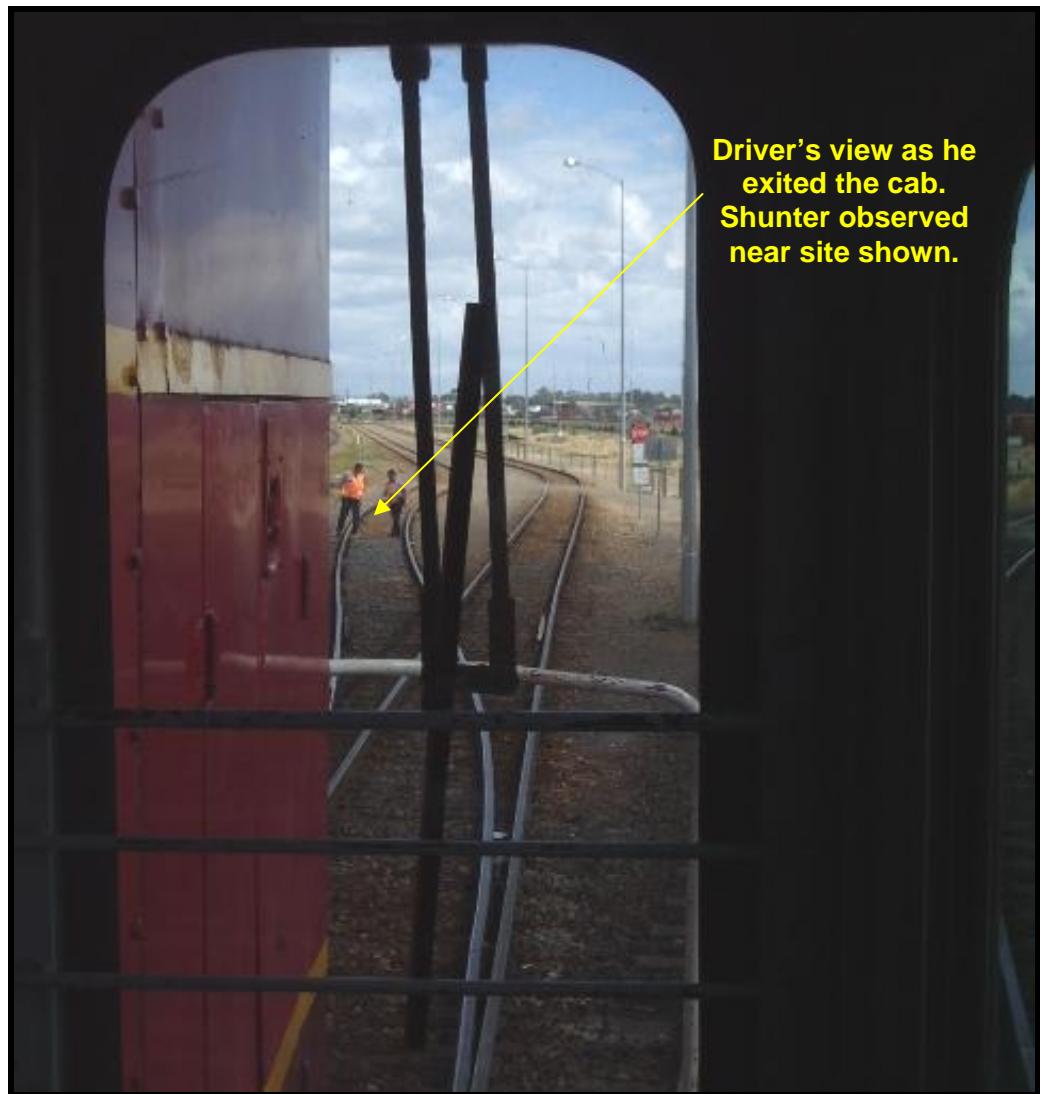
**FIGURE 10. T345 – Driver's view through cab/exit door looking south.**

When the shunter failed to respond to several radio calls, the driver decided to go and look for the shunter. As he exited the cab to descend the locomotive ladder, he saw the shunter on the ground just north of the hand operated derail. He rushed to the accident site. On arrival he observed that the shunter was laying face down, parallel to the track, with the right hand side of his body partly straddled across the rail lines. He had sustained serious injuries, his right arm was severed close to the shoulder, his right leg was crushed part way between the hip and knee and his left leg was crushed between the knee and ankle.

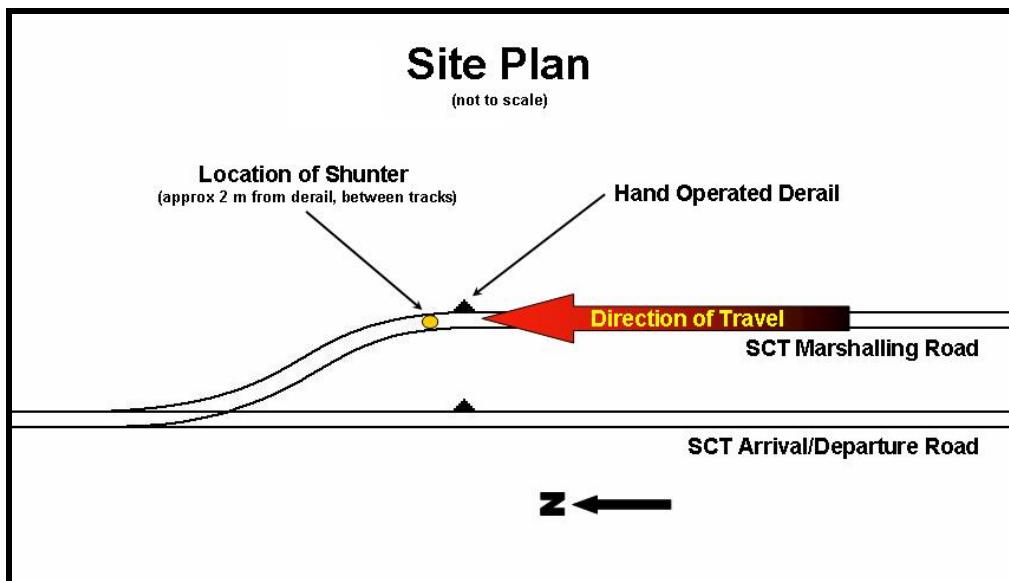
**FIGURE 12. Location of shunter at accident site**

The shunter was found lying face down in a semi-conscious state, approximately two metres north of the hand operated derail (Fig. 12) that protects the entrance to the SCT marshalling loop. His head was facing in a northerly direction; his body was parallel to the track. His hand held radio, safety vest, set of keys and one black work boot were located within the ‘four foot’ immediately adjacent to his body. An examination of the right hand running wheels (travelling in a northerly direction) of CQMY 3008N and all remaining wagons including the locomotive showed signs of blood and fleshy tissue on most wheels, indicating that the shunter had been run over by CQMY 3008N, then the remainder of the train. This lends support to the hypothesis that shunter was in front of the end step and/or about to embark on CQMY 3008N; or that he fell, after having embarked on the end step, lost his balance and tumbled forward and in front of CQMY 3008N.

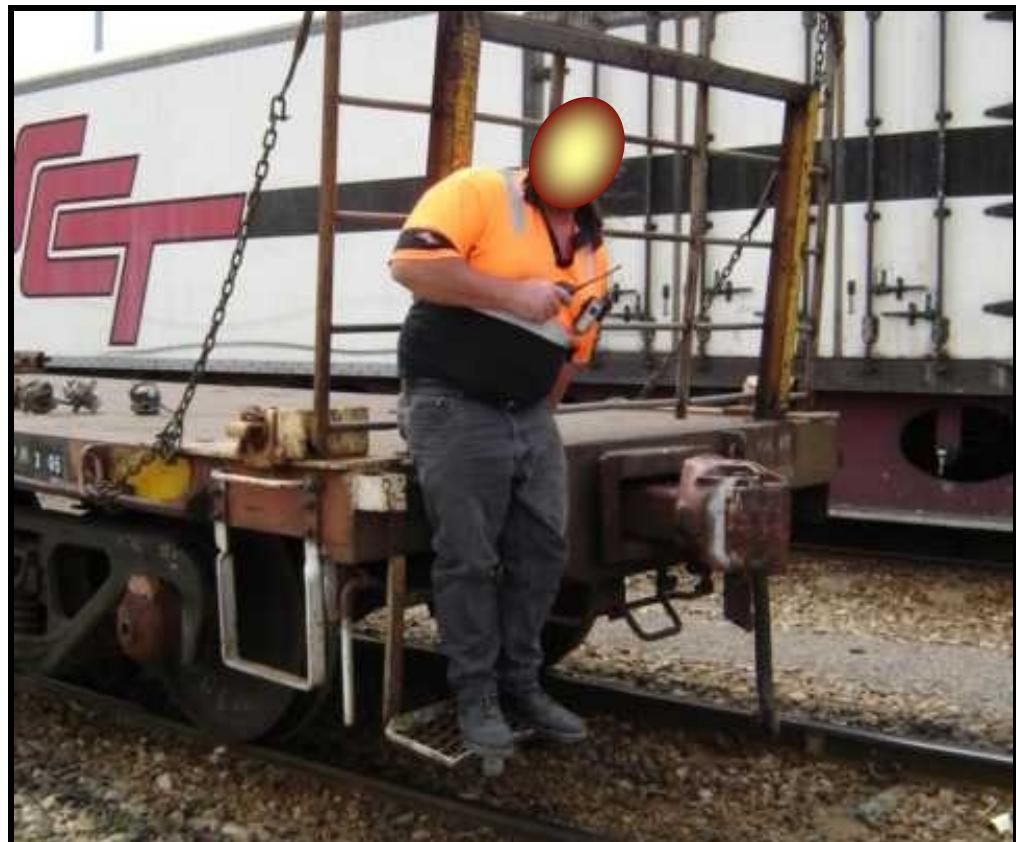
SCT's work procedures for shunting at Regency Park, most relevant to this accident, are shown at Table 4. (Appendixes) An examination of SCT's risk matrix, did not show 'Shunting' as a specific task and although Item 5E identifies Collision - Train/People, this reference is considered too vague. The risk matrix should clearly identify high risk processes, such as shunting, and propose strategies to mitigate high risk processes within a task.

**FIGURE 13. Illustration of shunter riding end step, (as at time of accident) facing forward holding radio. Practice now discontinued by SCT.**

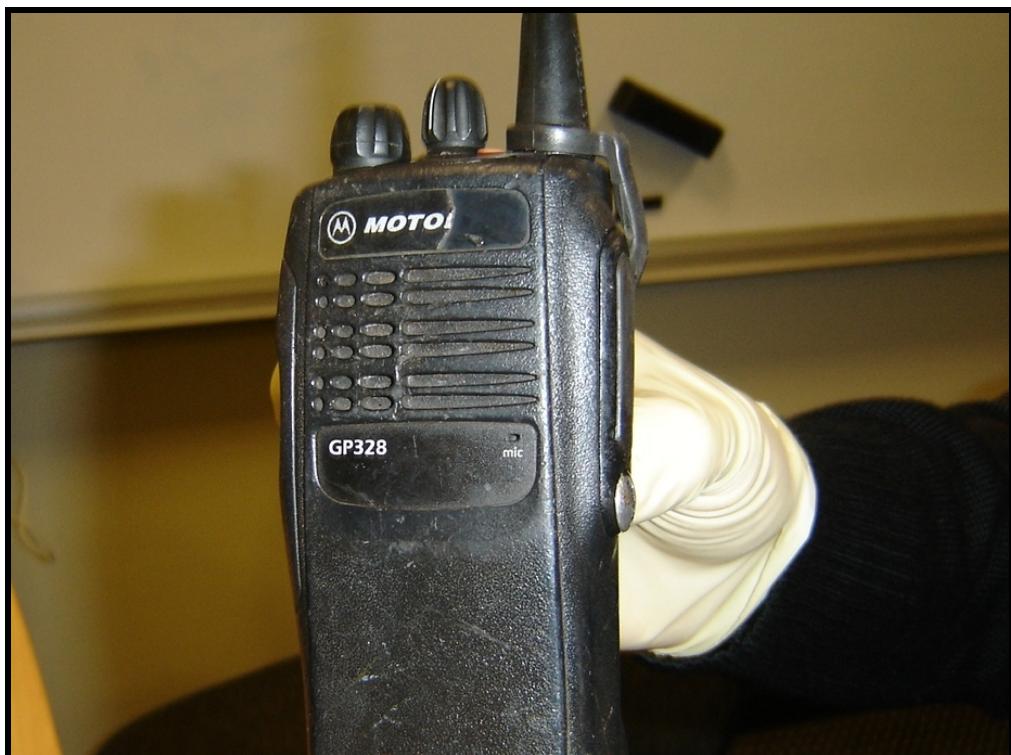
**FIGURE 14. Hand held radio, Serial No 672TDL4017 used by shunter on 2 February 2005**

A radio site survey (channel 1) was jointly conducted by the ATSB and SA Workplace Services using the shunter's hand held radio (Fig. 14) to establish whether any potential problems may have existed with the radio and/or radio coverage within the SCT yard area. No deficiencies were identified, as relates to the technical aspects of the radio/radio system.

- d) normally, SCT drivers and shunters communicate by hand signal and/or using hand held radios. No technical deficiencies were identified with the hand held radios or SCT's radio system.
