MARINE SAFETY INVESTIGATION
REPORT 181

Independent investigation into the grounding of
the Liberian registered container ship

ANL Excellence

in Moreton Bay, Queensland
19 July 2002

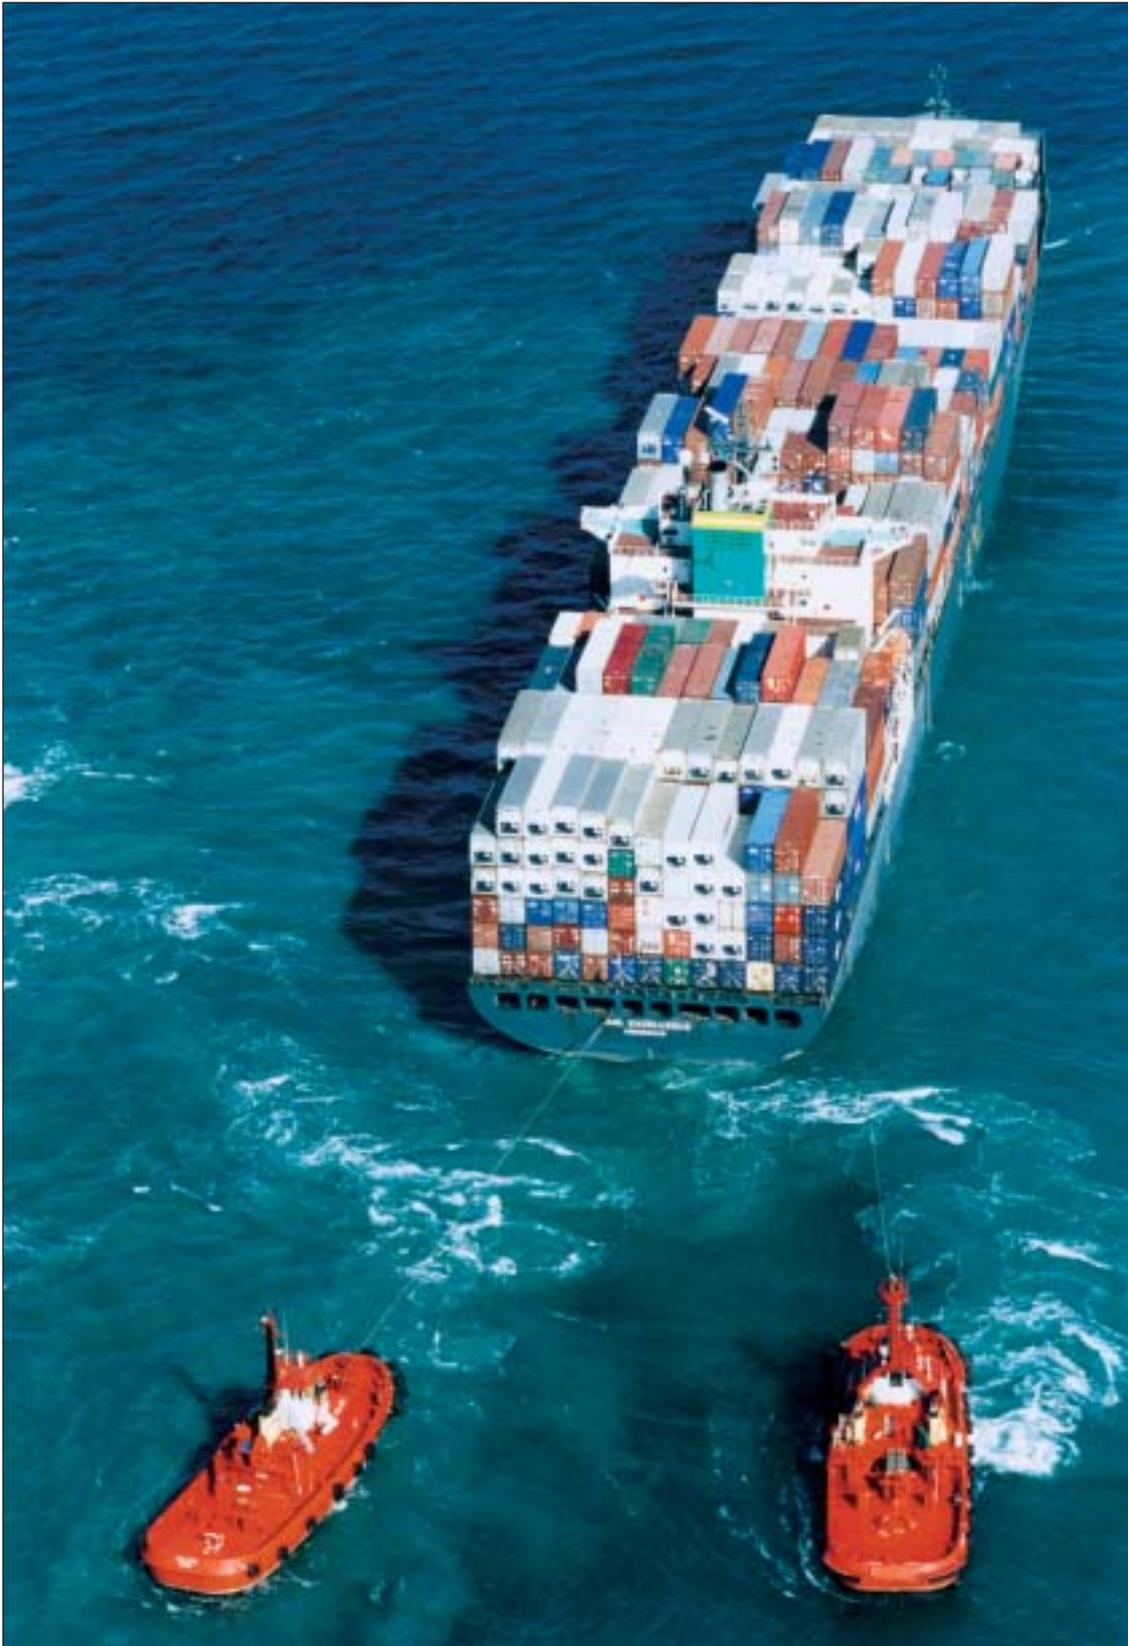
Figure 1:
ANL Excellence aground in Moreton Bay

The soundings revealed that the ship was afloat forward and aft, but aground amidships with no sign that the hull had been breached.

ANL Excellence was refloated on the rising tide at 1436 that afternoon, 19 July. The vessel went to anchor and was examined both internally and externally for any damage. The vessel remained at anchor until the afternoon of 20 July when it berthed at Fisherman Islands container terminal to resume its service.

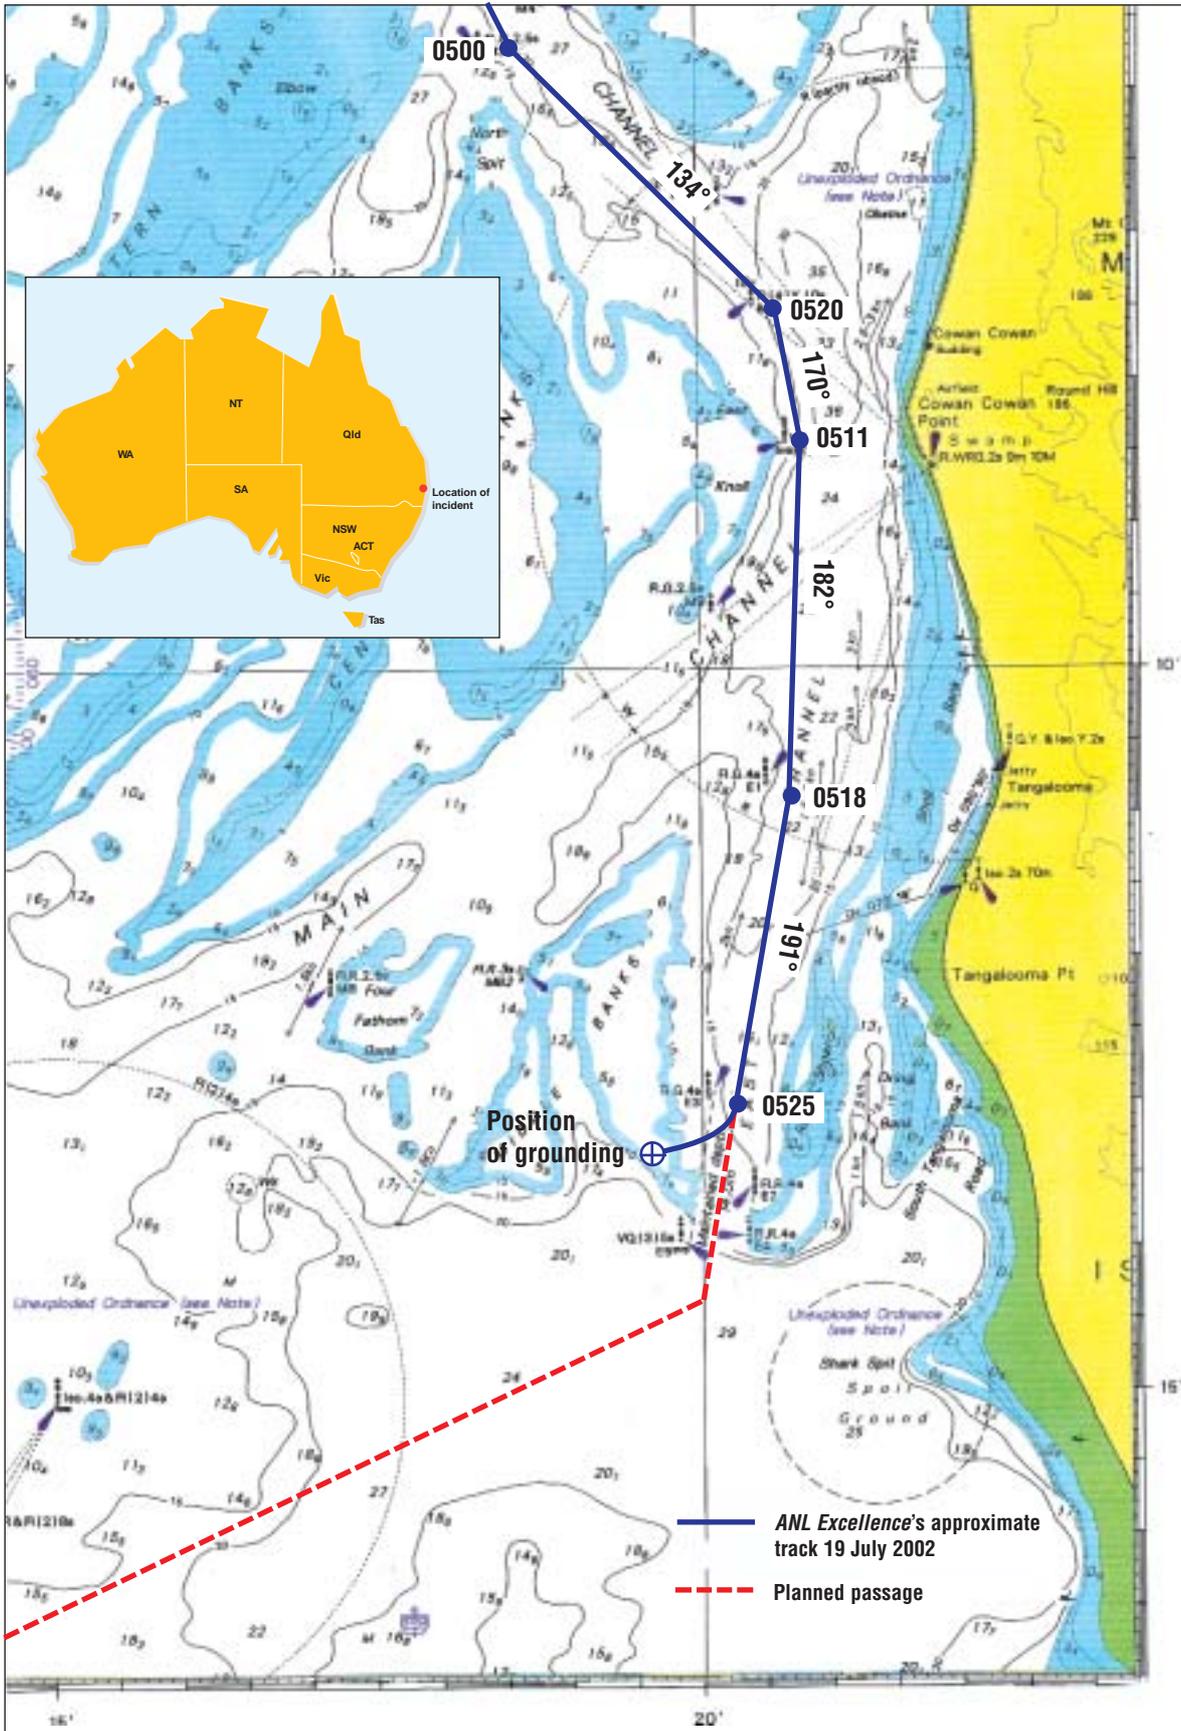
Figure 2:
ANL Excellence's position of grounding

At 0528 all way came off the ship in position 27° 13.28'S 153° 19.65'E, with the ship heading 246°. The ship was aground on Middle Banks, 1.2 miles north-north-west of the temporary buoy marking the position of the E5 channel beacon (see fig. 2). The master and helmsman felt that the ship seemed to surge as it decelerated from 17.5 knots. It was one hour after high water at Tangalooma Point with a tide height of 1.6 m above datum.

On 19 July 2002, *ANL Excellence* grounded on Middle Banks in Moreton Bay as a result of a simple error of judgement on the part of the pilot. The pilot stated that he had ordered the

alteration at E3 beacon, a starboard hand lateral mark, by mistake.

At, or approaching E3 beacon, the pilot apparently missed several visual and time cues and adopted his usual routine as though the ship was passing E5 beacon. The pilot said that, although he could not see the temporary buoy marking the position of E5 Beacon, he could see the lateral beacons E2 and E4 on the port side ahead of the ship. Despite this, he still ordered the course alteration and called port control to give them the ship's estimated time of arrival at the Entrance Beacons. He did not, however, check the ship's position using the ship's navigation aids or the portable electronic chart system, which was his usual practice, prior to ordering a course change. In the time leading up to the course alteration, the pilot was engaged in conversation with the master and it appears that when he ordered starboard rudder, for whatever reason, the pilot had lost his awareness of the ship's actual situation.

Where port authorities use a buoy or other temporary aid to replace an established navigation aid, the shape and the light characteristics of the temporary aid should be consistent with those of the aid it replaces.

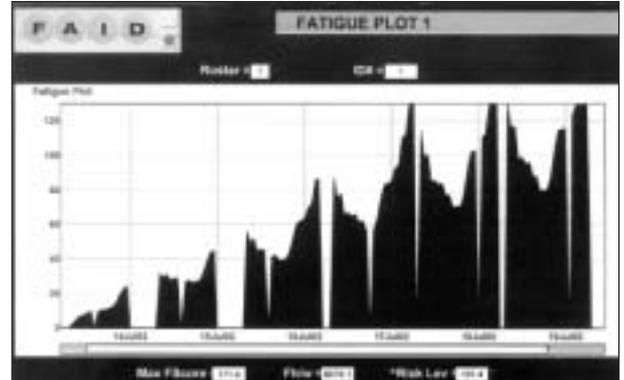
FIGURE 3:
Master’s fatigue index plot

In the case of the master and mate of *ANL Excellence* the FAID program is easier to apply. *ANL Excellence* had been on passage from Singapore, through the Great Barrier Reef. The ship had been maintaining normal sea watches since Singapore, but the master had been on duty for extended and irregular hours as a result of the demands of the pilotage through the Great Barrier Reef and the arrival time off Brisbane. On 16, 17 and 18 July, particularly, he had had less than six hours broken sleep each

A score in excess of 80 indicates that fatigue may start to affect performance. Both the master’s and mate’s scores at 171 and 158 respectively, were very high around the time of the incident with their pre-existing level of fatigue compounded by the time of the day.

Fatigue degrades performance. The fact that the master heard the pilot give an order to the helmsman but was slow to realise the implications of the alteration and that he first checked the helmsman, rather than query the pilot, is a sign of probable fatigue.

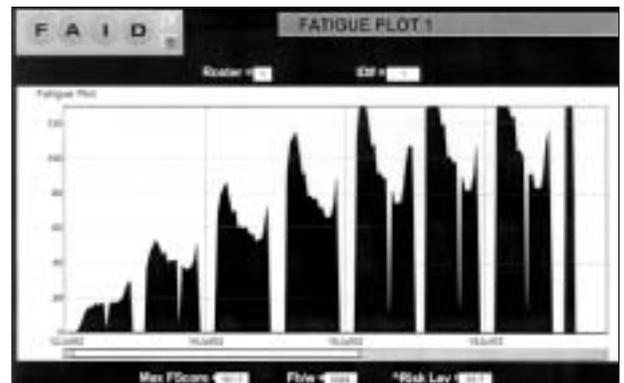
FIGURE 4:
Mate’s fatigue index plot

day (see fig. 3). The mate, although maintaining watches, had also worked extended hours particularly on 14 and 15 July (see fig. 4).

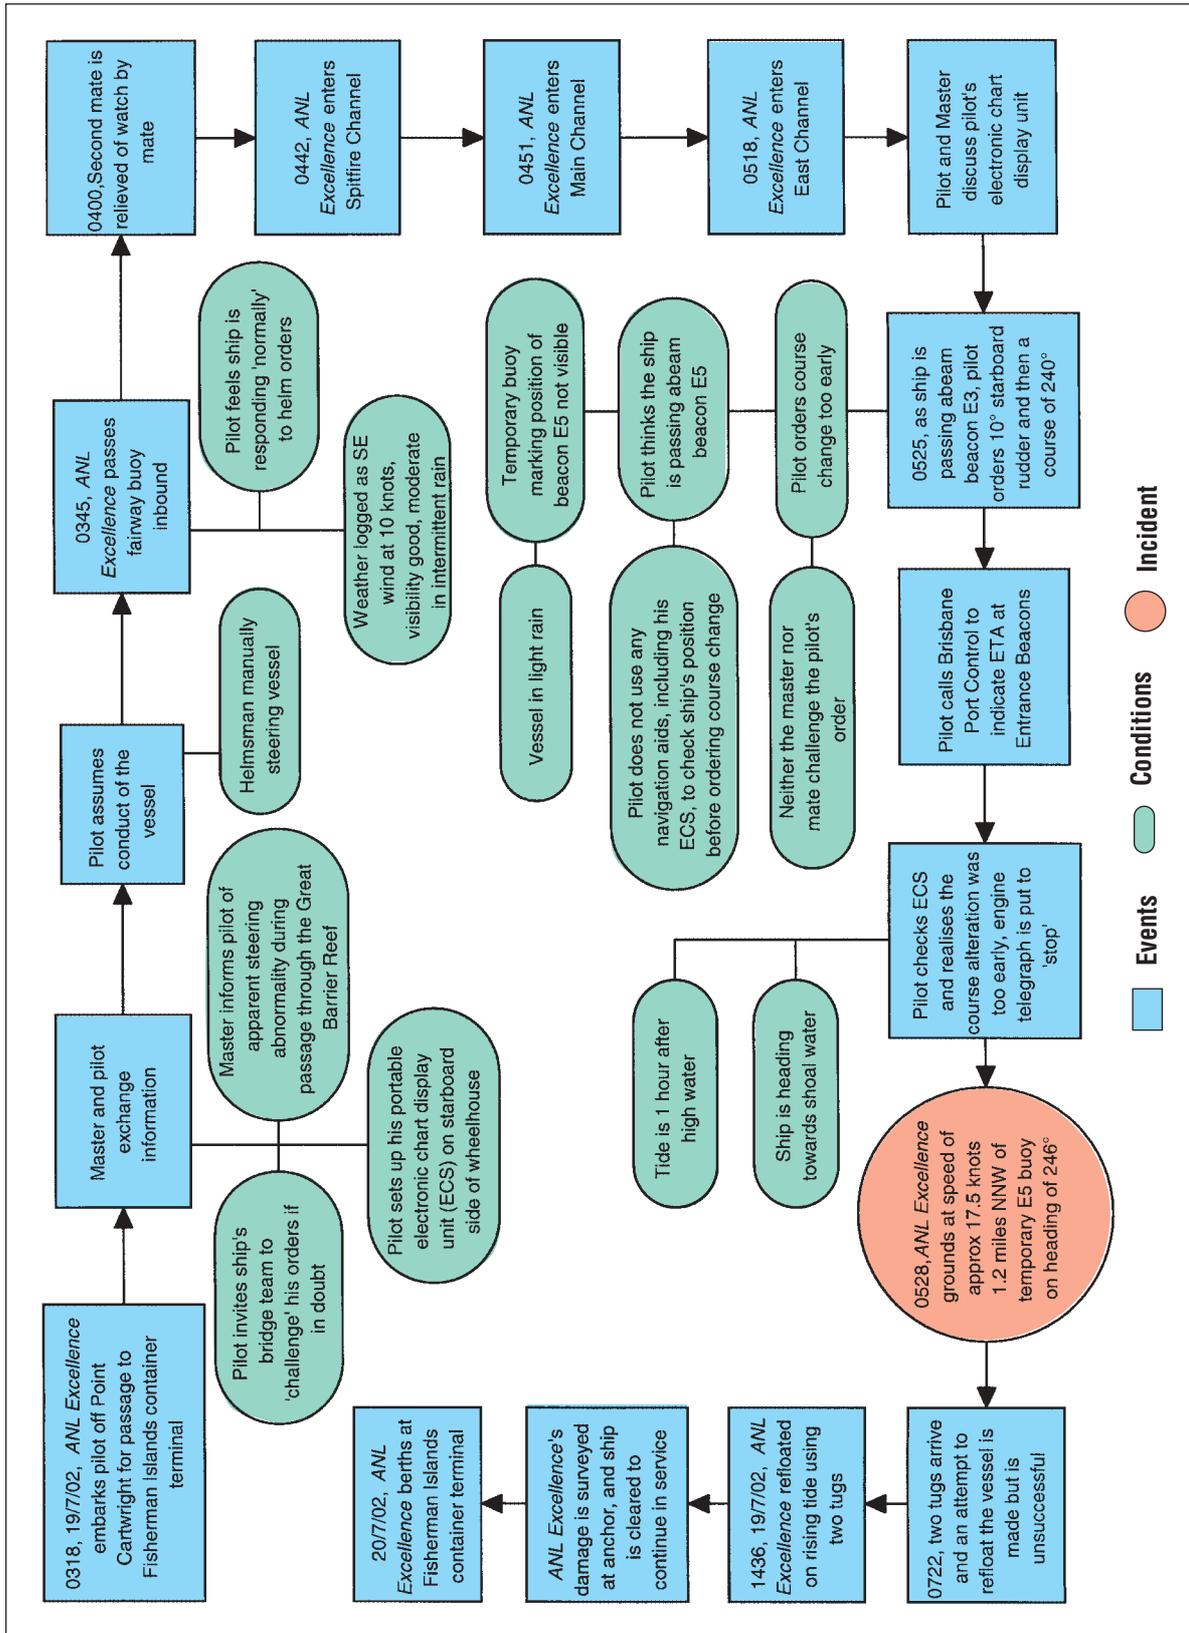
FIGURE 5:
ANL Excellence: Events and causal factors chart

3. Insufficient attention was paid to the ship's radar display.
 4. The navigation chart in use by the ship did not show the temporary replacement of E5 cardinal beacon with a temporary starboard lateral buoy marking the south-east extremity of Middle Bank.
