DEPARTMENTAL INVESTIGATION
INTO THE LOSS
OF THE BOW SECTION
OF THE GREEK REGISTERED
MOTOR TANKER

KIRKI

THE SUBSEQUENT FIRE,
EVACUATION OF THE CREW
AND SALVAGE OPERATION
FROM
20 JULY 1991 TO 23 AUGUST 1991

REPORT 33

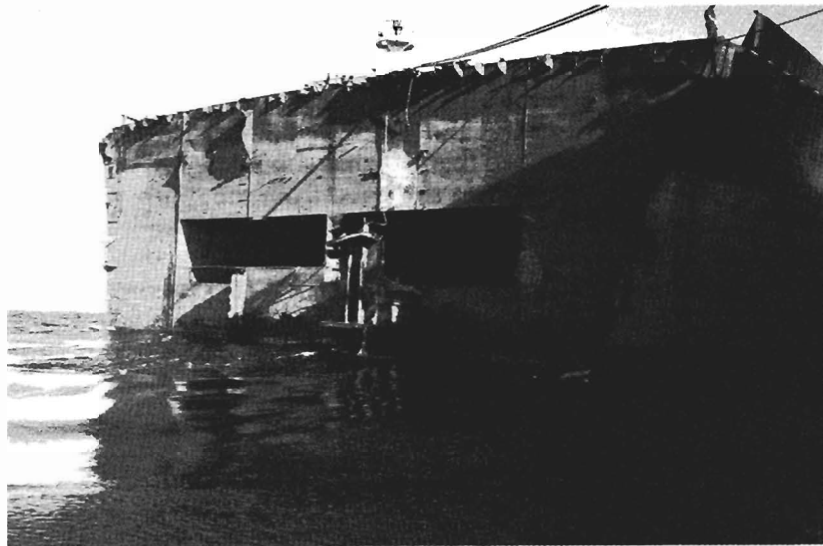
Photograph 2 - At frame 93, forward bulkhead No 1 cargo tanks at completion of 23 August discharge. Plates missing port and starboard of centre line were lost on or after 25 July, during tow northward.

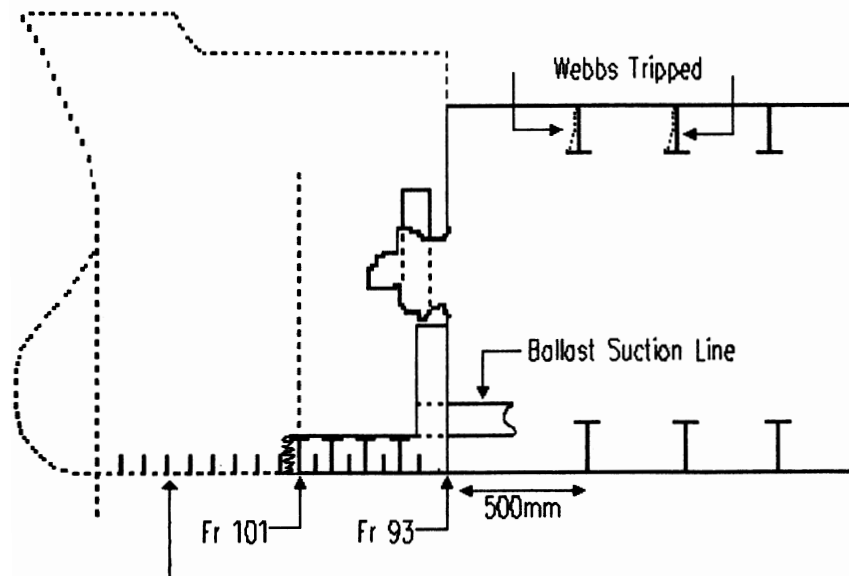
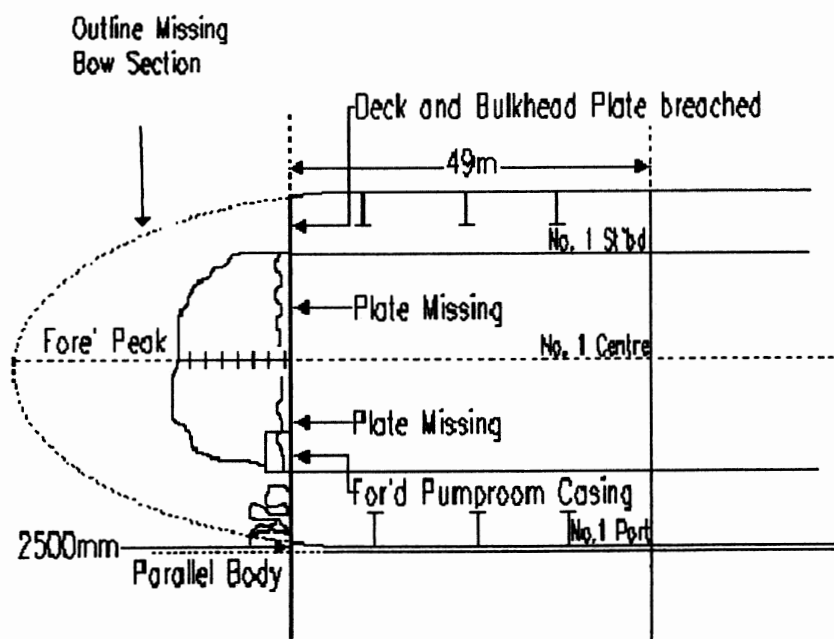
diagram 3

SKETCH OF BOW AREA ADAPTED FROM DIVER'S SURVEY SKETCH AND VIDEO TAPE - 12TH AUGUST 1991

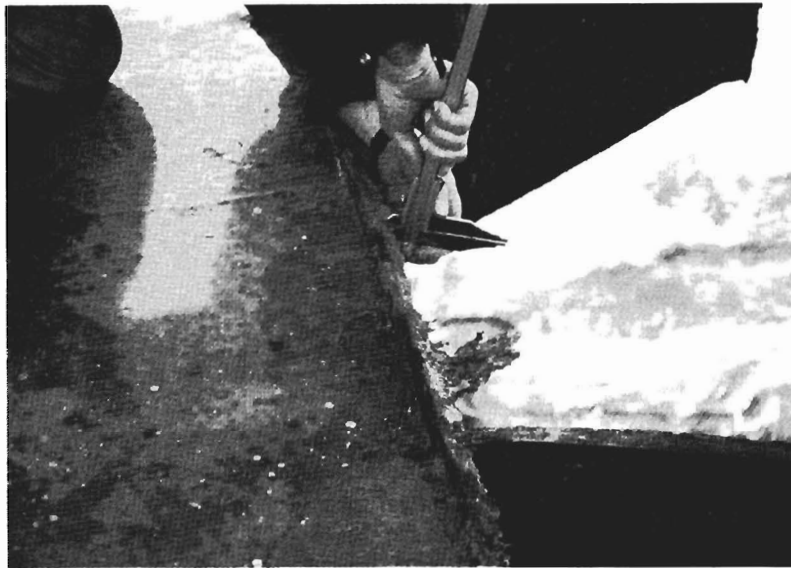
On 23 July 1991 the Inspector viewed the area of the break and, assisted by the Salvage Engineer, took a series of calliper readings across and immediately adjacent to the area of the break forward of frame 93 (Attachment 3). These readings were of the thickness of the deck plates (originally 13mm) and of some of the exposed brackets remaining in place on the forward bulkhead. A sample of deck plating was removed by bending the plate by hand, and submitted to the Materials Research Laboratories, Melbourne, for testing (Attachment 2).

Photograph 3 Calliper measurements taken of metal around the bow section near the break

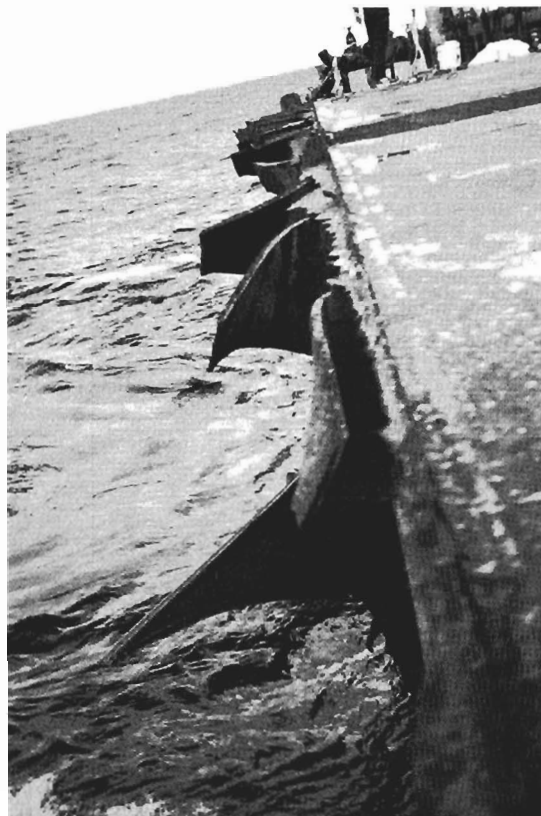
Photograph 4 View of fracture looking towards centre line from the port side

The Materials Research Laboratory reported that the sample plate was found to be severely corroded, with up to 90 per cent of the plate thickness having been lost in some areas, the corrosion being of a general nature with some shallow pitting attack. The corrosive attack occurred mainly from the underside of the deck plating (the deck head of the fore-peak ballast tank), and it was considered that extensive corrosion of the weld had also occurred. A chemical analysis of the steel itself confirmed that the steel conformed to the chemical requirements of Lloyds Grade "A" specification. The analysis also concluded that the plate was subject to a ductile overload mechanism as a result of high loads on the sample plate.

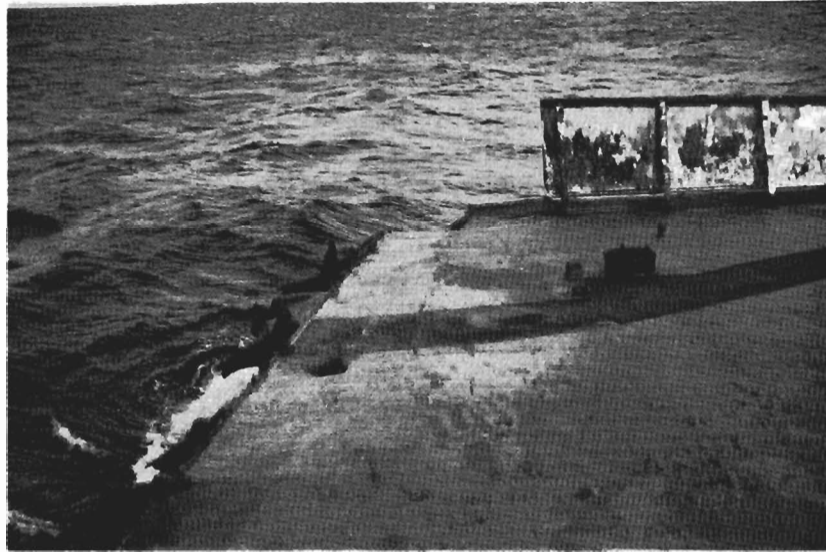
The main source of pollution on 21 July was from the breach in No 1 starboard tank. Sea water shipped through the breach at the top of the tank displaced the oil inside. Oil was also lost from the centre-line punctures in the upper part of No 1 centre tank.

*Photograph 5 Aft of frame 93 deck over No 1 starboard tank,
the initial source of pollution*

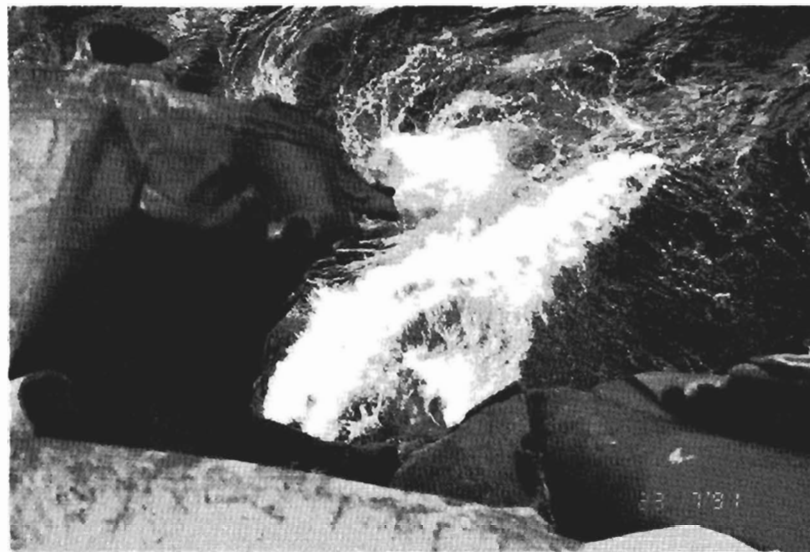
Photograph 6 Breach in No 1 starboard cargo tank

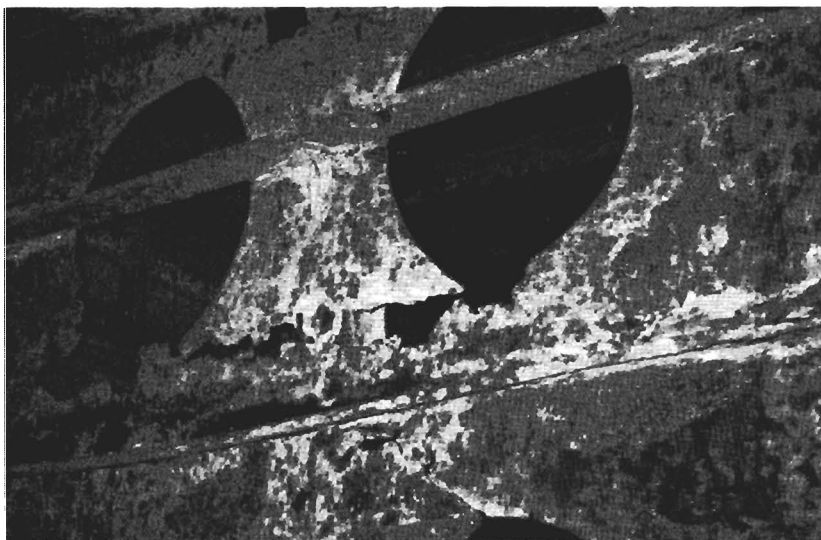
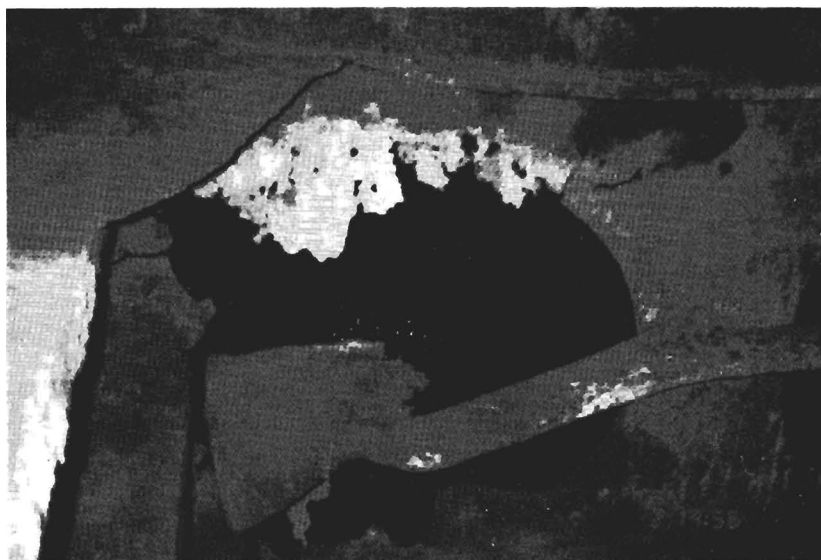
It is therefore concluded that the procedures adopted by the Germanischer Lloyd during structural surveys failed to identify the area of localised corrosion. The condition of ballast tanks 13 and 14 together with the number and nature of deficiencies in safety equipment, indicates that a number of surveys over a period of time, including surveys that were conducted under international safety conventions, were not performed effectively.

Photographs 7, 8 and 9 Internal condition of dedicated ballast tanks 13 and 14 (No 7 wing tanks)

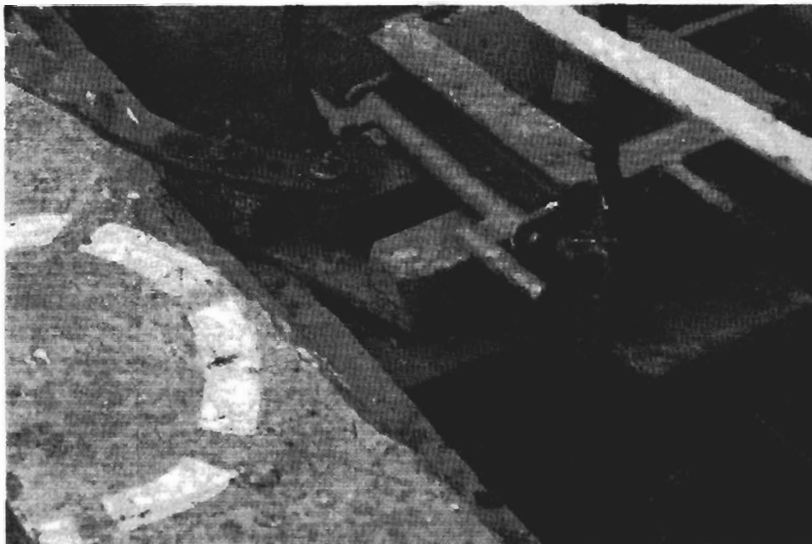
However the port lifeboat could not be released from the forward fall and block using the patent release mechanism. The forward thwart, which had evidently been renewed some time in the past, did not permit full travel of the releasing handle, whereas the after thwart had been fashioned to allow proper operation of the release mechanism.

Photograph 10 Port lifeboat forward fall release gear in the open position with handle fouling thwart. Note oiled hinge pins.

The Inspector, while accepting that the thwart may have been repaired as stated, rejects that there was no danger to the crew through this serious deficiency. It is totally unacceptable in a situation where the ship is abandoned in an emergency, in rough seas where simultaneous release of the falls is essential to prevent the boat being suspended by one fall, for the release mechanism to be inoperable. Moreover it was known to be in this condition for over 21 days. It was extremely fortunate that the after lifeboat fall was not released. Had it been, all those in the boat would have been thrown into the water and undoubtedly some, if not all, would have perished.

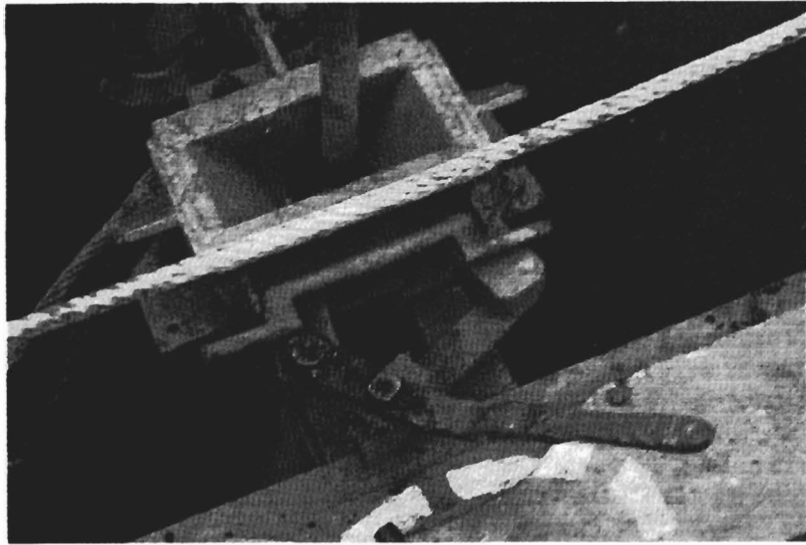
Photograph 11 Port lifeboat aft fall release gear in the open position

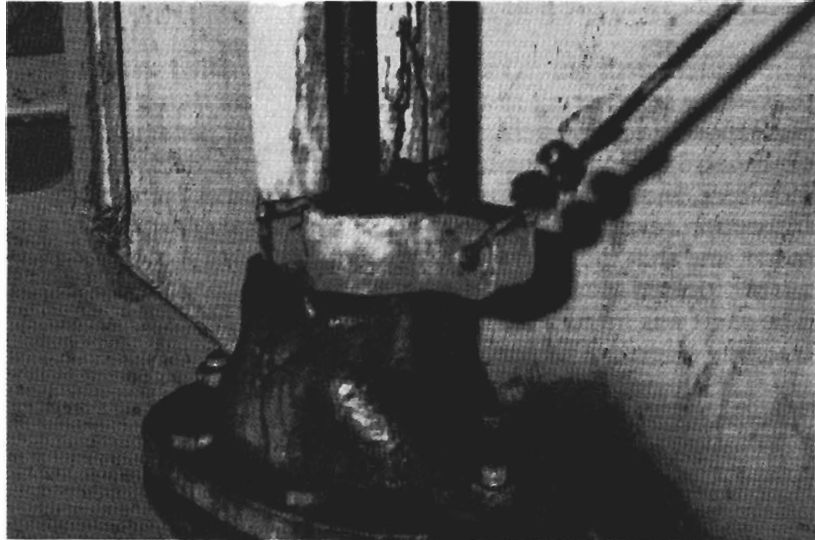
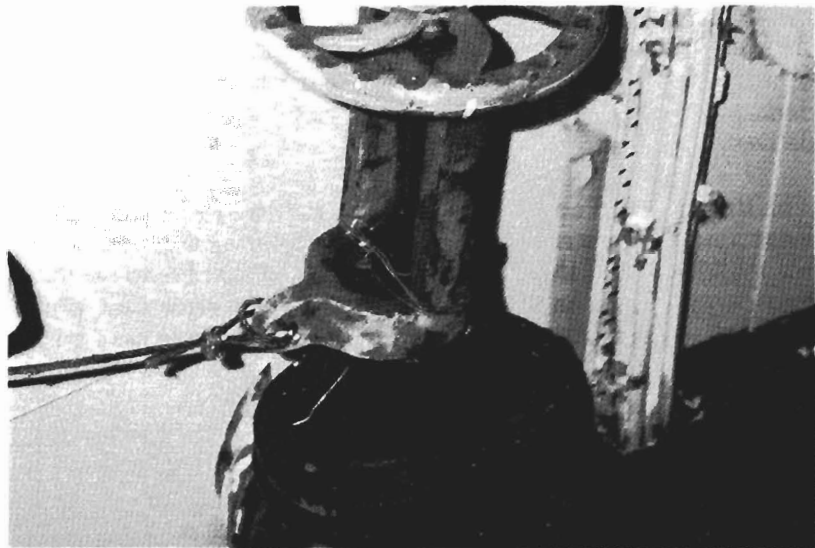
The number of turns and gauge of the wire would have made it impossible for the wire to be broken by the operation of the remote controls and for the valves to close remotely.

Photograph 12 & 13 Remote fuel shut offs and valve bridge pieces bound with wire.

Although the owners submitted the salvors bound the bridge pieces, the Inspector does not accept this. He is satisfied that the binding with wire of the remote fuel trip mechanism was done by crew members, not necessarily those onboard at the time of the incident. However, the bindings must have been obvious to all engineering staff. By rendering the system inoperable, the safety and lives of the whole crew were placed in jeopardy.

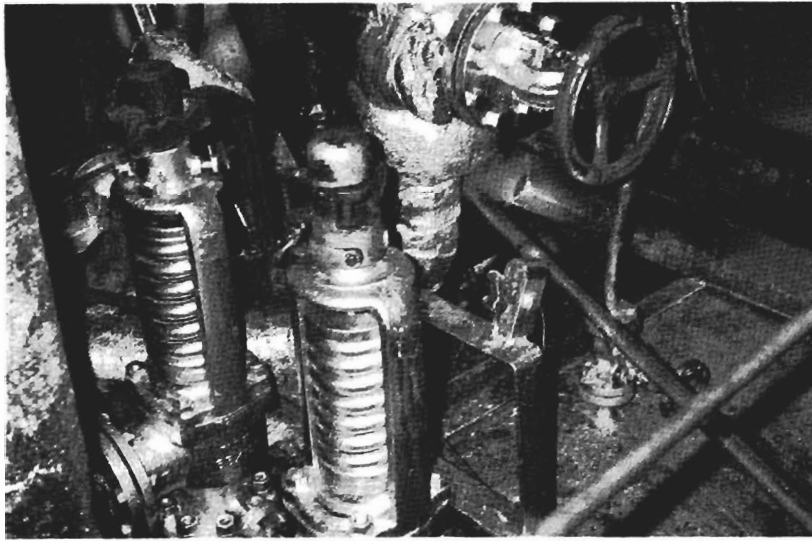
The potentially most dangerous defect related to the boiler safety valves. On 19 August, Mr Wilkinson reported that the port boiler's secondary circuit-feed pump stopped and the water level was lost in the steam drum. At the time the lightering tanker was letting go and all the salvage and transfer crew were on deck assisting with the operation. No trips or alarms operated, the primary boiler fire remained in operation and the boiler secondary circuit safety valves did not lift, despite pressure in the boiler rising to at least 46 bar before being discovered. The boiler fire was tripped manually and the safety valves, which were rated to lift at 37 bar, had to be levered open with crow bars to prevent an explosion. It was reported that in resetting the valves the springs had to be eased about 4cm to reset the valves to lift at the correct pressure.

Photograph 14 Port boiler primary drum safety valve failed to operate at 46 bar. Note missing easing gear.

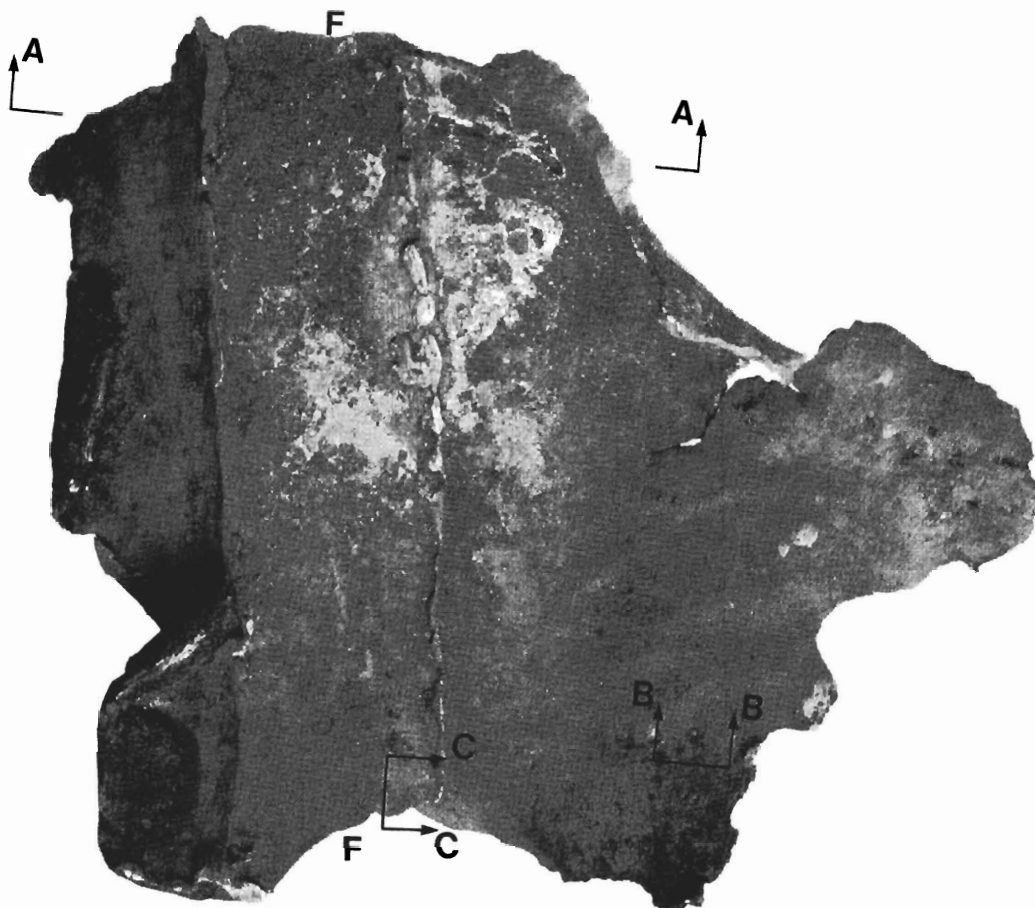
Figure 1. As received sample of upper deck plate from the tanker "Kirki" showing :

- a. Weld remnants (two lines of projections running top to bottom) delineating site of previously attached plate.
- b. Main fractures (marked F).
- c. Sections taken for further study: A-A, B-B and C-C.

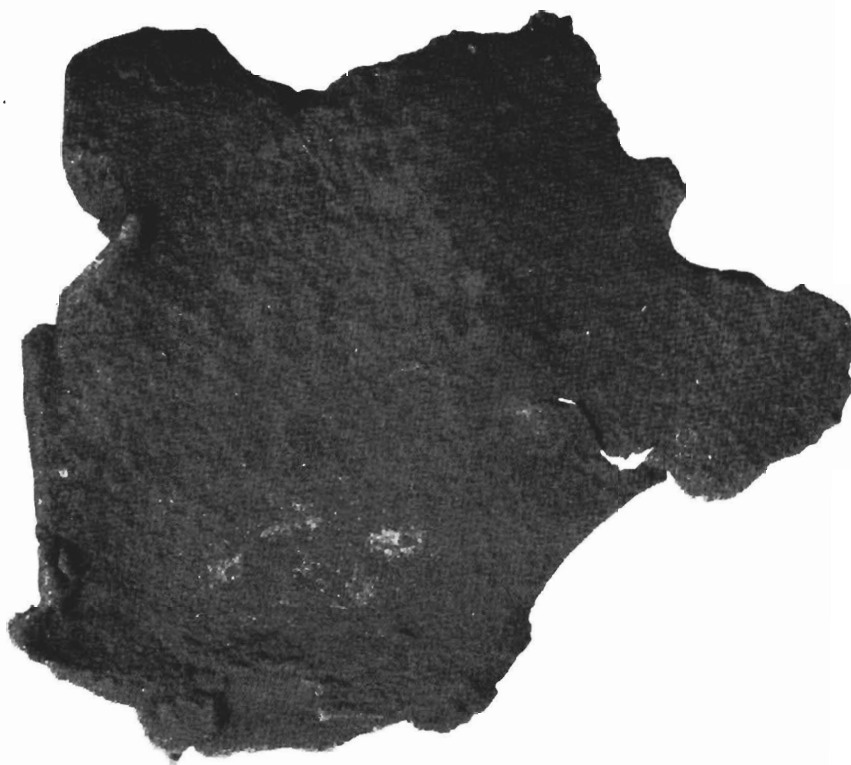
Figure 2. Reverse side of the view shown in Fig. 1 showing rub marks.
(Mag. X 0.9 approx.)

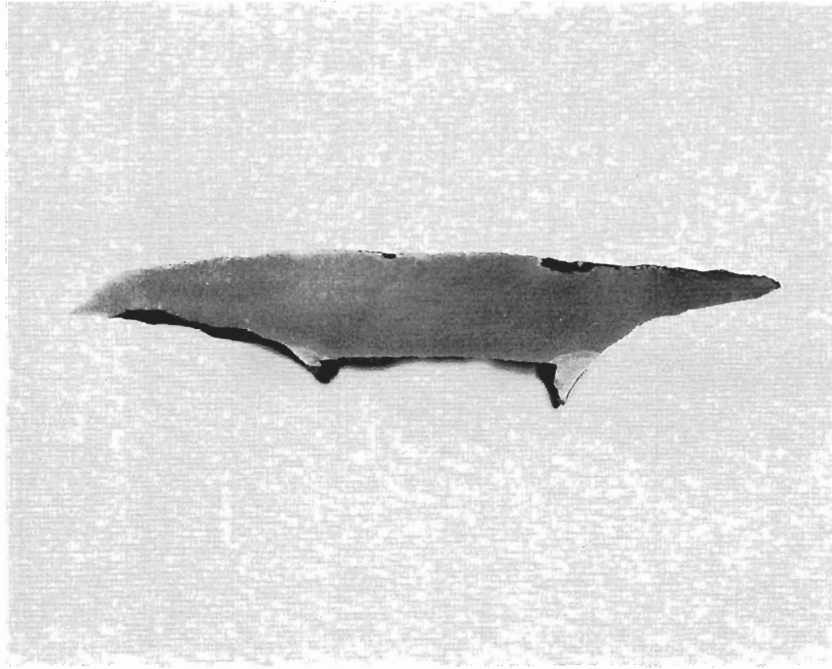
Figure 3. Section A-A (Refer Fig. 1), showing extent of plate thinning by corrosion. Weld remnants mark the site of a previously attached plate.

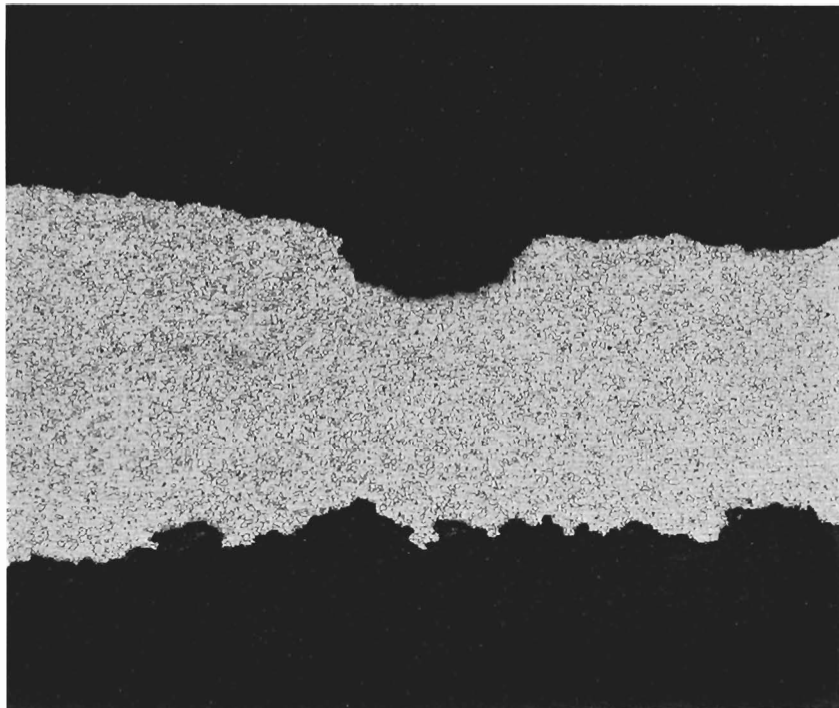
Figure 4. Optical micrograph of section B-B showing corrosion attack on upper and lower surfaces of samples.

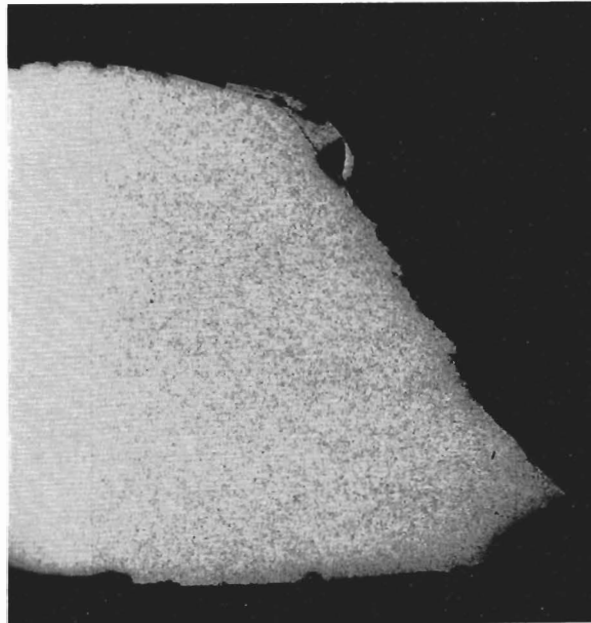
Figure 5a. Section C-C (Refer Fig. 1), through fracture in thick region. Fracture surface is at right.

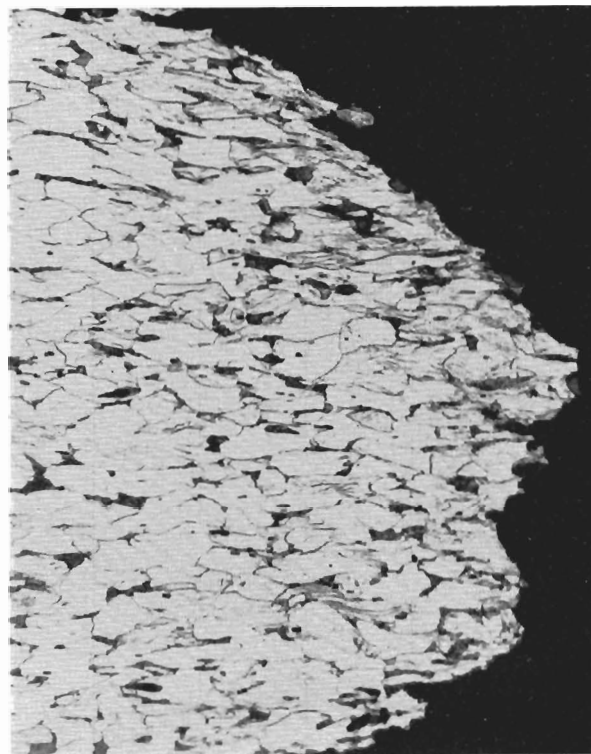
Figure 5b. Magnified view of Fig. 5a showing elongated grains adjacent to fracture, indicative of ductile overload.
