INVESTIGATION REPORT  
9704041

**Bureau of Air Safety Investigation**

**British Aerospace 146-300  
VH-NJL  
Cairns to Ayers Rock  
11 December 1997**

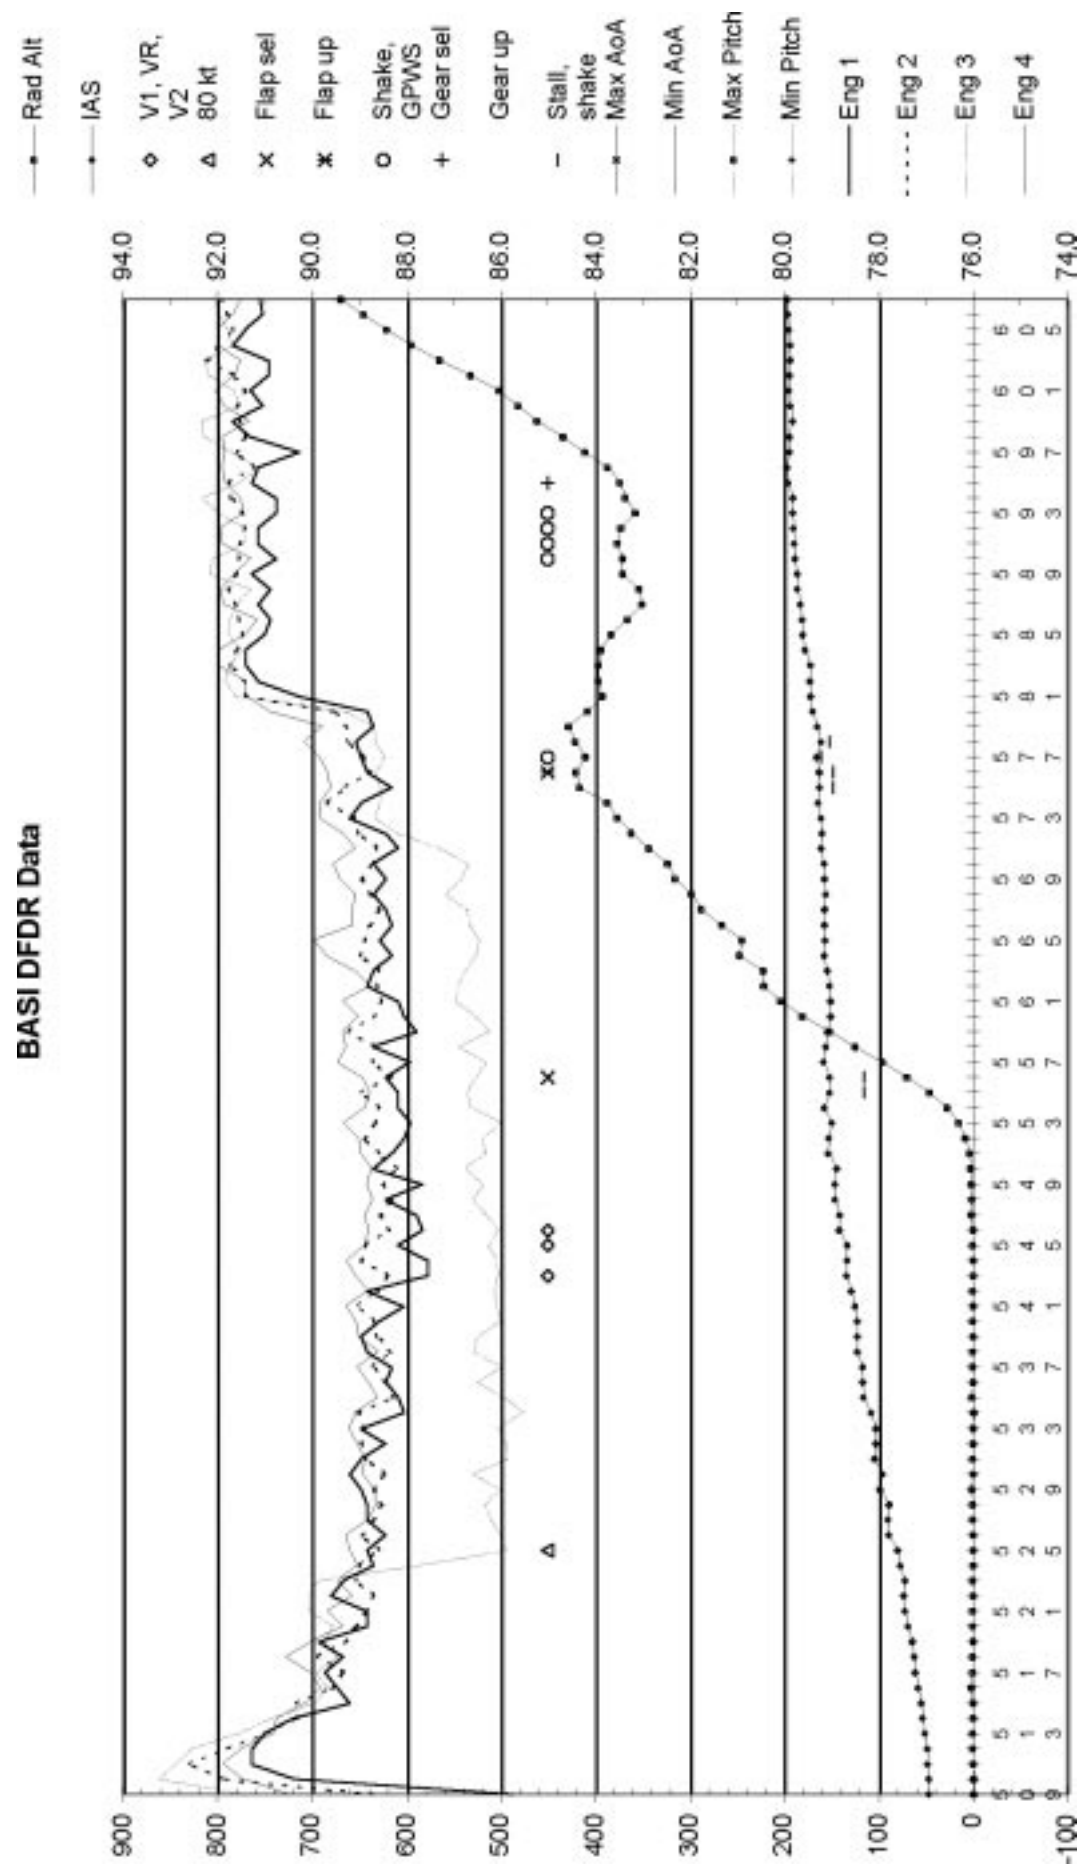
BASI DFDR Data

A graphical presentation of the DFDR data is at Attachment A. The table at Attachment B summarises the principal events in the sequence.

The recorded data indicated that the stick shaker and the stick pusher activated at the same time. The aircraft angle of attack (AoA) was recorded at intervals of 0.5 seconds. The recorded angle of attack values (in degrees) from 1 second before to 1 second after the stick shaker/stick pusher event were:

10. The data indicated that the stick shake and stick push actions took place simultaneously and that they were recorded for 1 second only, immediately after the flaps had fully retracted. At the same time, the aircraft angle of attack peaked at 16°. This value exceeded the parameter for stick shaker activation. The report from the pilot in command that both stall valve lights illuminated indicated that the stick pusher activation had occurred, even though the angle of attack did not reach 22.5°. The high rate of increase in angle of attack was probably sufficient to activate the system. However, the almost immediate reversal in the trend and value of the angle of attack would have de-activated the stick pusher. The high angle of attack and the rapid reversal were probably due to atmospheric factors, as distinct from any pilot action, which would have been later. The reported brief illumination of the stall valve lights, and the pilot in command's recollection that he did not feel the stick pusher operate (this was possible, given the short period of activation), support such a conclusion.

11. After the stick shaker activation had ceased, the aircraft altitude decreased by 80 ft. This triggered the ground proximity warning system (GPWS) 'Don't Sink' warning reported by the crew and indicated that the GPWS system had been functioning normally.
