ATSB TRANSPORT SAFETY BULLETIN  
Aviation Level 5 Investigations AB-2010-036  
Final

# Level 5 Factual Investigations: 1 April 2010 to 30 June 2010

Issue 2

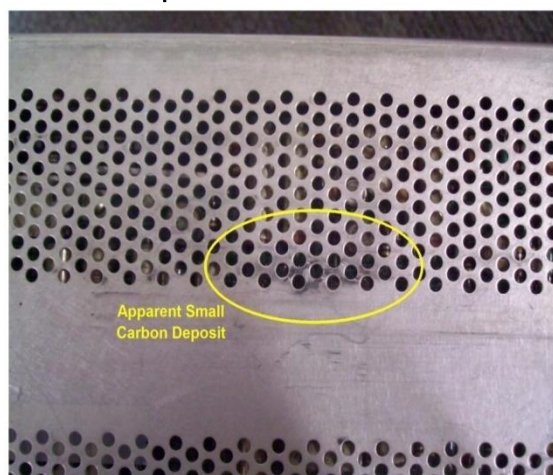
The weather radar indicator was removed and a small carbon deposit was noticed on the exterior of the casing (Figure 1). The weather radar indicator was replaced in accordance with the aircraft maintenance manual and the aircraft was returned to service.

**Figure 1: Indicator exterior casing small carbon deposit**

An inspection of the weather radar indicator confirmed that burning of a control circuit board had occurred, damaging the printed circuit board substrate. The damage was not the result of an aircraft system fault.

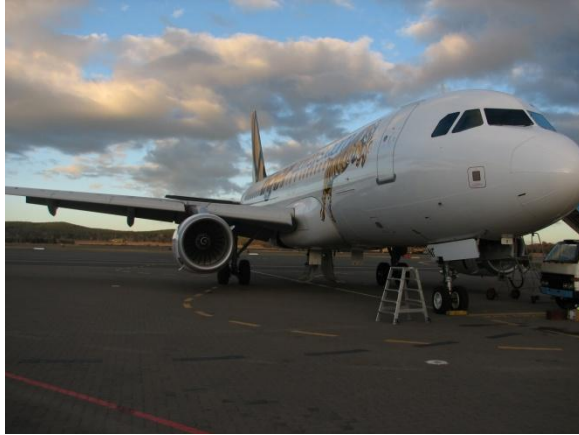
**Figure 1: VH-VND**

A post-flight examination of the cabin located the source of the burning smell as being from a fluorescent light ballast resistor in the cabin. Closer inspection found the presence of the electrical burning odour at the light's ballast resistor connection.

Testing of the ECAM system through its built-in test equipment (BITE), attributed the displaying of multiple continuous paging warnings to a fault in the number-2 DMC. After that DMC was replaced, the system was further tested and operated normally. The number-2 DMC was sent to the manufacturer for testing and examination.

The number-2 DMC underwent manufacturer inspection and testing in accordance with procedures laid down in the component maintenance manual. No defects or faults were found. However, a review of the DMC's BITE memory indicated that an internal fault had occurred, resulting in corruption of software parameters used in the DMC's data receiving function.

As a result of similar reported DMC failures, the DMC manufacturer introduced a cyclic software check of parameters used in the receiving function, with an auto reset of the DMC occurring if corrupted parameters were identified.

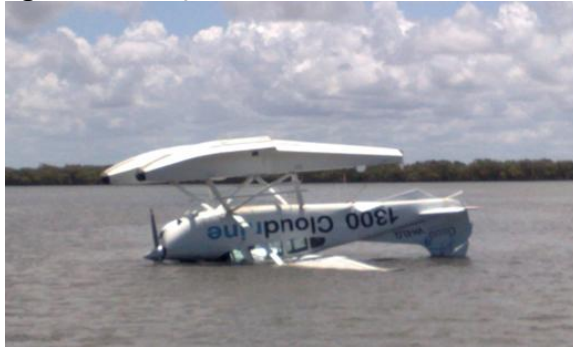
**Figure 1: VH-ELQ**

Shortly after, a crab pot was observed within close proximity to the aircraft. The pilot reported that it was probable that the crab pot had become entangled around the aircraft's right water rudder<sup>3</sup>,

An examination of the crab pot float and line by the Queensland Police Service determined that the float sustained damage consistent with the line being pulled with some force and subsequently, cutting into the foam structure. A grease-like substance and a number of indentations were also found on the float. These were compared with the surface of the aircraft's floats and found to be consistent. The Queensland Police investigation was, however, unable to determine where the contact was made, and for how long the crab pot was attached to the aircraft.

As a result of this investigation, the ATSB issued a recommendation to the Civil Aviation Safety Authority (CASA) to review the requirements for wearing life jackets under Civil Aviation Order (20.11). In particular, to extend the requirements for the occupants of any aircraft that is standing, taxiing, taking off, landing or approaching to land, on water.
