**ATSB TRANSPORT SAFETY REPORT**  
Rail Occurrence Investigation – 2007/001  
Final

# **Level crossing collision Back Creek, New South Wales**

10 March 2007

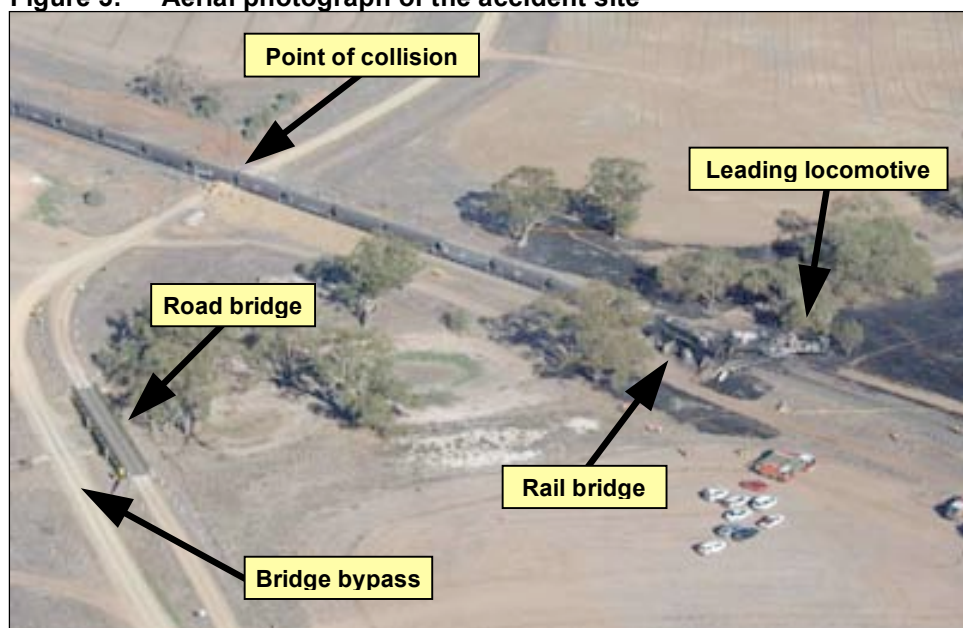
**Figure 3: Aerial photograph of the accident site**

The speed limit for road traffic on the Tallabung - Back Creek Road is 100 km/h; the speed limit for rail traffic is 100 km/h, but a permanent speed restriction of 40 km/h was in place on the rail bridge over the Back Creek watercourse at the time of the collision. The proximity of this bridge to the Back Creek Road level crossing meant that, in practice, the speed of trains would be substantially less than 100 km/h. Likewise, the proximity and layout of the Back Creek watercourse crossings to the level crossing means that the speed of road traffic, particularly heavy vehicles, would be substantially less than 100 km/h.

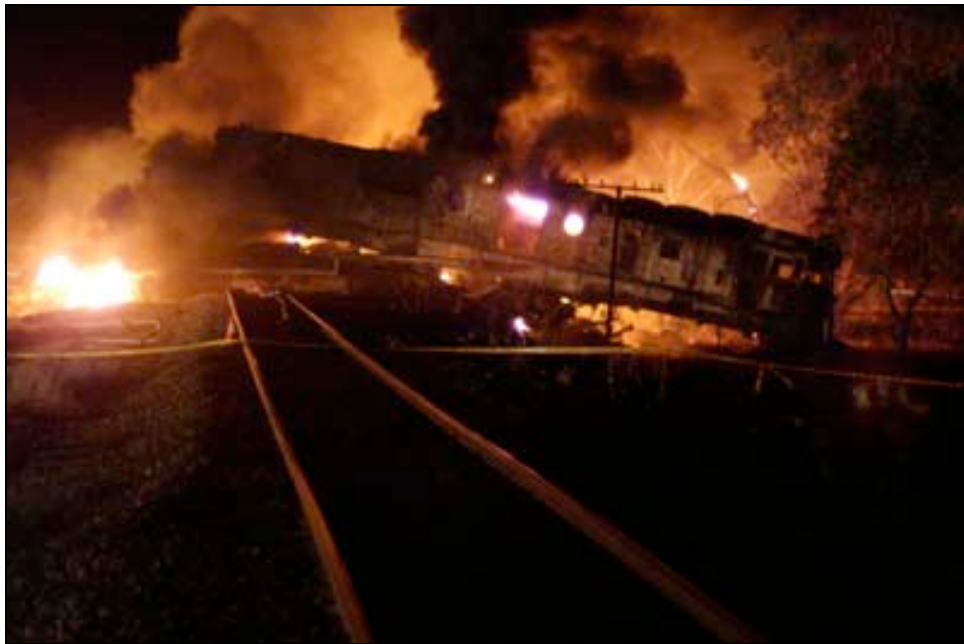
**Figure 4: Locomotives engulfed in flames, some hours after collision**

A 500 m exclusion zone was placed on the site by fire brigade personnel who feared, due to the increasing intensity of the fire, that an explosion could occur. By this time the timber-topped rail bridge, which the two trailing locomotives and a portion of the leading wagon were standing on, was alight. Also, the fire had spread to the adjacent land and caused grass fires. At the time of the collision the diesel fuel tanks on each locomotive were estimated to be near full capacity. (The total

By early evening (about 2000) fire brigade personnel estimated that it would take at least six to 7 hours to control the fire. Due to the intensity of the fire, a containment policy was adopted aimed at controlling the spread of grass and 'small timber' fires. The locomotives and timber top bearers of the railway bridge were left to burn out as it was deemed to be unsafe to approach the seat of the fire because of the amount of fuel/oil that was feeding the fire and the potential of the wooden members of the bridge to burn out and collapse (with two locomotives standing on it).

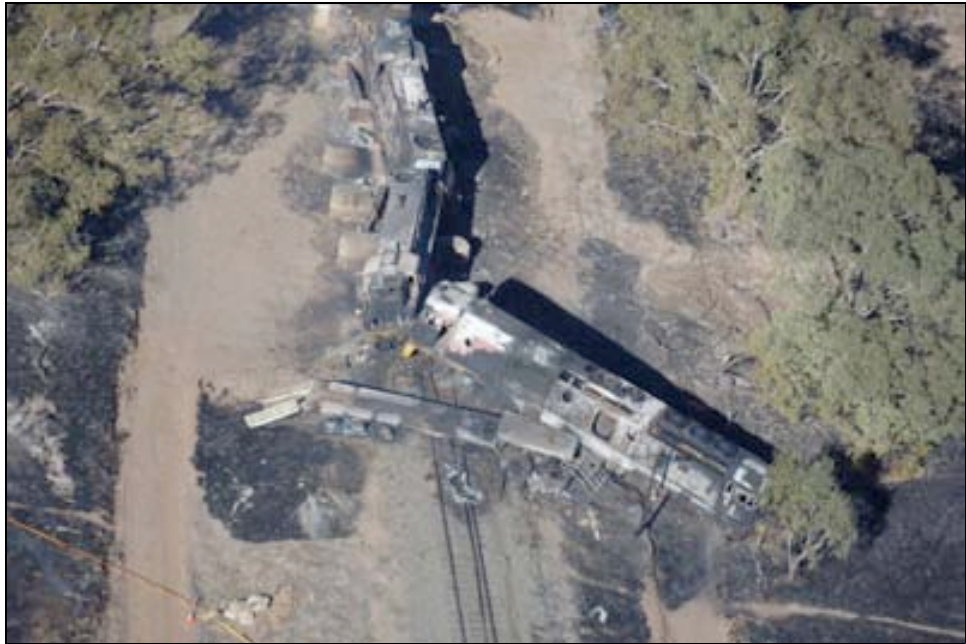
**Figure 5: Aerial photograph of the locomotives and semi trailer later the following day, fire extinguished**

At about 1610, the site was declared safe by the fire brigade and released to the ARTC. The two derailed locomotives on the bridge had remained nearly upright throughout the fire and, by first light on Sunday 11 March 2007, were being supported by the rail lines only.

The semi trailer prime mover and trailer were destroyed by the collision. All three locomotives were destroyed by the subsequent fire. The leading grain wagon suffered considerable heat damage, including some buckling.

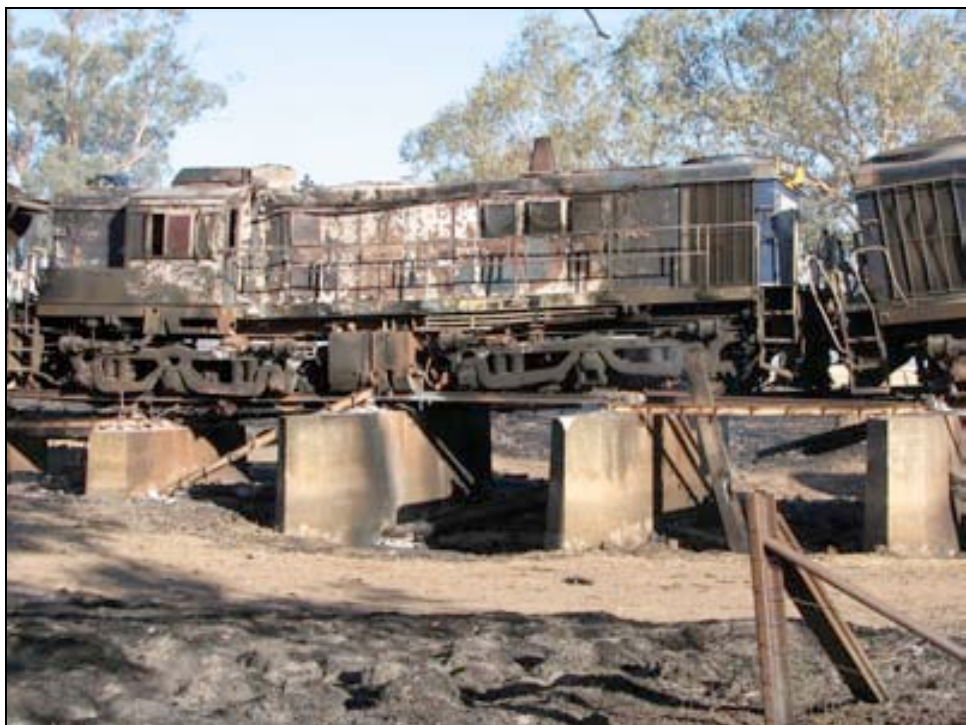
**Figure 6: View of burnt out locomotives and bridge, note timber bearers of the bridge burnt from beneath locomotives**

All timber components of the Back Creek railway bridge were completely destroyed by fire, about 180 m of track needed replacement, and the aerial wires associated with the safeworking arrangements of the rail corridor (electric staff) were also damaged by fire.

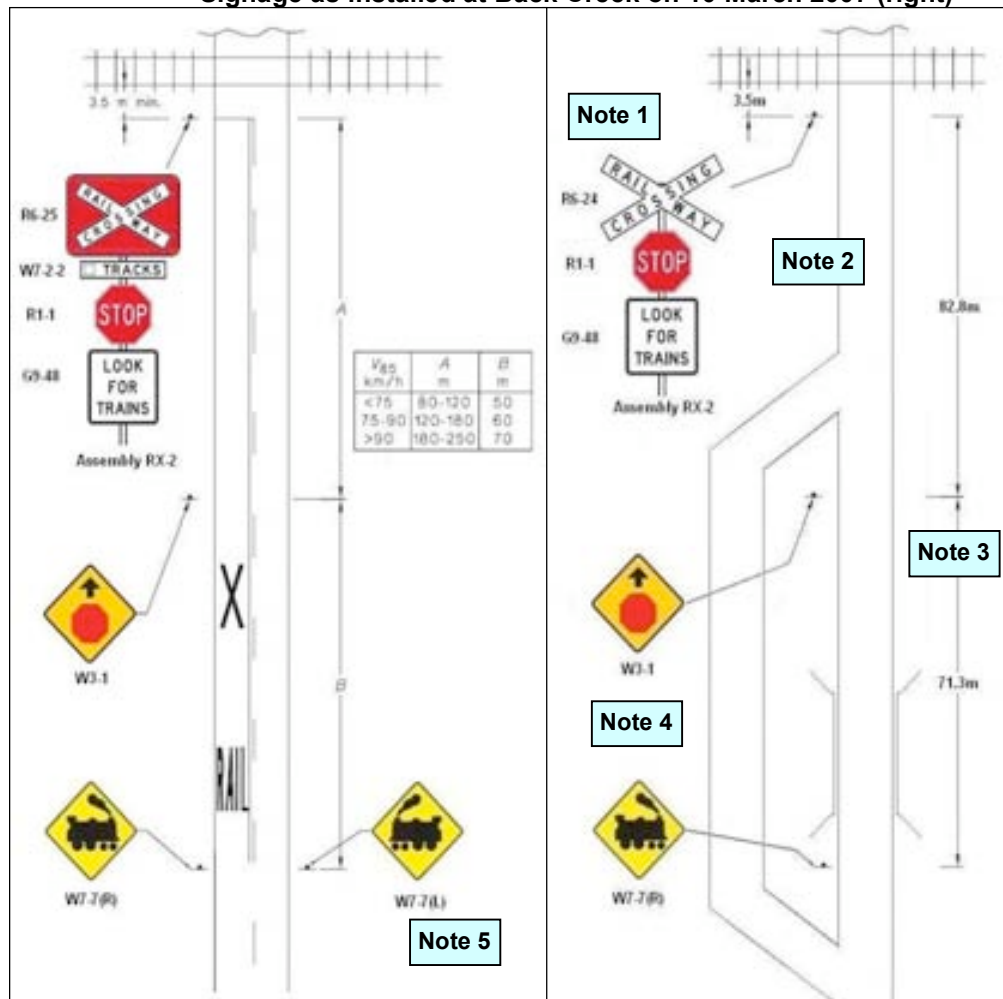
**Figure 7: Signage as required by AS1742.7-2007 (left)  
Signage as installed at Back Creek on 10 March 2007 (right)**

Australian Standard 1742.7-2007 requires a passive level crossing with Stop sign control to have a specific configuration of approach warning signs. The Back Creek Road level crossing and road/rail approaches were surveyed using a 3D laser survey system and assessed against the requirements specified in AS 1742.7-2007. The illustrations in Figure 7 show the minimum traffic control requirements as specified in the Australian Standard and the actual traffic control installation at the Back Creek level crossing on 10 March 2007.

Note 1: The railway crossing stop assembly (RX-2) was compliant, but not of the preferred design specified in the current standard (AS 1742.7-2007) for new or refurbished level crossing installations. The preferred design incorporates the 'Railway crossing position sign' (R6-25) with a large red target board.

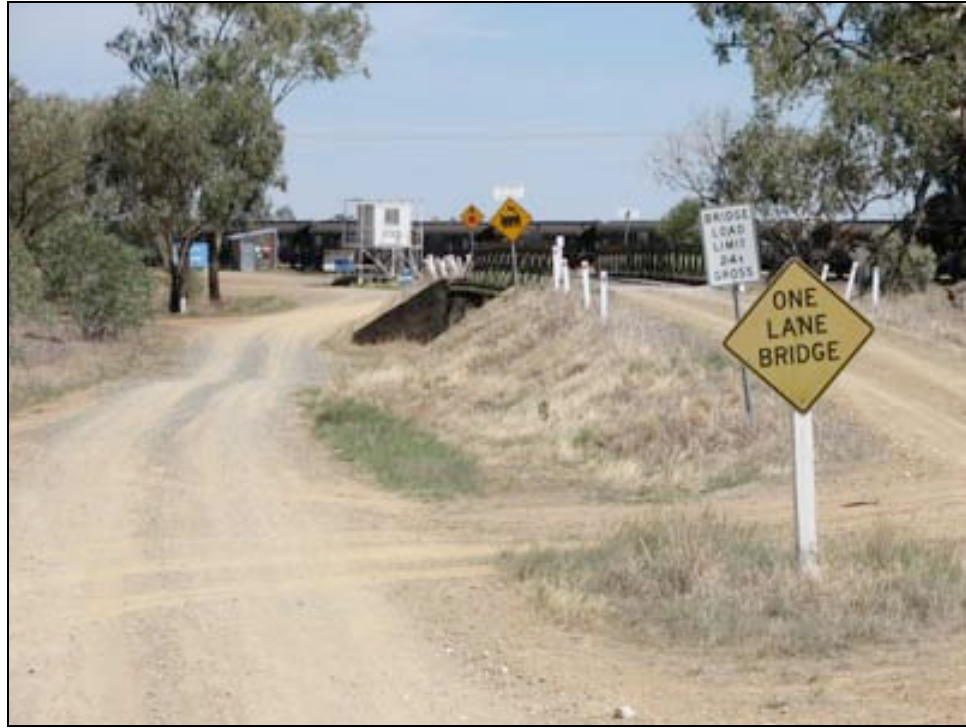
**Figure 8: Photograph of main and by-pass roads on eastern approach**

of train 3835. However, the by-pass road did not conform to AS 1742.7-2007 since there was no advance or intermediate signage positioned on the left of the carriageway (clearly shown in Figure 8).

There also appeared to be minor non-compliances with respect to the placement of the ‘Railway crossing ahead – Passive control’ (W7-7(R)) sign on the main road approach passing over the bridge. It was evident that the crossing design was based on 85 per cent of road vehicles travelling at less than 75 km/h<sup>4</sup>. However, the distance between the W7-7(R) sign and the ‘Stop sign ahead’ (W3-1) sign on the eastern approach was 21.3 m further than defined by the standard. The lateral placement (about 0.8 m less than required) and height (about 0.5 m lower than required) of the sign was also non-compliant.

The correct location for the W7-7(R) sign is part way across the road bridge, between 2.0 m and 5.0 m from the edge of the bridge and at least 1.5 m above the bridge surface which, in this case, is not possible. The standard states that a sign may be placed outside the required location ‘... if a satisfactory site for the sign cannot otherwise be found’. Consequently the W7-7(R) sign has been positioned on the bridge abutment.

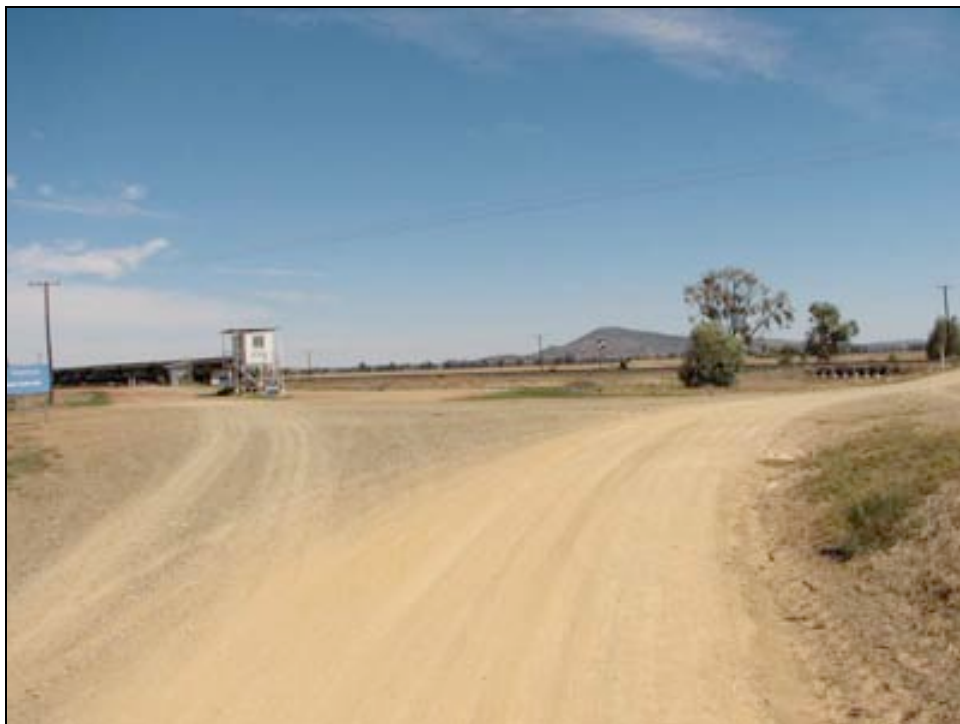
**Figure 9: Sight distance beyond the Back Creek watercourse**

Once beyond the Back Creek watercourse, the sighting distance along the rail line to the south was hindered to a moderate extent by several small trees and some equipment huts associated with the Back Creek grain silo. However, if rail wagons are occupying the northern end of the grain siding that is located to the east of the main line (as shown in Figure 9 below), then sighting along the track is significantly restricted. As a consequence, there was insufficient sighting for give-way control so Stop sign traffic control was installed at the level crossing.

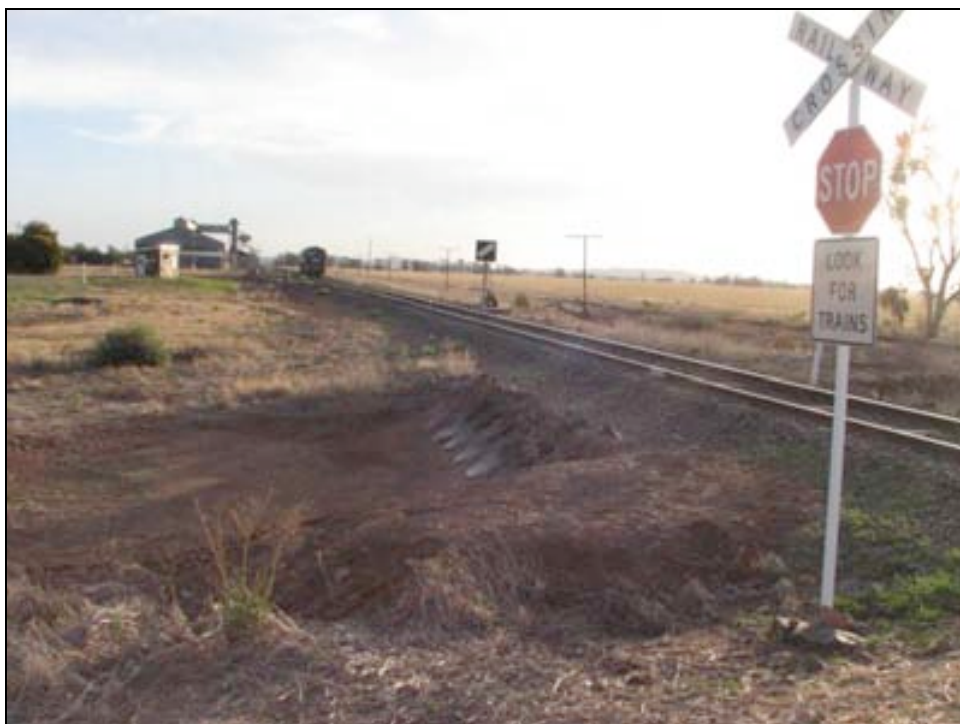
**Figure 10: Sight distance to the south from the Stop sign.**

When positioned at the Stop sign, a road vehicle driver needs to be able to see far enough along the railway to be able to start off, cross and clear the crossing safely before the arrival of any previously unseen train. The required sighting distance to achieve this is calculated from the formula contained in AS1742.7-2007<sup>5</sup>. Based on this formula, the minimum sighting distance, in either direction, for a 19 m road vehicle and a track speed of 100 km/h, is 421.5 m. If the same formula and parameters are applied to a 26 m long B-double truck<sup>6</sup> the minimum sighting distance requirement is 460.4 m. The actual sighting distances along the rail lines from the Stop sign at the Back Creek Road level crossing exceeded 690 m in both directions.

The photograph in Figure 10 was taken at 1851 the day following the collision. Note the position of the sun and that the 81 class locomotive, stationary awaiting recovery duties, has no headlight or ditch lights illuminated.

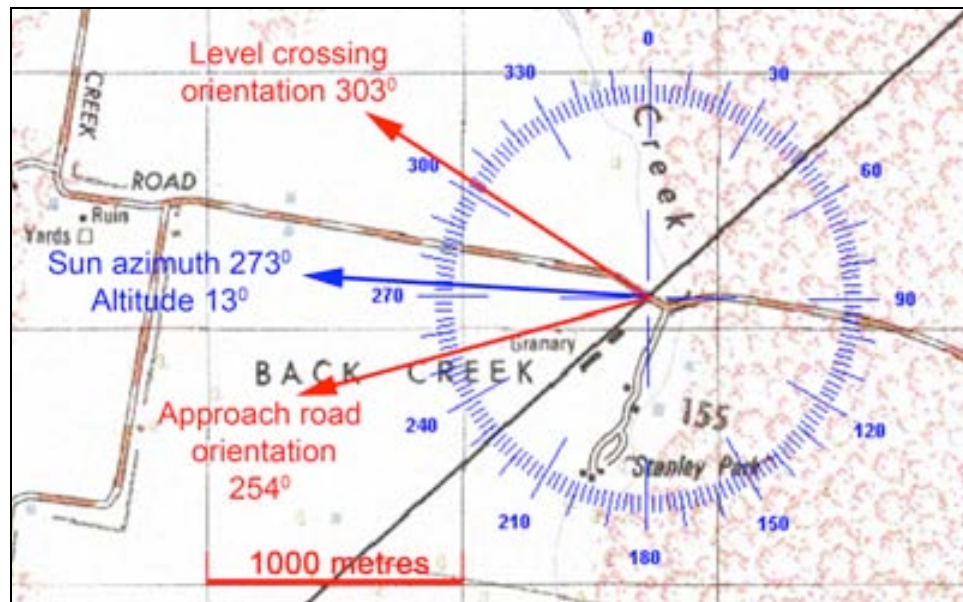
**Figure 11: Diagram of sun azimuth and road/level crossing orientation**

At the time of the accident, the sky was clear of cloud and the sun was at an azimuth of about 273 degrees, and an altitude of about 13 degrees with a flat horizon. Bureau of Meteorology (BoM) records indicate that sunset was at 1934 hours (about 1 hour after the collision). As the semi trailer was heading towards the level crossing, the road was on a bearing of 254° at the Back Creek watercourse deviation and a bearing of 303° at the level crossing.

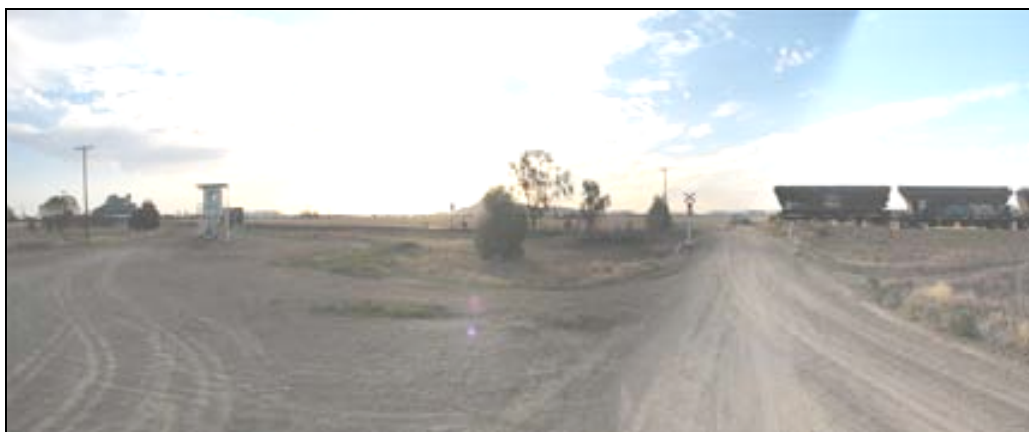
**Figure: 12 Photograph of the approach to the level crossing**

Figure 12 shows a composite photograph taken on the following afternoon at about 1855 and is considered representative of what the semi trailer driver would have seen approaching the crossing.

The angle and altitude of the sun was such that the side of the train facing the semi trailer driver would have been in shadow and would probably have tended to blend with the background. The semi trailer driver's task of visually identifying the train would have included discriminating a moving object in a cluttered visual environment. With the sun directly in the semi trailer driver's field of vision, the glare<sup>8</sup> would have been considerable. Glare can cause a reduction of visual performance (due to light scattering in the eye) and/or discomfort to the point where pain is felt and the eyes squint. In an overall sense, glare can lead to a decreased ability to detect visual cues from the surrounding environment.

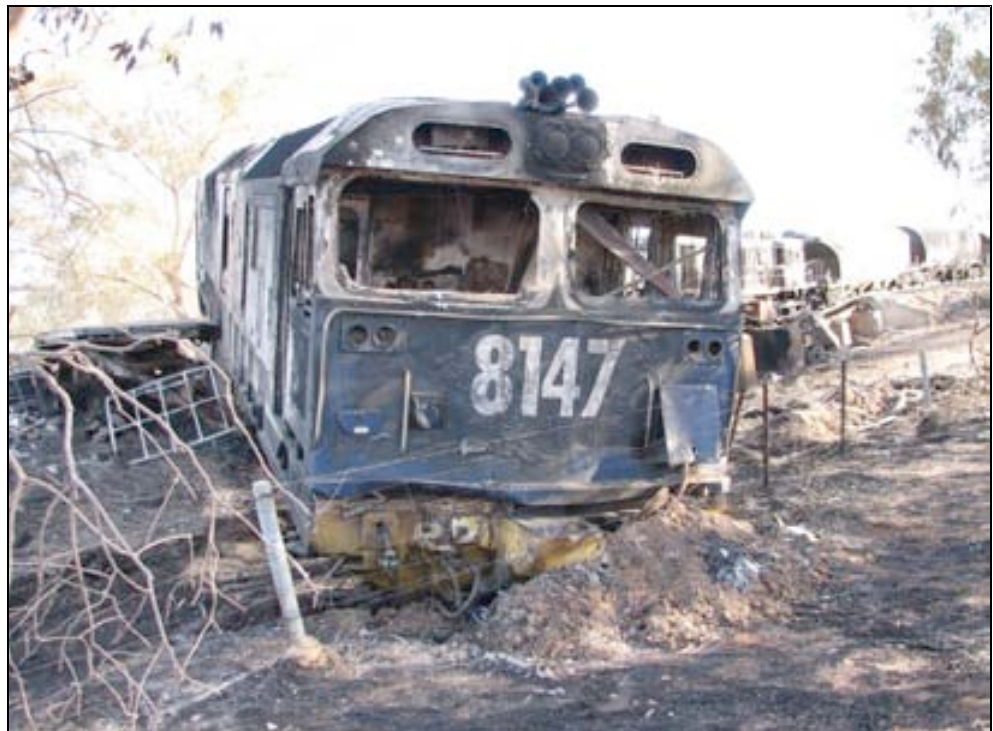
**Figure14: Locomotive 8147 after fire extinguished**

The evidence is that the Hasler recorder in the rear of Loco 8147 probably survived for some hours before the flames reached it. However, access to it was considered unacceptably hazardous. If the event recorders on the locomotives of train 3835 had greater heat and flame resistance than those fitted, it is possible that data may have been recoverable.
