ATSB TRANSPORT SAFETY REPORT  
Aviation Occurrence Investigation AO-2009-030  
Final

Wirestrike  
24 km NNE of Albury Aerodrome  
New South Wales  
23 June 2009  
VH-CAP  
Bell Helicopter Company 206B  
JetRanger III

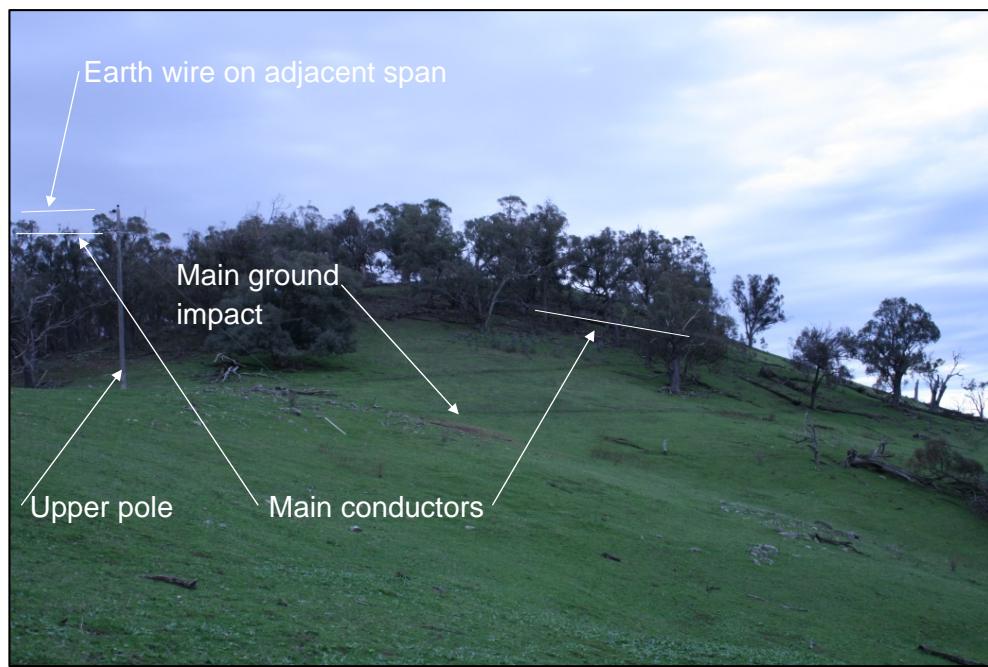
**Figure 4: Helicopter approach path towards the wire<sup>5</sup>**

The accident occurred over sloping terrain at an elevation of about 1,650 ft above mean sea level (AMSL) (Figure 4). The lower guide of the WSPS contacted the powerline ‘earth’ wire as the helicopter was travelling along the sloping terrain at about 15 m above the ground. The wire cut into the lower guide before failing and separating at some point during the accident sequence (Figures 5 and 8).

<sup>5</sup> This image was taken from the ground, about 15 m below the pilot's viewpoint.

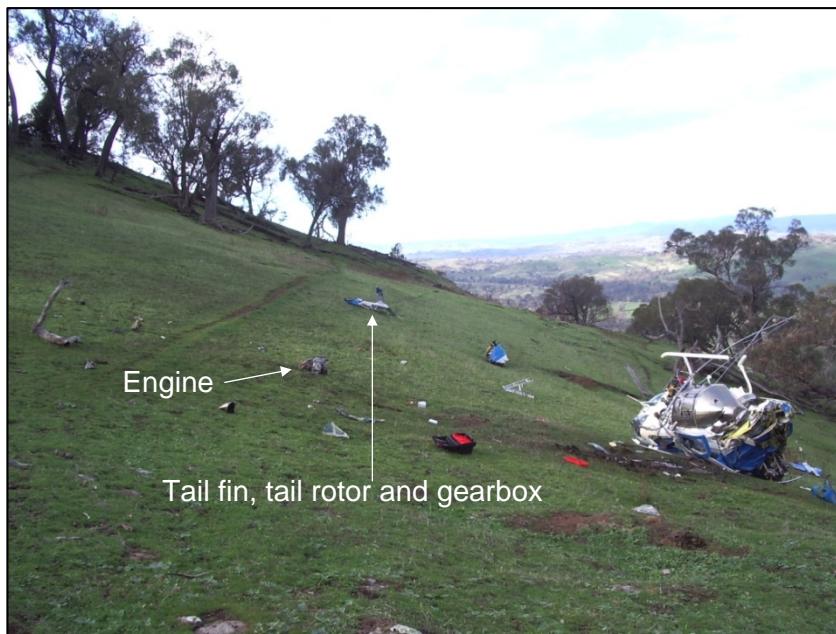
**Figure 6: Accident site prior to the movement of the wreckage**

Significant damage to the helicopter’s structure behind the rear cabin indicated that the majority of the energy associated with the ground impact was absorbed in that area (Figures 6 and 7). A number of components, including the main rotor, engine and tail boom detached during the accident sequence; however, the forward cabin structure and pilot’s four-point harness restraint remained intact.

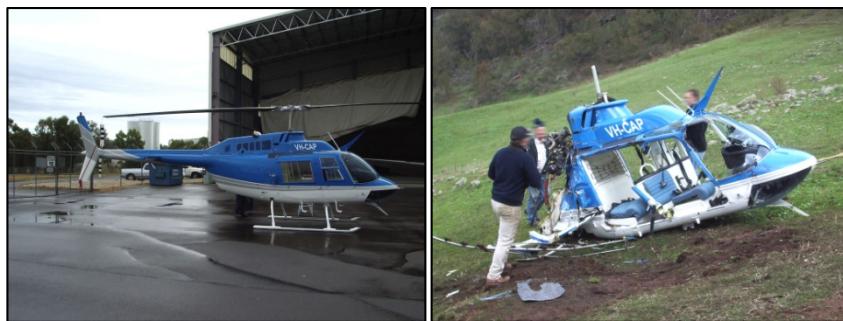
**Figure 7: Rear structure impact damage**

Examination of the helicopter wreckage indicated that the most likely reason for the pilot's survival was the absorption of the ground impact energy by the rear section of the helicopter and the maintenance of the structural integrity of the cockpit area, including the pilot's harness anchor points. This provided a survivable space which, combined with the protection afforded by the pilot's helmet and the secure restraint of the four-point harness, probably prevented serious, if not fatal injury. The low operating altitude, combined with the retarding effect of the wire as described by the pilot may also have reduced the potential for severe injury by reducing the overall ground impact energy.

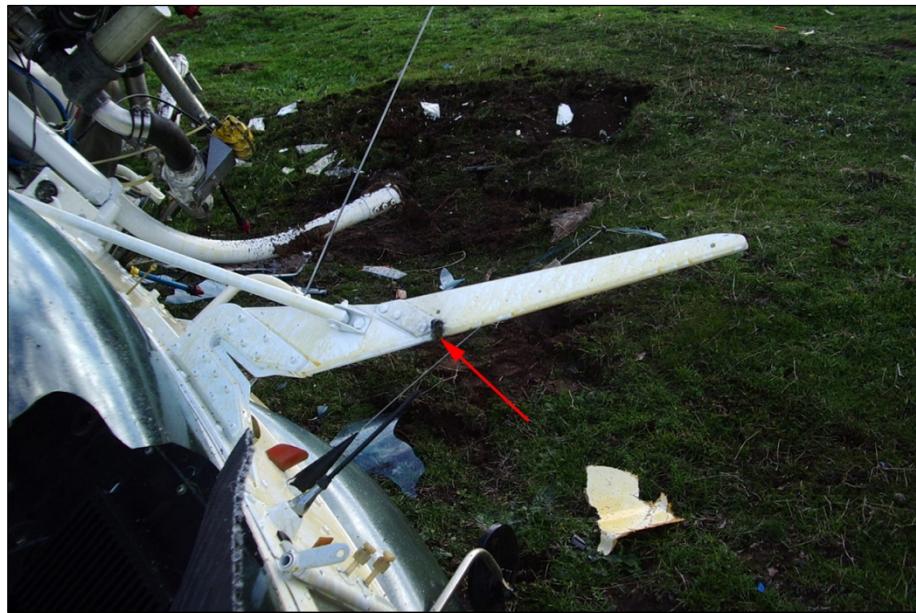
**Figure 8: Penetration of the lower deflector by the wire**

Examination of the breakaway tip<sup>6</sup> indicated that the helicopter impacted the wire at the lower extremity of the tip. The wire slid up the deflector towards the cutter blades, before embedding in the vicinity of the riveted join (Figures 8 and 9). There was evidence that, following the initial contact with the wire, the helicopter remained in contact with and travelled along the wire. That resulted in the localised heating of the aluminium deflector, increasing the likelihood that the wire might penetrate the deflector.

Examination of the hole in the deflector that was created by the wire indicated that the helicopter contacted the wire at a strike angle of  $40^\circ$ . The hole appeared to be relatively symmetrical in shape, and was about 6 to 7 mm in diameter, consistent with that of an earthing wire.

The helicopter contacted the wire outside the strike angle and cable span design parameters of its wire-strike protection system (WSPS). The strike angle, likely resultant sliding movement between the helicopter and the wire and the orientation of the helicopter, probably contributed to the penetration of the wire into the breakaway tip. The investigation was unable to determine whether the WSPS might have operated as intended, had the wire continued its initial movement towards the cutter blades.

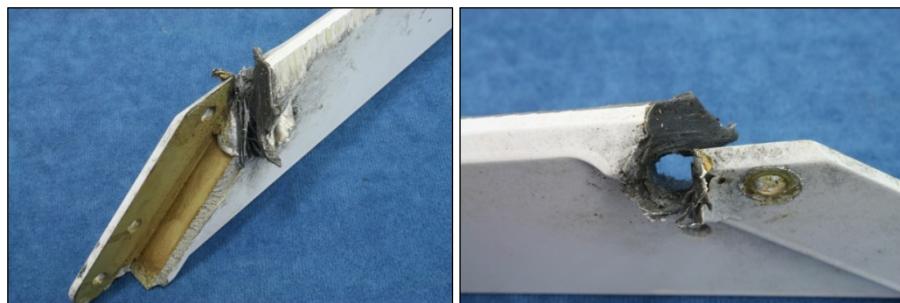
**Figure 9: Penetration of the lower deflector by the wire**

Following technical examination of the breakaway tip by the Australian Transport Safety Bureau (ATSB), it was forwarded to the WSPS manufacturer for assessment. The manufacturer concluded that the helicopter probably contacted the wire outside of the WSPS design parameters, and that the cable penetrated the WSPS in the vicinity of the discontinuity between the breakaway tip and the deflector (Figure 9) due to a combination of the strike angle and the helicopter's orientation.

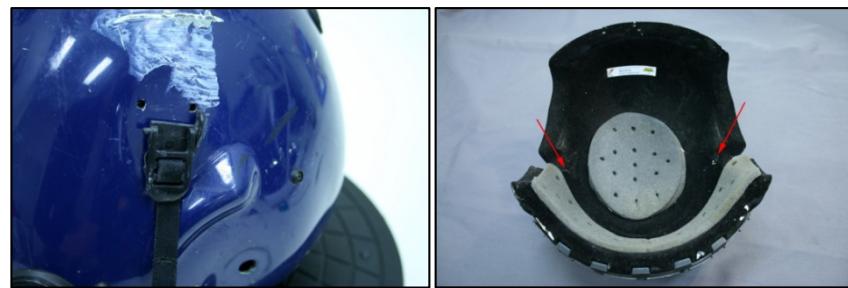
**Figure 10: Helmet impact damage (arrows indicate crack locations)**

The pilot's helmet exhibited impact damage on the right side in the region of the ear cups. Additionally, cracks were observed on either side of the helmet in the region adjacent to the ear cut outs. That was indicative of the flexing of the foam from the front and back of the helmet (Figure 10). The degree of damage to the helmet indicated that the pilot sustained a significant impact to the front and possibly the back of the head during the accident sequence.

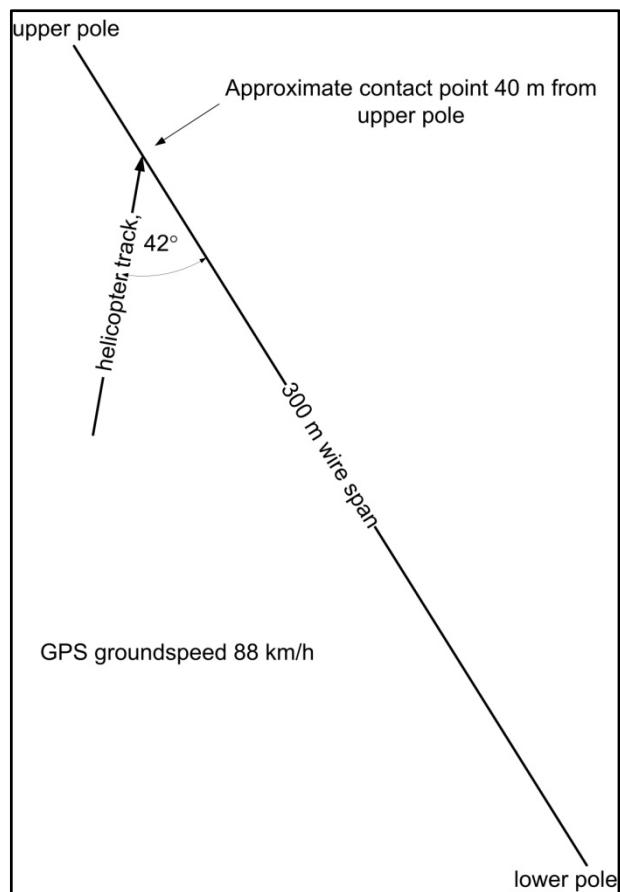
**Figure 11: Helicopter position at the time of the wirestrike**

The helicopter was equipped with differential GPS equipment that provided guidance to the pilot during the application of the chemical. Examination of the recorded GPS data log indicated that about 1 second before contacting the wire, the helicopter had a ground speed of 88 km/h and was operating about 15 m above the ground. The data also indicated that the helicopter contacted the 300 m span of wire about 40 m displaced from the upper pole at a strike angle of about 42° (Figure 11).
