ATSB TRANSPORT SAFETY REPORT  
Aviation Occurrence Investigation A0-2010-043  
Preliminary

# Collision with terrain, VH-PGW

## 6 km north-west of Bankstown Aerodrome, NSW

### 15 June 2010

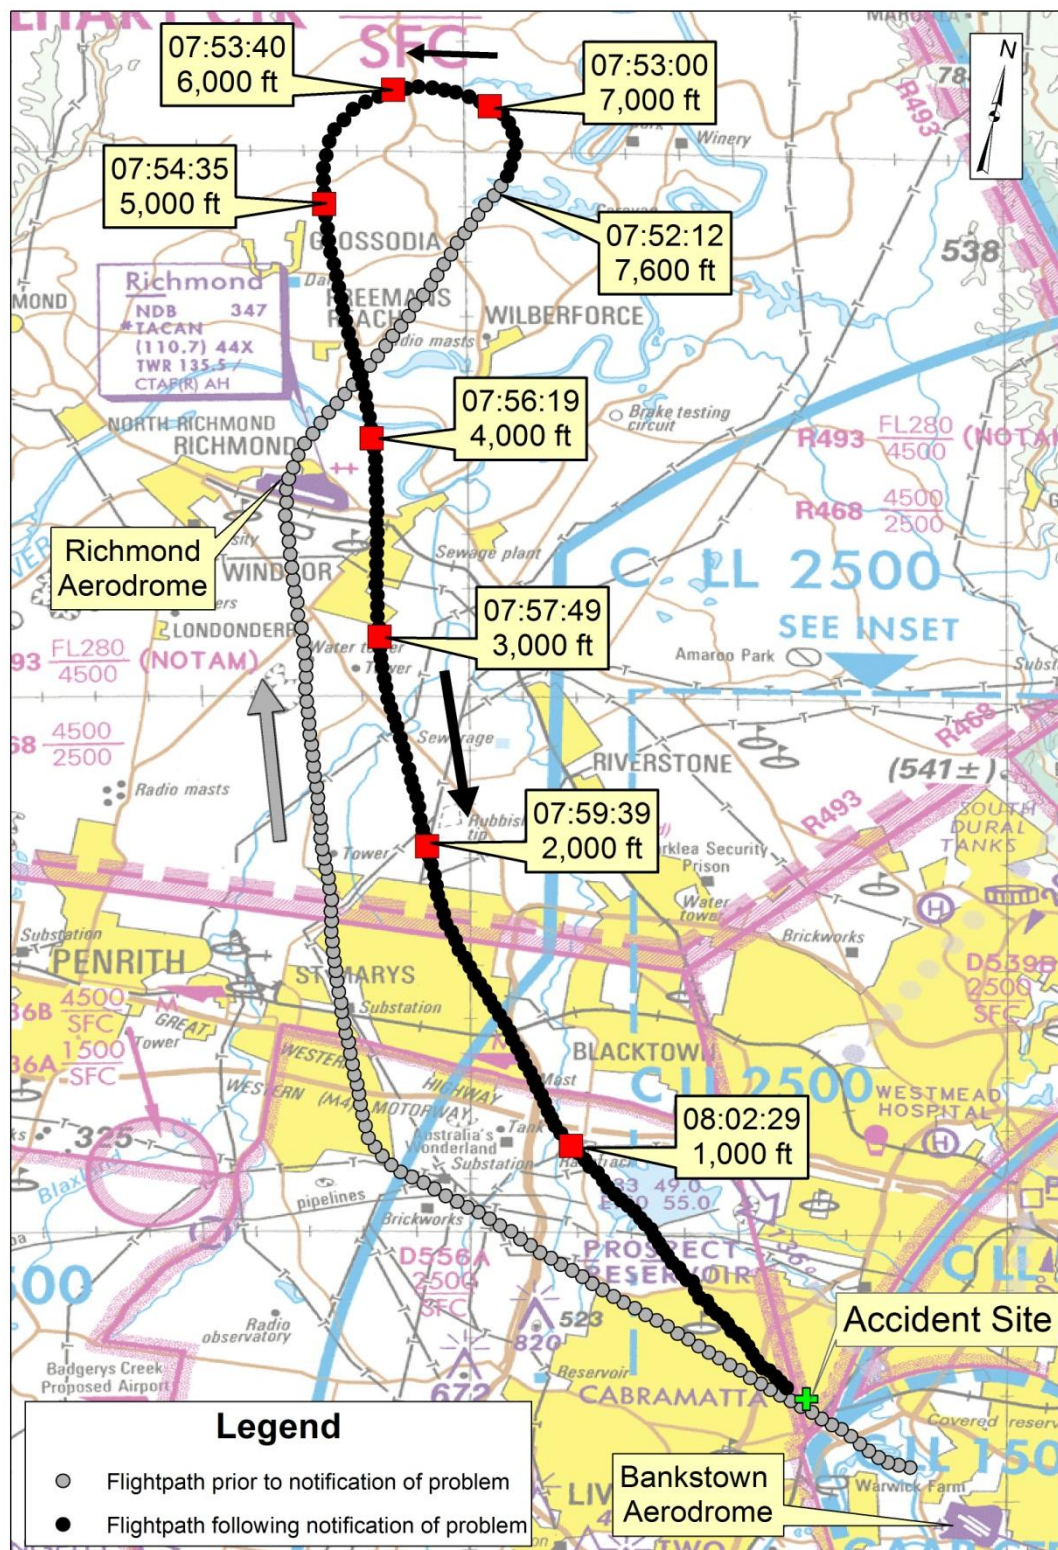
Figure 1: Aircraft flight path

Transponder information from the aircraft was recorded in The Australian Advanced Air Traffic System (TAAATS) by the air traffic services provider, Airservices Australia. The system track data, relating to the aircraft's position, groundspeed and altitude, was logged every 5 seconds. The logged data was reviewed to establish the radar track and altitude following the aircraft's departure from Bankstown Aerodrome. Figure 1 shows the recorded track of the aircraft relative to Richmond and Bankstown aerodromes.

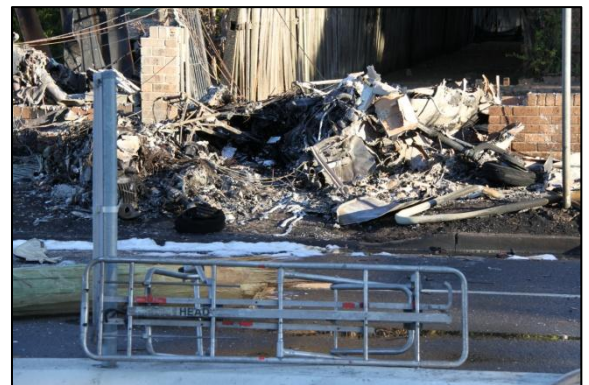
**Figure 2: Accident site**

The accident site was located about 6 km north-west of Bankstown Aerodrome. Contact marks on the support pole indicated that the aircraft's right wing initially impacted the pole as the aircraft proceeded in an easterly direction. Damage to other support poles and ground

impact marks were consistent with the aircraft rolling to the right after the initial impact with the first pole and then continuing eastwards along Canley Vale Road, before coming to rest inverted in the driveway of a residential property.

The pilot and flight nurse were fatally injured and the aircraft was seriously damaged<sup>3</sup> by impact forces and an intense post-impact fire (Figure 2).
