**ATSB TRANSPORT SAFETY REPORT**  
Aviation Occurrence Investigation AO-2008-014  
Final

**Midair collision**  
**10 km NE of Wee Waa, New South Wales**  
**26 February 08**  
**VH-CJK, Air Tractor 502**  
**VH-ATB, Air Tractor 502B**

Midair collision – 10 km NE of Wee Waa, New South Wales - 26 February 2008 - VH-ATB, Air Tractor Inc. 502B and VH-CJK, Air Tractor Inc. 502

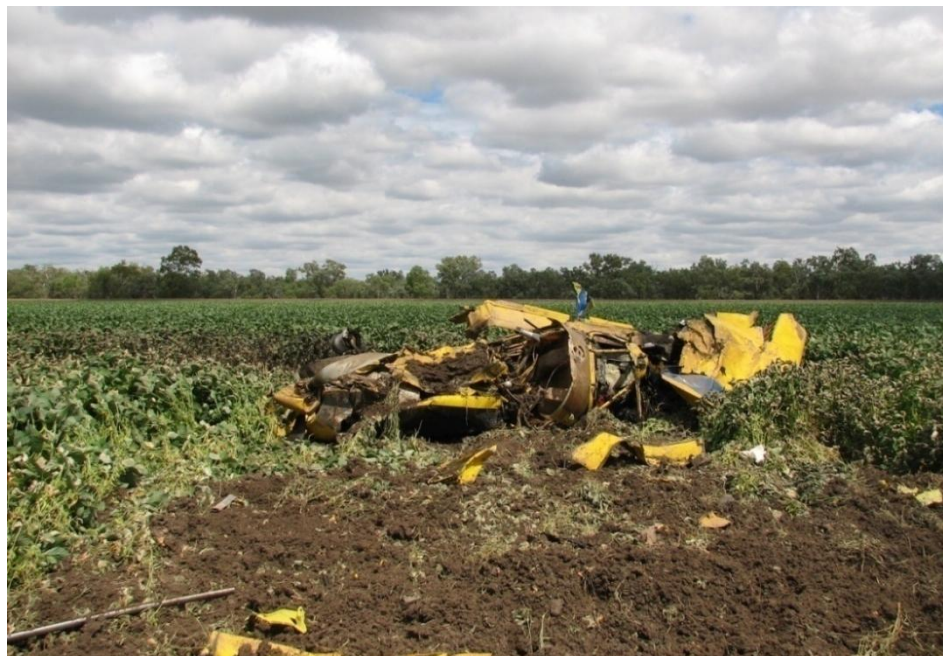
**Figure 4: Wreckage of ATB**

The wreckage of ATB was lying in a soy bean crop that stood nearly 1.2 m high. A localised, intense post-impact fire destroyed part of the aircraft's structure and the immediate environment. A chemical spill of Glyphosate herbicide from the aircraft's ruptured hopper contaminated some of the surrounding crop. The chemical was not classified as a hazardous material.

and elevators remained integral with the fuselage and exhibited ground impact damage. The left main landing gear was attached to the airframe, but the right wheel and gear leg had separated. The engine and propeller were attached to the fuselage and displayed evidence of power being produced at the time of the impact with the ground.

The inboard sections of the right wing and wing flap were found along the wreckage trail in the direction of the wreckage of CJK. The fin of ATB was destroyed but the rudder remained attached to the aircraft by its control cables. The top panel of the fibreglass hopper and lid actuating mechanism and other components from ATB were found 100 m back along the wreckage trail. That damage was consistent with separation as a result of the midair collision.

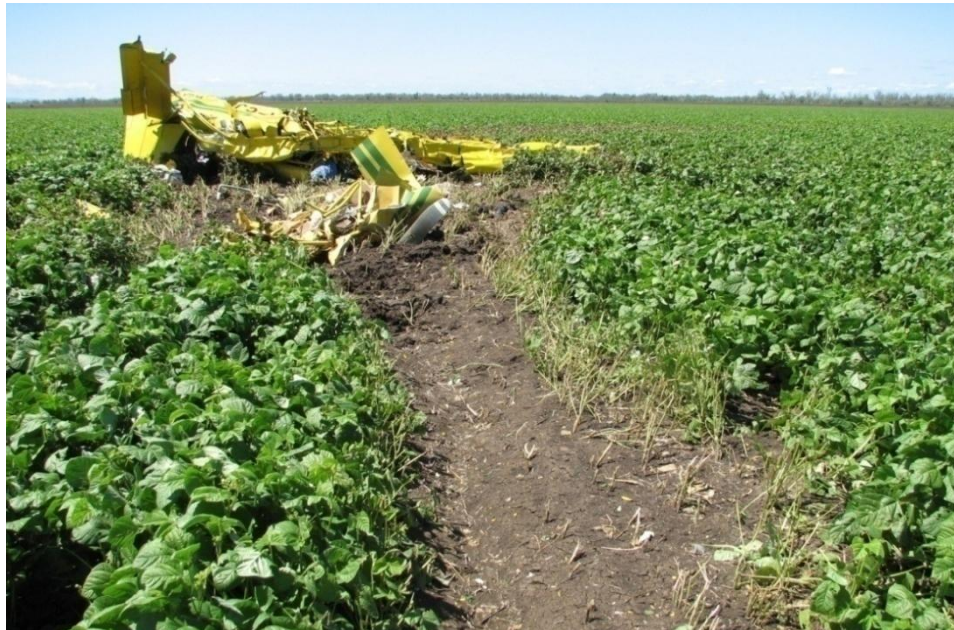
**Figure 5: Wreckage of CJK**

The wreckage of CJK was lying in a 600 mm high crop of mung beans (Figure 5). The site was contaminated by a chemical spill from the ruptured hopper, and by aviation turbine fuel. The chemical (Alpha-Cypermethrin) was classified as a Group 3A insecticide, and access to the site required full protective covering for a period of 48 hours after spillage.

The main wreckage came to rest inverted with both wings detached from the fuselage. The flap screw jack was extended 60 mm indicating that some flap was extended at ground impact. The right wing was intact and had sustained high velocity, vertical impact damage along its entire leading edge. The left wing was pushed rearward and was missing the outboard section. The left side of the fuselage, adjacent to the cockpit, sustained considerable damage from ground impact forces.

The right landing gear leg was with the main wreckage, but the wheel had detached on impact with the ground and was lying behind the wreckage. The engine and propeller had detached from the fuselage during the collision with the ground and came to rest about 10 m from the main wreckage. Examination of the engine indicated that it was producing power at the time of impact with the ground and there was no evidence of any pre-existing defects.

The separated section of the left wing was found about 80 m from the main aircraft wreckage, toward the wreckage of ATB. The left horizontal stabilizer displayed high-energy damage to its tip and the left elevator had been torn from its torque tube. The left landing gear had separated from the aircraft and was found about 60 m from the main wreckage, beside a deep furrow that marked its initial impact with the ground. Fragments of unpainted fibre glass were found imbedded in the wheel and tyre. Damaged sections of the spray booms<sup>17</sup> and other components from ATB were scattered along the wreckage trail. Damage to the liberated items was consistent with separation as a result of the midair collision.

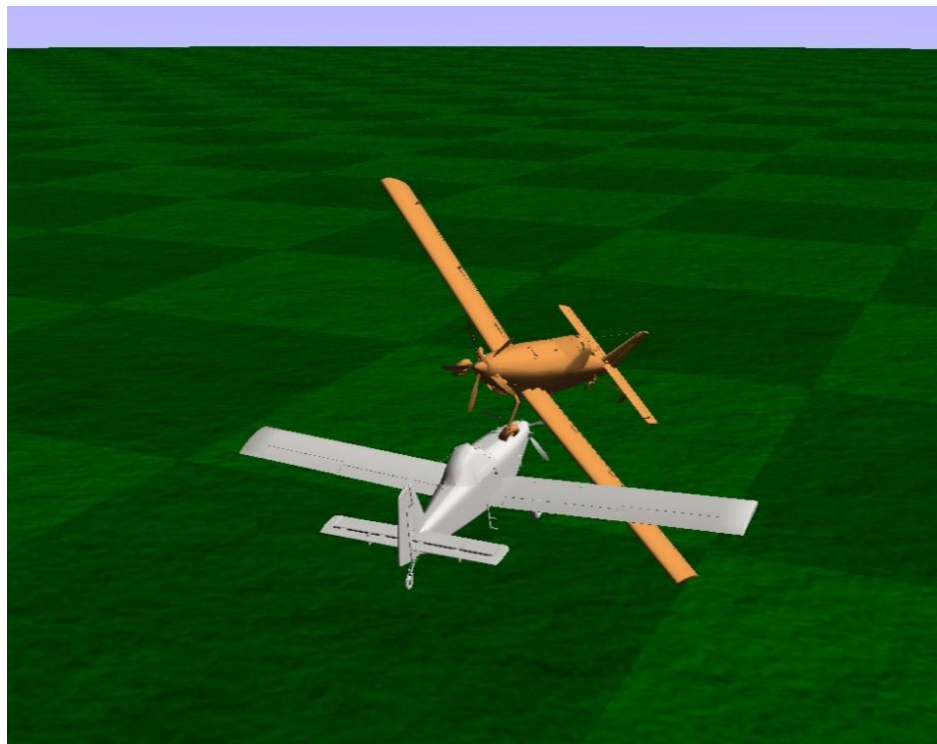
**Figure 6: View of the derived relative position of ATB (grey) and CJK (bronze) at impact**

The limited amount of recorded data prevented a precise reconstruction of each aircraft's flight path. However, using the available data, witness accounts and aircraft damage patterns, it was possible to gain an appreciation of the relative positions of each aircraft during the critical moments prior to the collision. The pilot of ATB reported taking off to the south-south-east. After becoming airborne and retracting take-off flap, he climbed at a speed of 90 KIAS and commenced a climbing, right turn toward the west-south-west. The distance along the projected flight path from the airstrip to the location of the collision measured 2.67 NM (about 5 km) on the satellite image. The elapsed time from when ATB commenced its takeoff, to the moment it collided with CJK, was estimated to be not more than 1 minute and 55 seconds.

The calculated climb gradient of ATB to the point of collision at an altitude of just over 200 ft AGL was 1.4 %. That equated to a rate of climb of about 120 ft/min. The optimum climb performance for ATB at a take-off weight of 4,451.6 kg could not be determined. The manufacturer's Airplane (aeroplane) Flight Manual (AFM) stated that at 2,954 kg (6,500 lb) gross weight, climb performance under standard atmospheric conditions at sea level, '...has been demonstrated to exceed 600 FPM [ft/min] at the best rate of climb airspeed with maximum rated take-off power.'

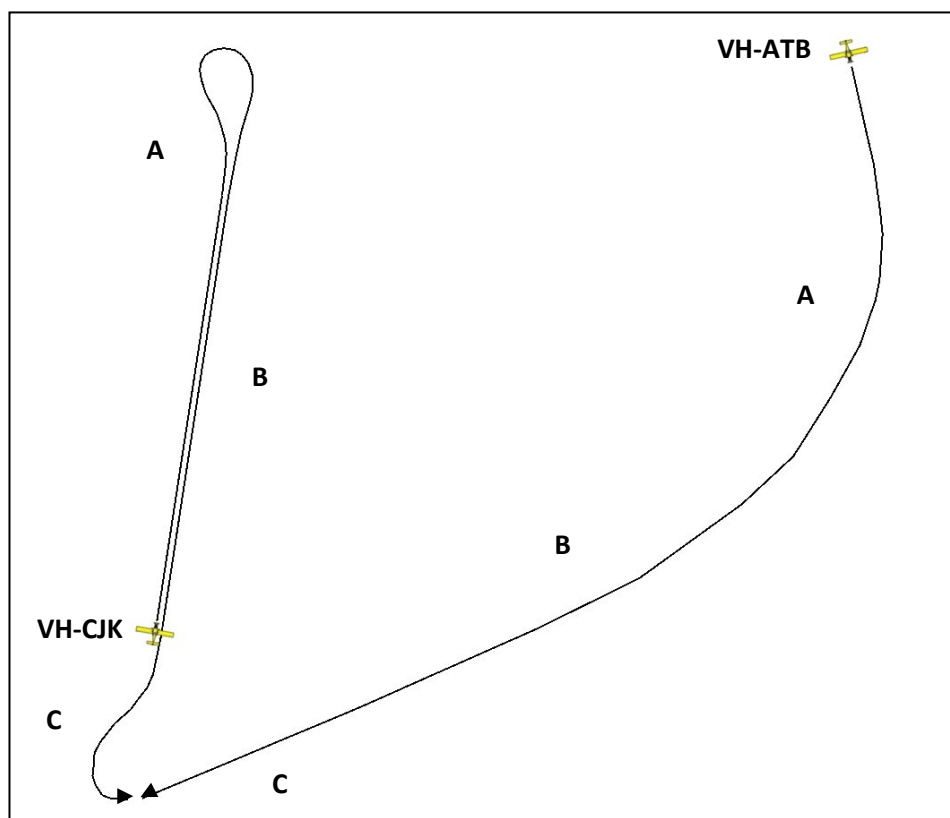
**Figure 7: Probable flight paths of ATB and CJK**

The pilot of ATB would not have had CJK in his field of view until after takeoff and making the right turn. At about that time (Figure 7- each aircraft at about A), when the pilot of ATB would have been scanning to the right to check for other traffic, CJK would probably have been well to the north of ATB. The nose-high climb attitude of ATB would not have obscured CJK during its southerly spray run until probably just before the pilot of CJK commenced the procedure turn. At about the time CJK pulled up into the procedure turn (Figure 7 – each aircraft at about C), CJK would have been obscured beneath the nose of ATB. That meant that the pilot of ATB probably had less than 1 minute in which to detect CJK. The probability of him seeing CJK during that time was minimal, considering that:

- during a climb a pilot's scan is directed to the sky above the horizon, where potential traffic conflicts are more likely to be found and not below it, where CJK was flying
- it was possible that CJK was obscured by a window pillar for some of the time
- the aircraft's converging flight paths probably meant that there was very little relative movement for the pilot's eyes to more readily perceive CJK
- the usual cockpit duties associated with the operation of the aircraft during the initial climb would have required a few moments of the pilot's attention, further reducing the time available for visual scanning for other aircraft
- the time available to complete a thorough scan that included the airspace both left and right of the aircraft's nose, as well above and below the horizon takes over 54 seconds.
