Aviation Occurrence Investigation AO-2009-032

Final

**Collision with terrain**  
**Gold Coast Aerodrome, Queensland**  
**2 July 2009**  
**VH-OML**  
**Robinson Helicopter Company**  
**R22 Beta II**

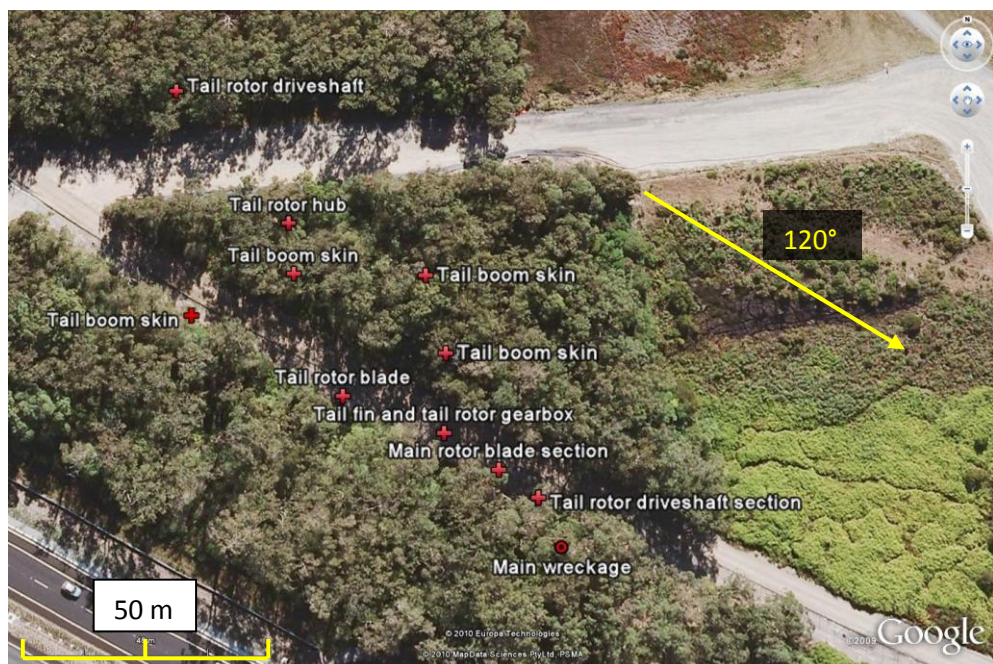
**Figure 2: Wreckage site**

The wreckage of the helicopter was located about 240 m to the west of the runway 14 centreline (Figure 1). The wreckage, including pieces of the tail boom skin, tail rotor driveshaft and tail rotor, was dispersed in a heavily wooded area, over a distance of about 130 m (Figure 2). The approximate bearing of the wreckage trail was 120°. The helicopter came to rest facing back along the direction of flight, lying on an angle of about 30° to the right of vertical (Figure 3).

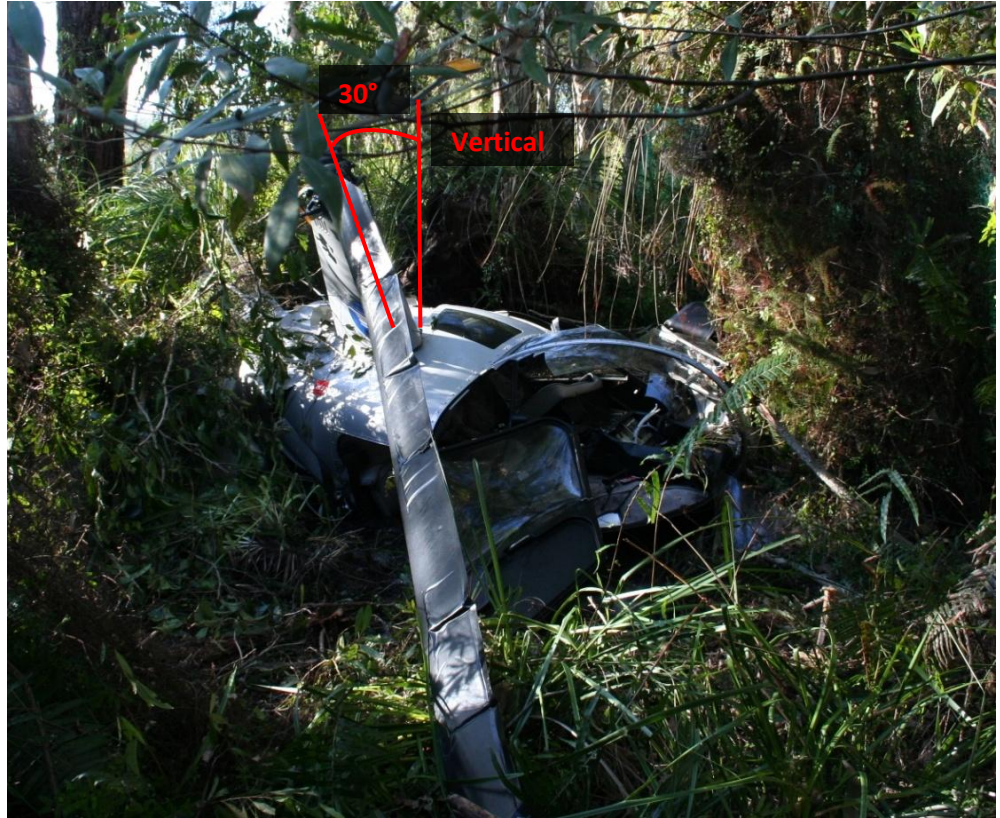
**Figure 3: Main wreckage**

section of tail rotor driveshaft and about 30 cm of the outer portion of one of the tail rotor blades. The corresponding fracture surfaces on the remaining tail rotor driveshaft and tail rotor blade showed that those fractures were a result of impact overload.

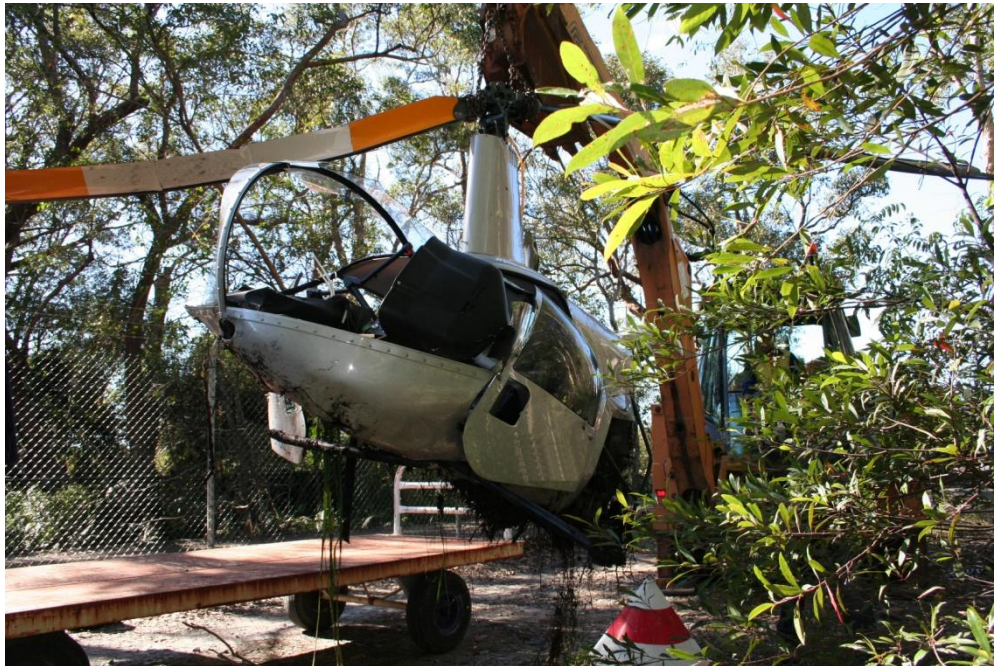
**Figure 4: Wreckage recovery**

The wreckage was removed from the accident site and relocated to a secure hangar for detailed examination (Figure 4). The deformation of the cabin and skid landing gear was consistent with high vertical impact forces.

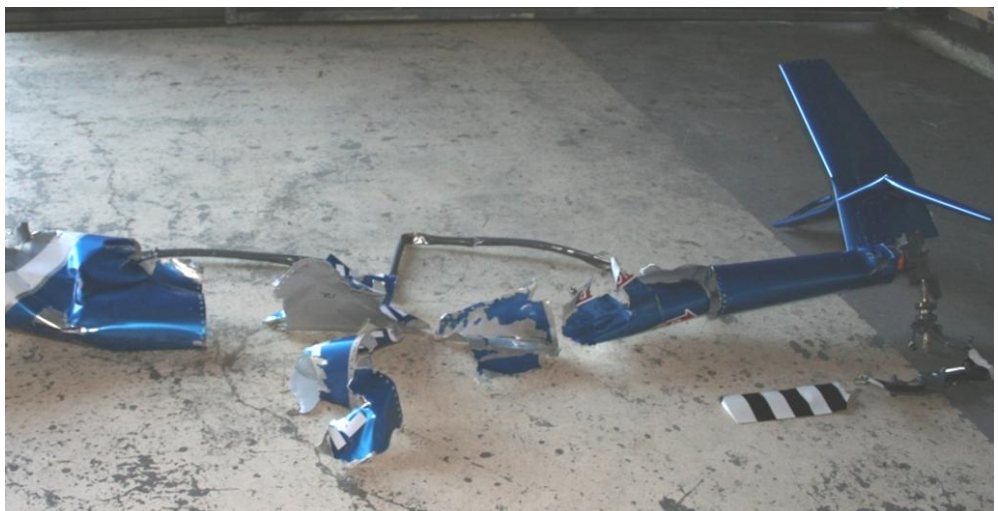
The distribution of the tail boom assembly along the wreckage trail, and damage to the assembly was consistent with it having separated from the aircraft in flight. There was extensive deformation of the assembly (Figure 5), and evidence of paint transfer from the tail boom onto one of the main rotor blades. That blade aligned with the damaged tail boom (Figure 6).

**Figure 5: 'Reconstructed' tail boom assembly**

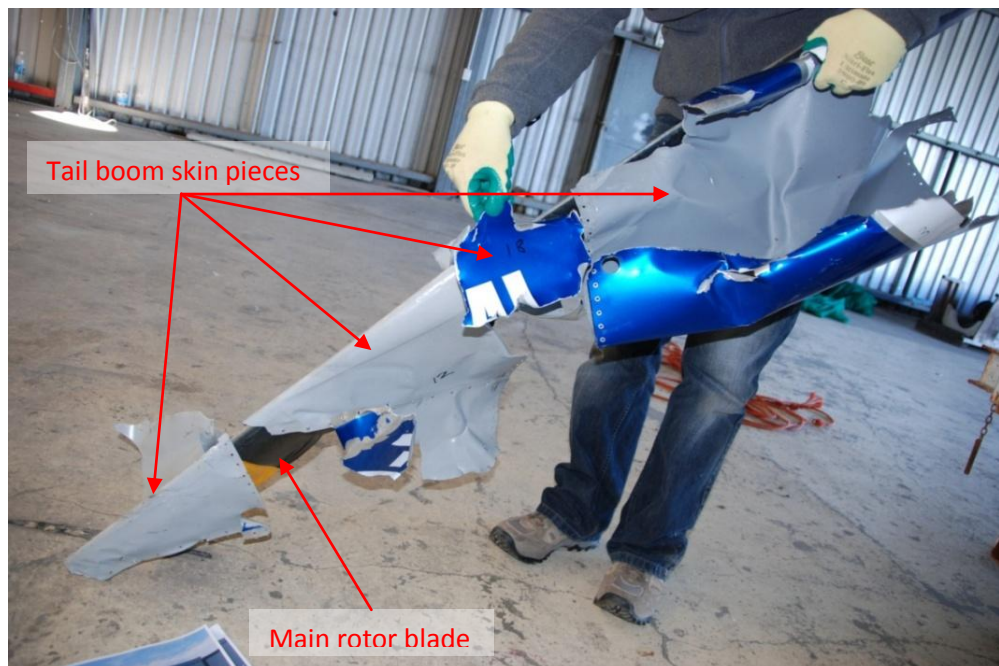
**Figure 6: Tail boom assembly aligned with the affected main rotor blade**

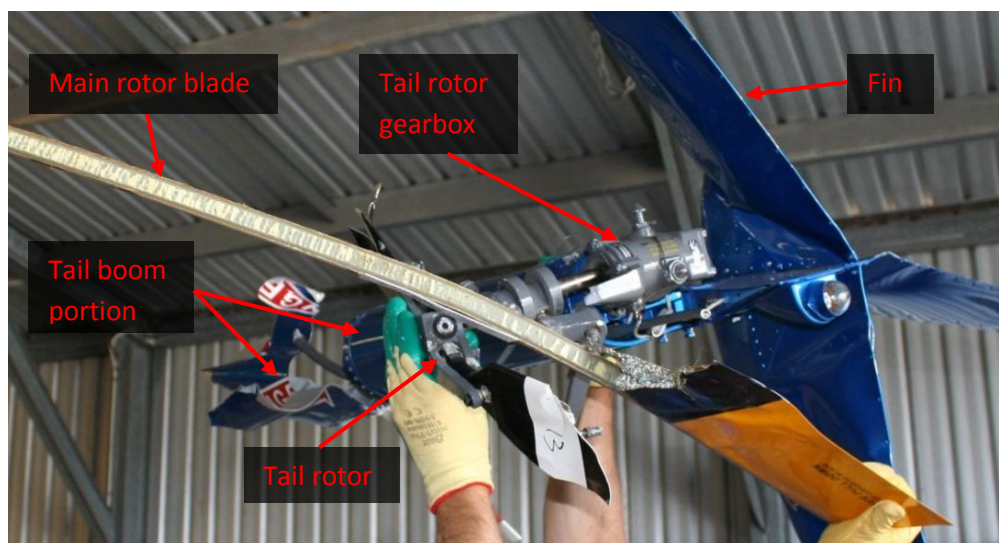
In addition, there were matching impact marks on one of the helicopter's main rotor blades and the tail rotor hub assembly (Figure 7).

**Figure 7: Main rotor blade to tail rotor hub contact**

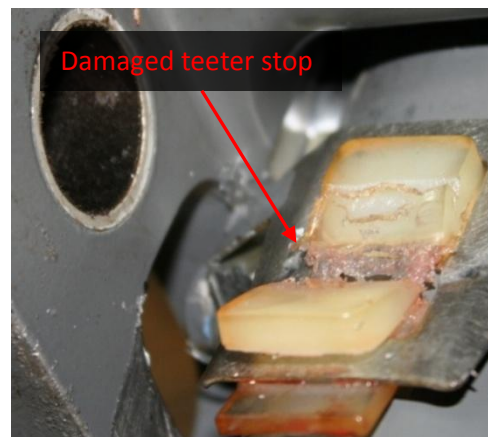
Both main rotor blades were examined in detail and no pre-accident defects were identified. The main rotor blades were removed from the main rotor hub, which revealed severe deformation of the mast teeter stops (Figure 8).

**Figure 8: Teeter stop damage**

The stable climb configuration immediately prior to the accident lessened the likelihood that main rotor stall was a factor. In addition, although there was severe deformation of the mast teeter stops consistent with mast bumping, the damage to the main rotors did not indicate low main rotor RPM. On that basis, main rotor stall leading to severing of the tail boom was discounted.

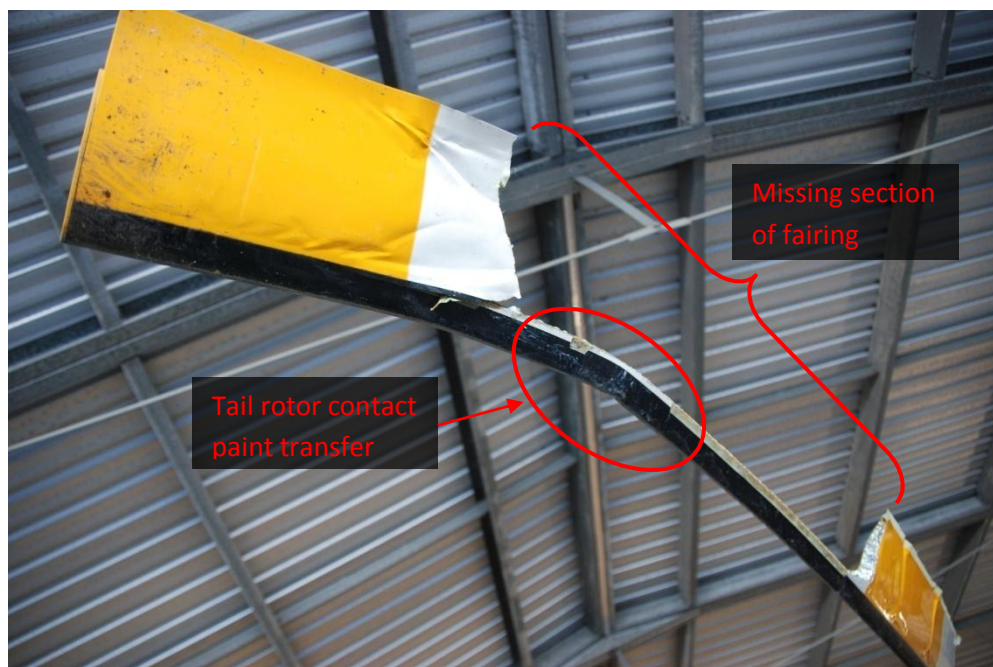
The other main rotor blade displayed signs of impact damage. There was a dent in the leading edge of the main rotor blade and the tip of the blade was bent forward (Figure 9). In addition, sections of the main rotor blade fairing had separated from the spar. The droop tusk on this main rotor blade was bent down (Figure 10).

**Figure 9: Main rotor blade, displaying forward bending and missing fairing**

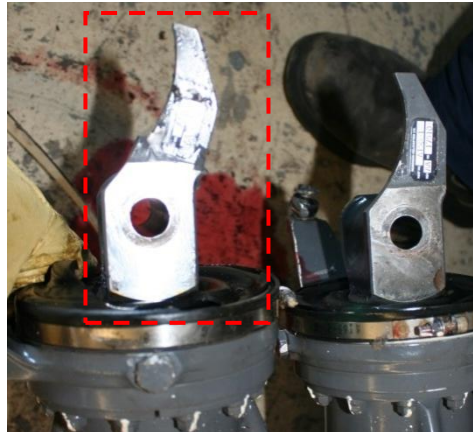
**Figure 10: Bent droop tusk (highlighted)**

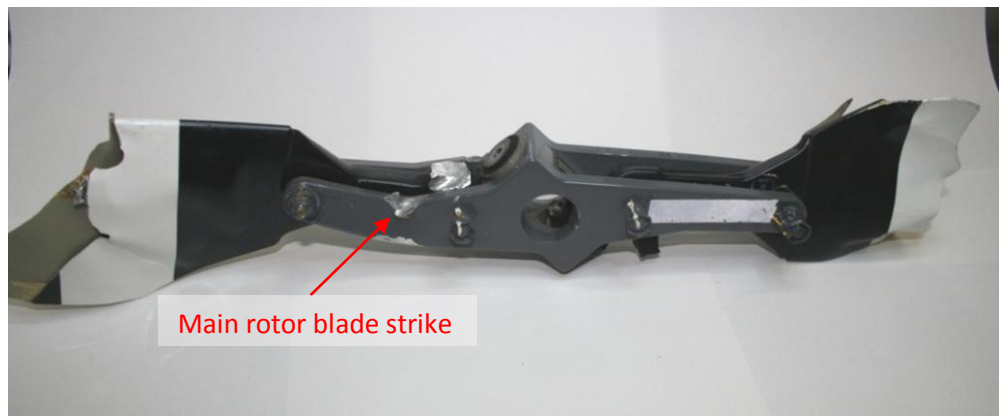
The tail rotor hub showed damage consistent with a main rotor strike (Figure 11).

Specialist metallurgical examination of the tail rotor showed no evidence of any pre-existing defects, fatigue cracking, corrosion or other mechanical deficiencies that may have predisposed the assembly to premature failure.

**Figure 11: Tail rotor hub showing main rotor strike**

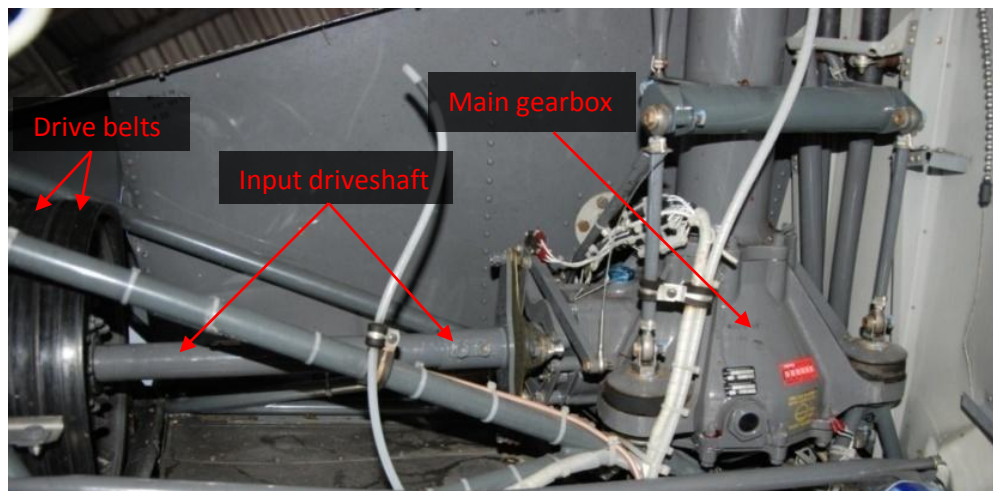
**Figure 12: Main rotor driveshaft and gearbox**

The continuity of the drive train was confirmed, with no pre-impact defects noted (Figure 12). When the helicopter was placed in the upright position, the main rotor was free to turn, and the input driveshaft turned in unison with the main rotor. That confirmed the continuity of the main rotor drive system.

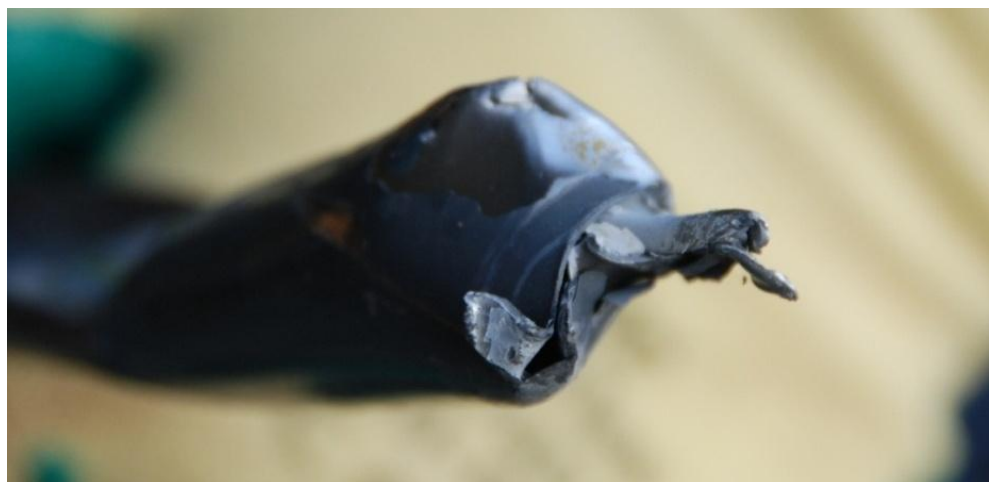
Examination of the main and tail rotor drive systems did not reveal any condition that would have precluded their normal operation. The torsional damage to the tail rotor driveshaft was indicative of significant rotational energy when it was severed (Figure 13).

**Figure 13: Tail rotor driveshaft with torsion damage**

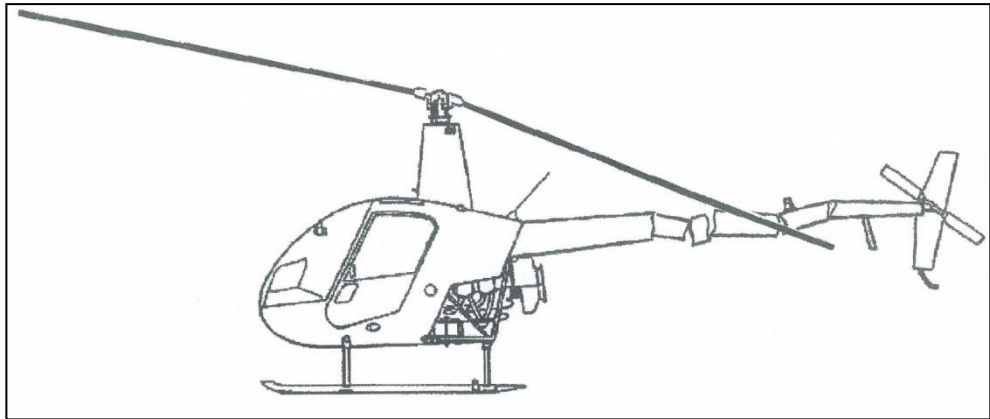
The impact damage to the tail boom and the tail rotor hub indicated that the main rotor blades struck the tail twice before the helicopter impacted the ground. The first strike passed through and severed the mid section of the tail boom (Figure 14). That was consistent with the fracture surfaces of the tail rotor driveshaft, which were due to impact with the main rotor blades, and not a result of an in-flight failure.

**Figure 14: First strike<sup>20</sup>**

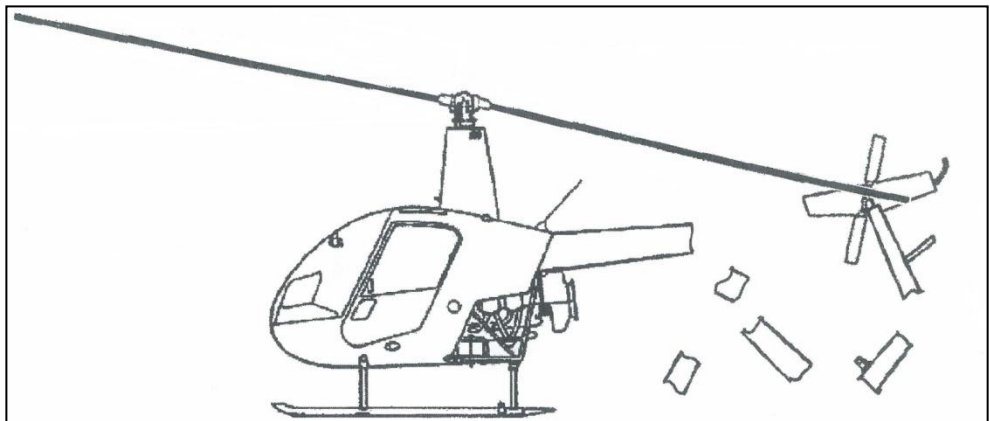
The dimension of the main rotor blades and their position relative to the tail rotor meant that the second strike can only have occurred after the severed section of the boom and tail rotor assembly had separated from the helicopter (Figure 15). The dual strike was consistent with the likely normal main rotor RPM at that time, and with the rapid movement of the now-detached tail rotor assembly into the path of the main rotor.

**Figure 15: Subsequent strike<sup>20</sup>**
