ATSB TRANSPORT SAFETY REPORT
Aviation Occurrence Investigation AO-2009-047
Final

Nose landing gear axle fracture VH-VBA, Boeing 737-700 Melbourne aerodrome, Victoria 25 July 2009

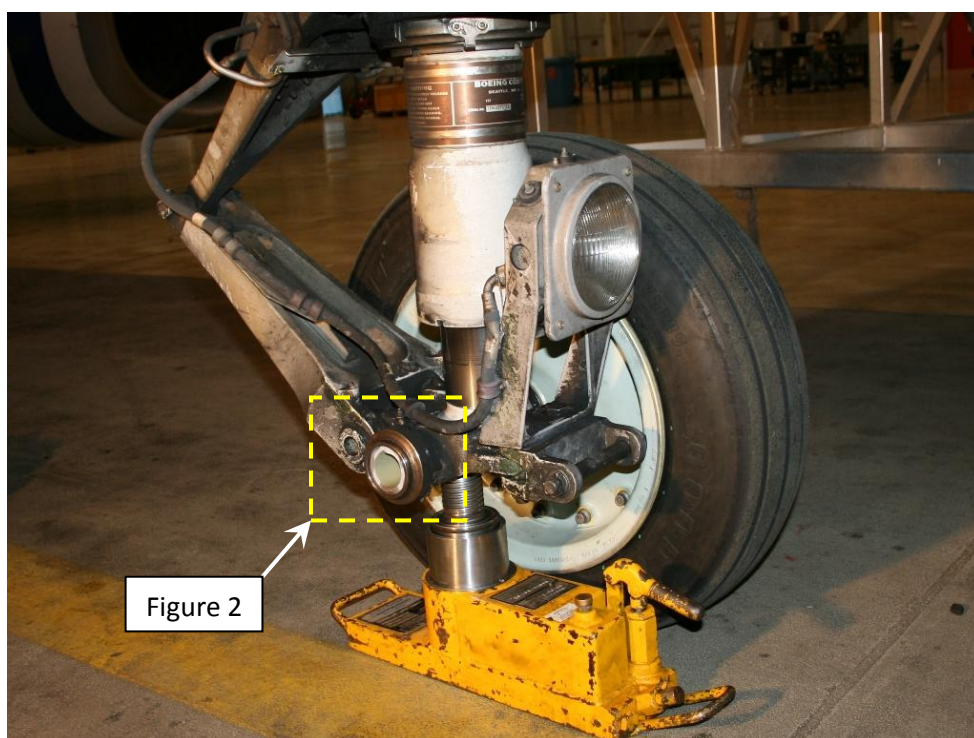
The aircraft was stopped on the taxiway to allow company engineers to inspect the nose landing gear. It was found that the right nose landing gear (NLG) axle had fractured and the entire right nose wheel had separated. The aircraft was taxied back to the gate and passengers disembarked. There were no injuries to passengers or crew and no further damage sustained by the aircraft.

Figure 1: Nose landing gear with fractured axle indicated

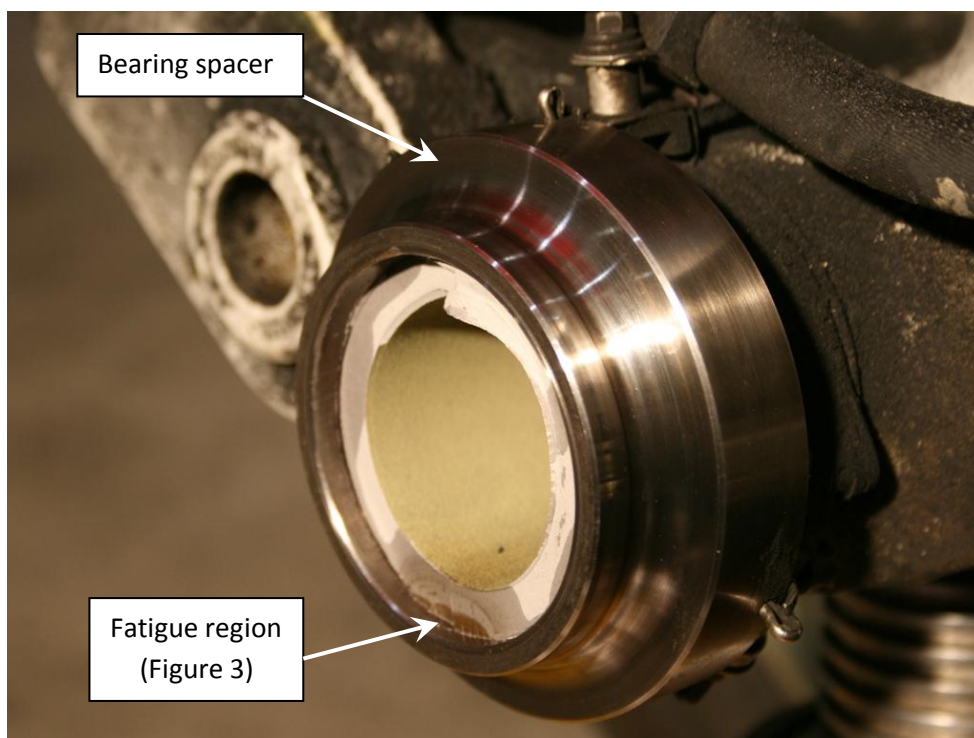
The NLG inner cylinder right axle had fractured through the chromium plated inner-bearing journal surface, underneath the area covered by the wheel bearing spacer (Figure 2). The outboard section of axle remained in, and was subsequently recovered with the right wheel. Both wheel bearings were in good condition and the wheel nut was lock-wired in place.

Figure 2: Axle fracture with bearing spacer in situ

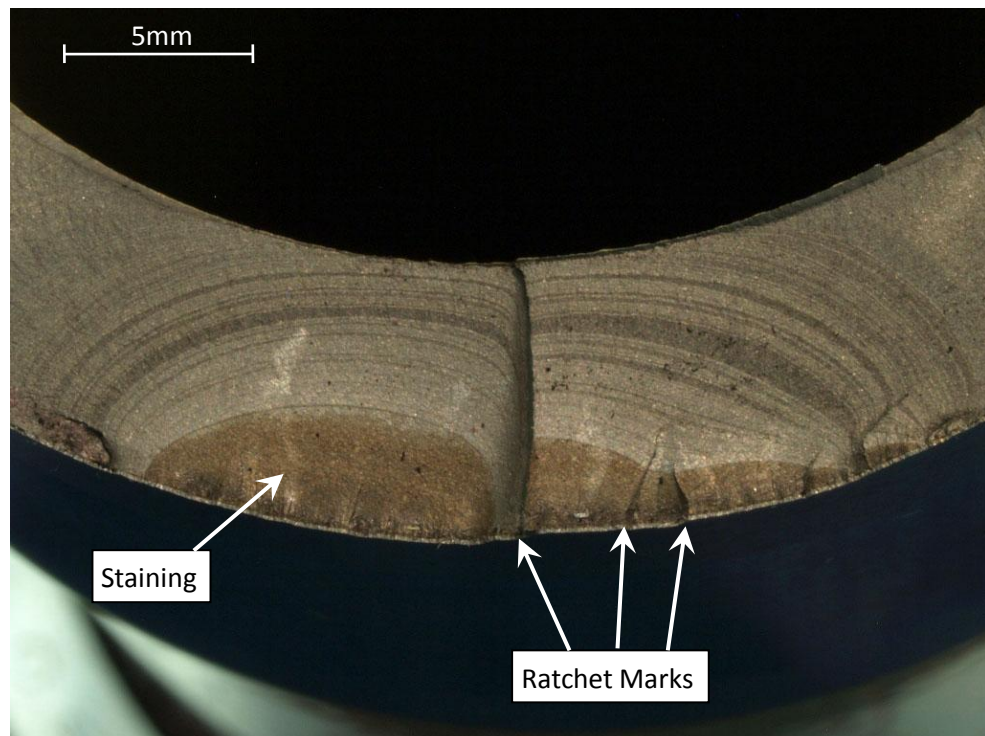
Figure 3 shows the fatigue portion of the axle fracture in detail. A series of clear crack progression (beach) marks were observed radiating outward from the 6 o'clock position (underside) of the axle, consistent with a fatigue fracture originating from the exterior surface. Several ratchet marks² were also present, which indicated multiple crack initiation sites. The final fracture had occurred by ductile overstress after the fatigue cracking had extended through approximately 15 to 20% of the total axle cross-sectional area.

The initial portion of the fatigue crack showed a brown discolouration/staining that was diffusely bounded by one of the more prominent crack progression marks (Figure 3). The discolouration was easily removed utilising an ultrasonic bath with anionic detergent.

Figure 3: Fatigue region of fracture surface

The ATSB considered that the discolouration of the fatigue fracture surface corresponded to a particular event in the history of the inner cylinder and was not a contributing factor in the initiation of the fatigue cracking. The diffuse boundary of the discoloured area suggested that it may have formed from the introduction of a fluid or contaminant into the crack during cleaning of the axle, during non-destructive testing procedures, and/or as a result of heating effects during post-plate baking. Maintenance records indicated there were no such procedures performed on the axle subsequent to overhaul in 2008, and as such, it was considered probable that the crack was present at that overhaul (at the size illustrated by the discoloured area shown in Figure 3), but was not detected during the associated visual and non-destructive inspections.

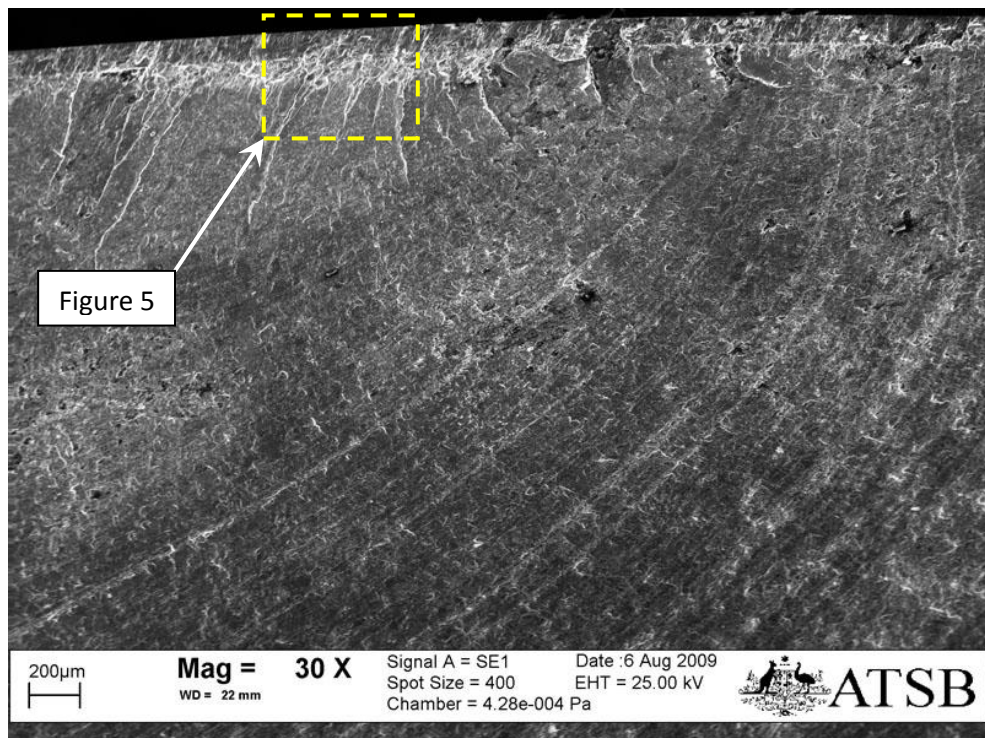
Electron microscopy of the chromium plate/steel interface (Figures 4 and 5) at the crack origins showed areas of mixed-mode intergranular and transgranular fracture immediately below the plated surface. Those features had progressed to a depth of approximately 0.1 mm before transitioning to fatigue crack progression.

Figure 4: SEM image showing crack origin and progression marks

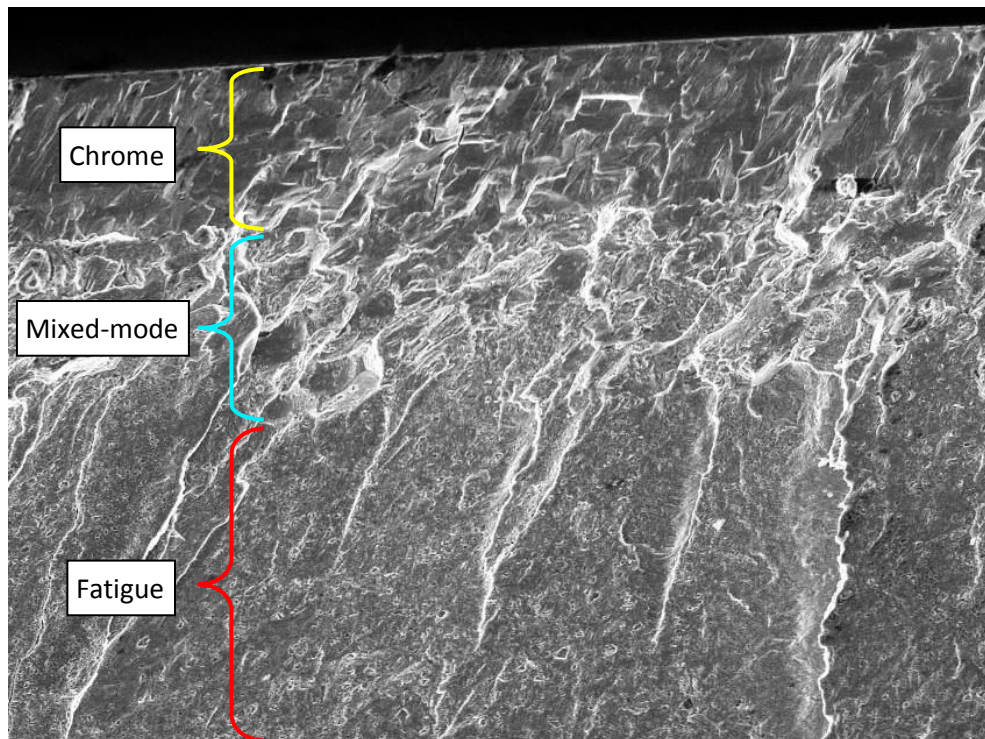
Figure 5: Detail of crack origin

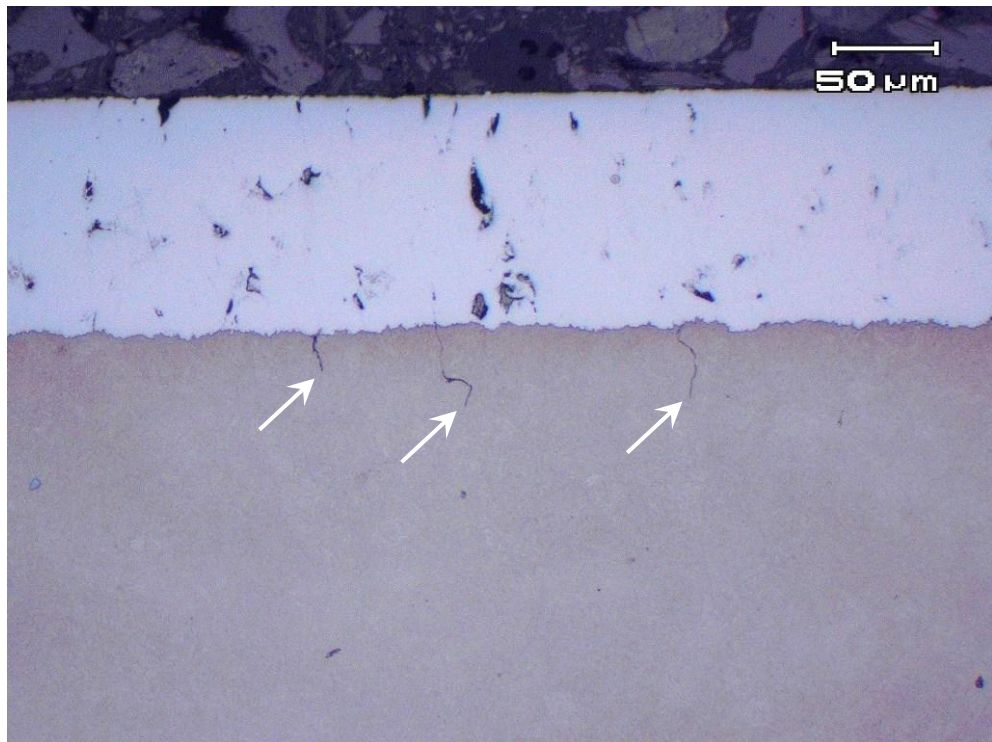
A cross section was taken through the fracture surface, polished and Nital³ etched for microstructural analysis. The structure was uniform in appearance through the section and was consistent with a high strength, low-alloy steel in the hardened and tempered condition. No microstructural anomalies were observed; however, several small cracks were noted, originating at the steel/plating interface (Figure 6).

Figure 6: Cracks at steel/chrome interface

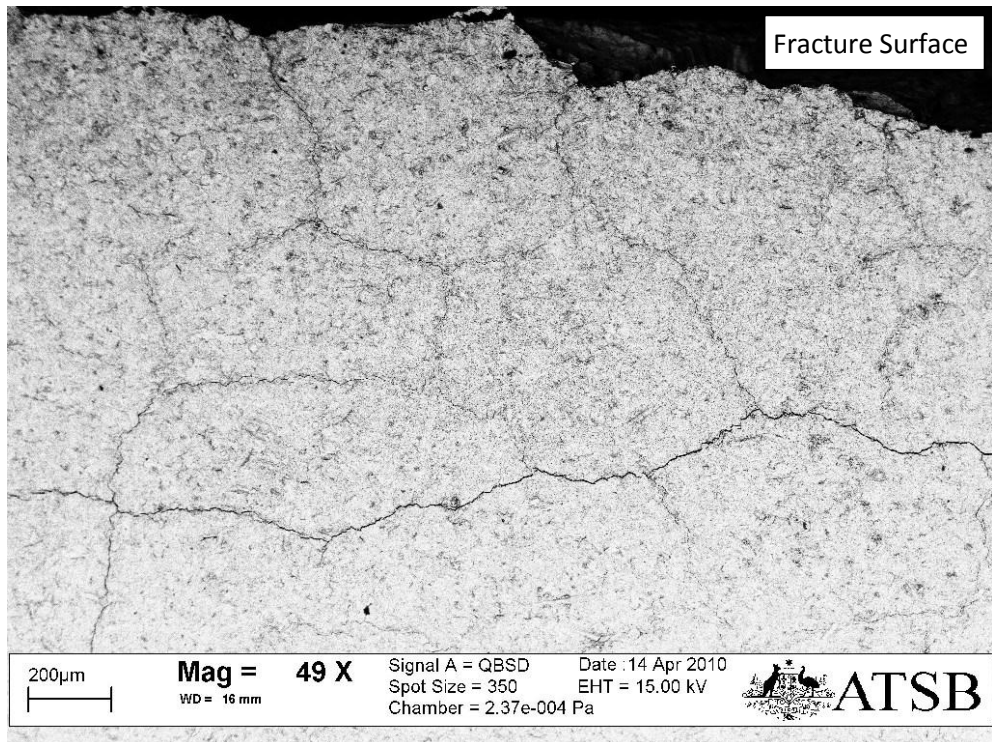
Examination of the region adjacent to the primary fracture surface revealed an extensive network of randomly oriented cracks or 'mud-flat' cracking (Figure 7). A Nital etch test³ was performed on the steel surface, revealing evidence of a slightly darker etching band adjacent to the fracture.

Figure 7: Steel surface cracks adjacent to fracture surface

The multiple crack origins and mud flat surface cracking observed was consistent with the effects of residual tensile surface stress. The additional identification of localised areas of overtempered martensite was evidence that the area had sustained thermal damage; most likely generated from frictional effects during a surface grinding or dressing process. The overtempered surface areas are typically associated with a reduction in strength and hardness, as well as a significant reduction in fatigue strength. There was no significant, detected variation in microhardness, which indicated that the grinding damage under the chromium plating was predominantly superficial. The bearing journal had not been reworked during the life of the inner cylinder and therefore the damage had most likely originated during original manufacture.
