**ATSB TRANSPORT SAFETY REPORT**  
**Aviation Investigation AO-2008-006**  
**Final**

# **Breakdown of separation, VH-TQZ**

## **Tamworth Aerodrome, New South Wales**

### **7 February 2008**

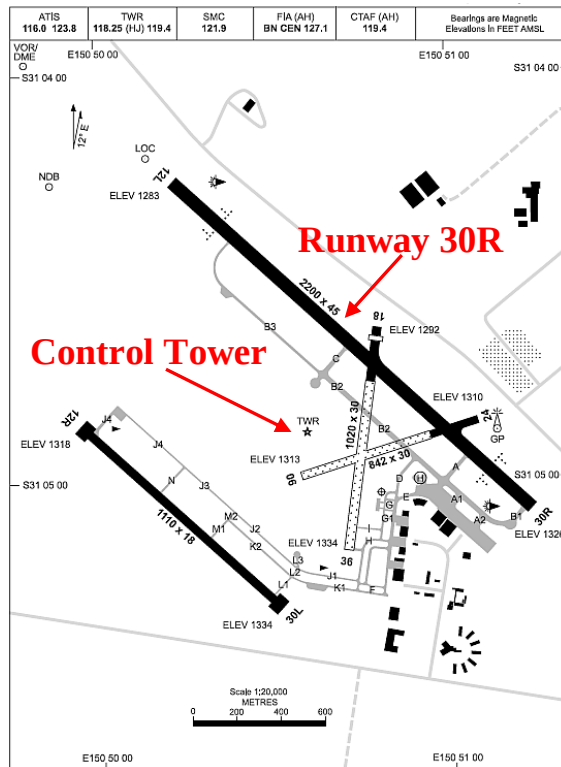
Figure 1: Tamworth Aerodrome

- The DHC8, which was to depart from runway 30R for a right turn to track south to Sydney via Singleton.
- A Twin Comanche aircraft that was conducting a practice instrument approach to runway 12 Left (12L), the reciprocal of runway 30R (Figure 1). This instrument approach involved a left teardrop pattern<sup>2</sup> and potentially placed the DHC8 and the Twin Comanche in a head-on conflict.
- An Avions Mudry & Cie CAP 10 (CAP 10) that was inbound from the south-west. That aircraft was to initially overfly runway 30R for right downwind. However, when the CAP 10 was at 4 NM (7 km) from the aerodrome, the pilot was
