**Bureau of Air Safety Investigation**

INVESTIGATION REPORT

9403038

**Boeing 747-312 VH-INH  
Sydney (Kingsford-Smith) Airport  
New South Wales  
19 October 1994**

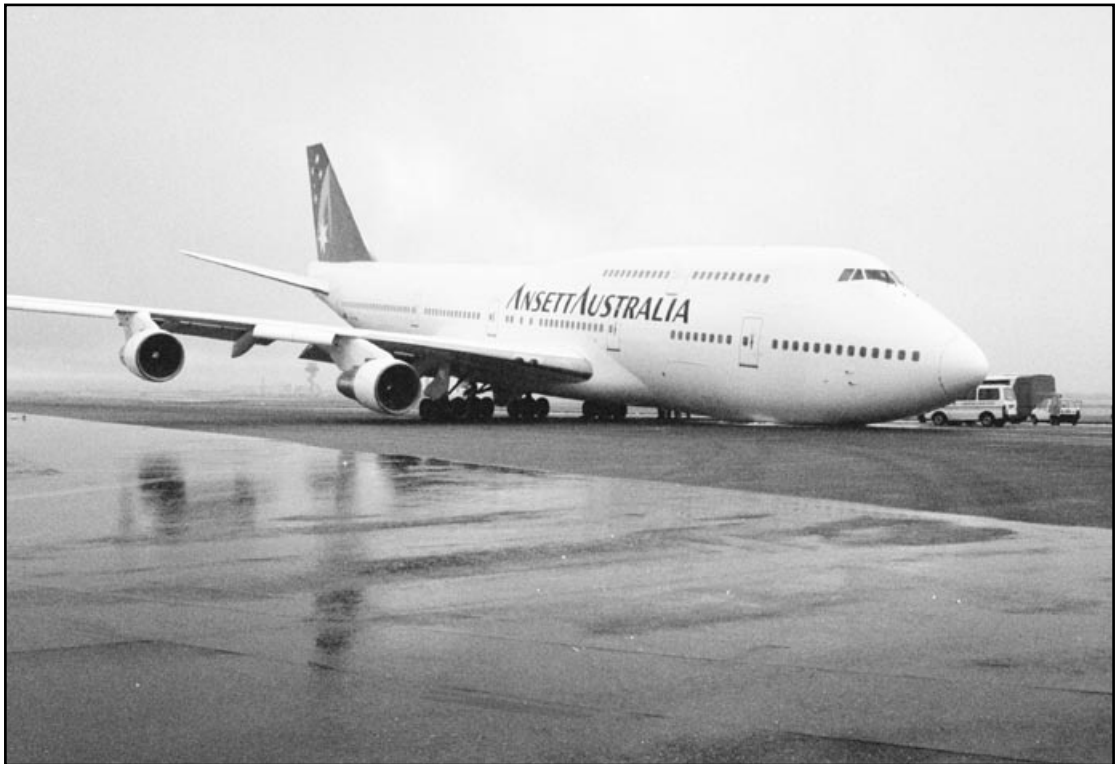
The Air Traffic Control surface movement controller observed that the approaching B747 did not have its nosewheel extended. He alerted the aerodrome controller, who transmitted the information to the aircraft. The warning was given after the mainwheels were on the ground and as the nose was being lowered. The initial reaction of the two pilots to the Air Traffic Control alert was to initiate a go-around, but there was quick recognition by the flight engineer followed immediately by the pilots that this was not possible, because reverse thrust had been selected. Ten seconds later the nose was gently lowered onto the runway.

**Figure 1.** The aircraft on the runway with its nose-gear retracted.

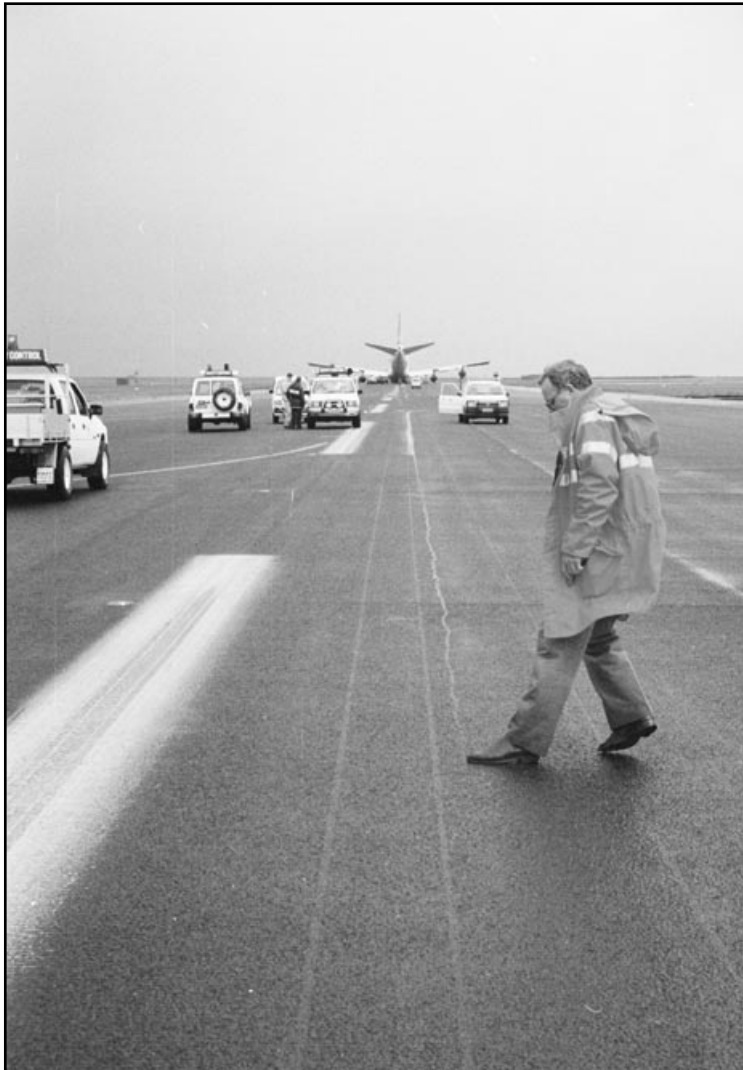
**Figure 4.** Commencement of scrape mark.

The damage to the aircraft was confined to abrasive wear and distortion of fuselage skin, stringers and frames in a 3.8-metre section under the front of the aircraft, including the rear 0.5 metres of the nose-gear door. Some of the skin was worn away completely, allowing steam and 'hot smells' to infiltrate to the forward cabin via the forward avionics bay. Several antennae were damaged or broken off during the sliding contact of the fuselage undersurface with the runway.

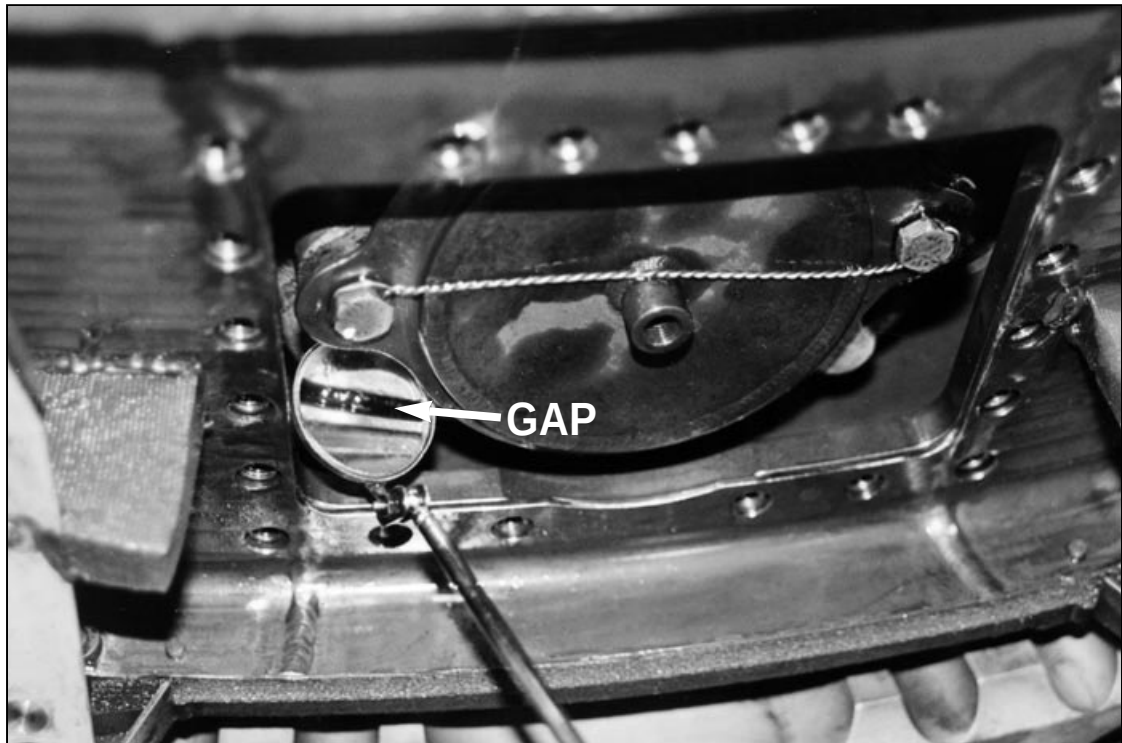
The cover was removed and the angle gearbox housing cover was found to be partially detached, allowing overboard spillage of engine oil (see below).

**Figure 7.** Partially detached angle gearbox housing cover.

The angle gearbox housing cover is secured to the angle gearbox casing by two bolts which attach to the casing by screwing into steel-threaded inserts, which in turn are screwed into holes in the casing. The left steel-threaded insert was loose in the casing but remained bolted to the cover. The right insert was secured within the casing, with the cover retaining bolt in place. Both bolts were lockwired together and had not rotated.

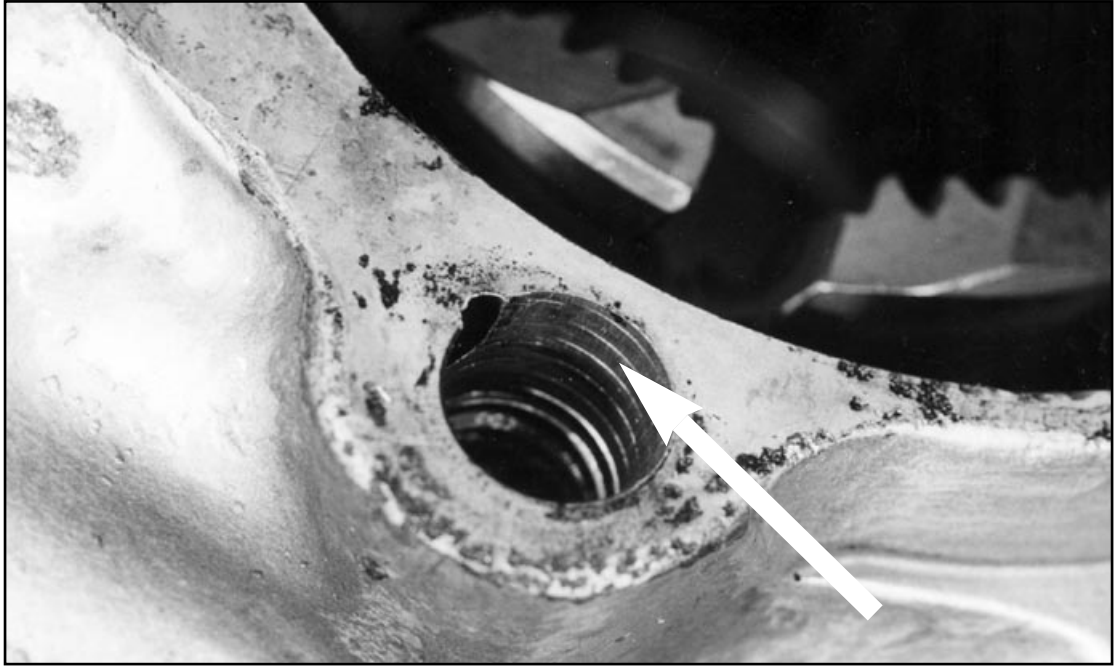
The threaded left insert had been tightened against the angle gearbox housing cover. Examination of the cover showed definite imprints consistent with the impressions of the heads of both inserts. The right insert was found to be flush with the case. The failed insert had been installed either proud of, flush with, or at an inadequate distance below the casing surface.

**Figure 8.** The metal threaded insert had milled out the internal threads of the gearbox casing.

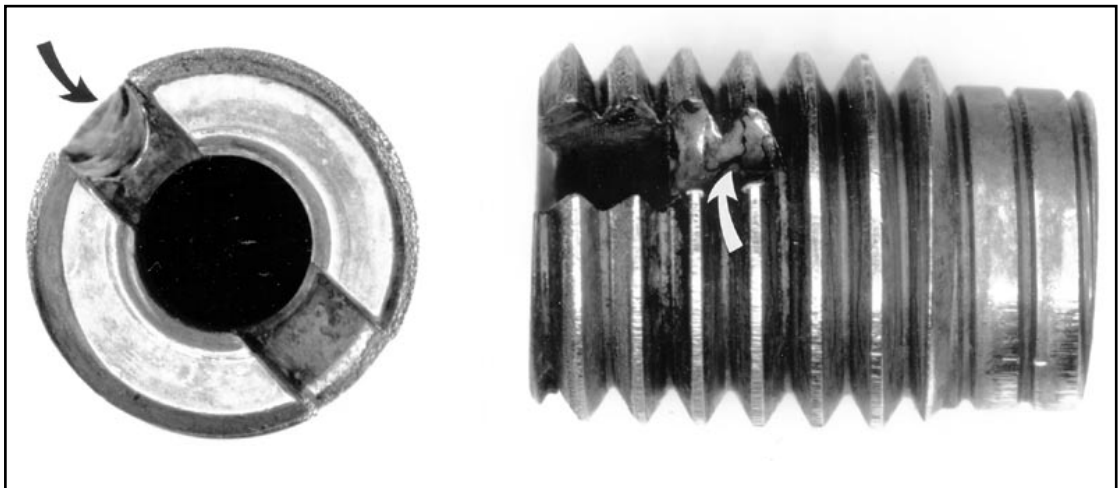
The left insert exhibited signs of wear associated with vibratory loading. This was extensive in the region of contact between the locking pin and the thread insert. Extensive wear had also occurred as a result of movement between the flanks of the external thread of the insert and the internal thread of the gearbox casing.

**Figure 9.** The detached thread insert showing the extent of wear created by relative movement between the locking pin and the insert. Magnification 4.3X.

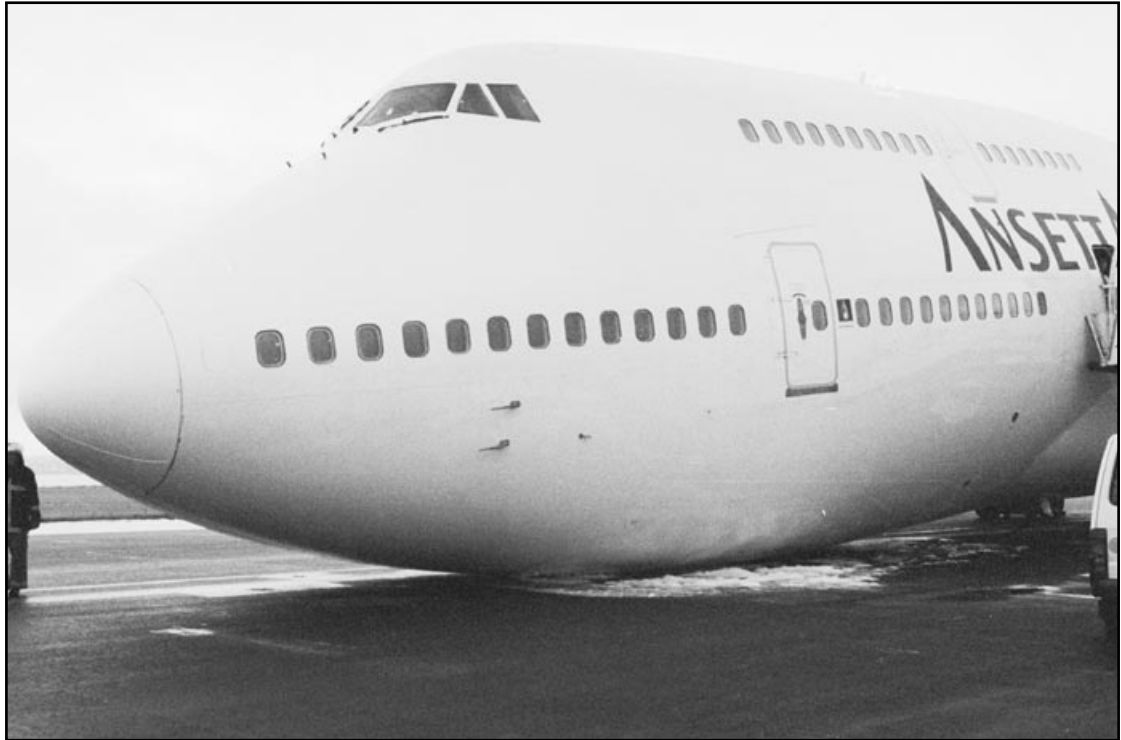
The Rescue and Fire Fighting Service crew noted what appeared to be smoke emanating from the contact point between the fuselage and the runway and applied foam to the area (see below). No evidence of fire was found when the aircraft was recovered. However, the aircraft had come to a halt on a wet runway after sliding for more than 810 metres and sustaining substantial friction damage. Consequently, what the rescue crew observed was probably steam.

**Figure 10.** Foam was directed at the point of contact between the runway and fuselage.
