Aviation Occurrence Investigation – AO-2008-078

Final

Wirestrike
13 km north of Murray Bridge, SA
19 November 2008
VH-PLJ
McDonnell Douglas 369D

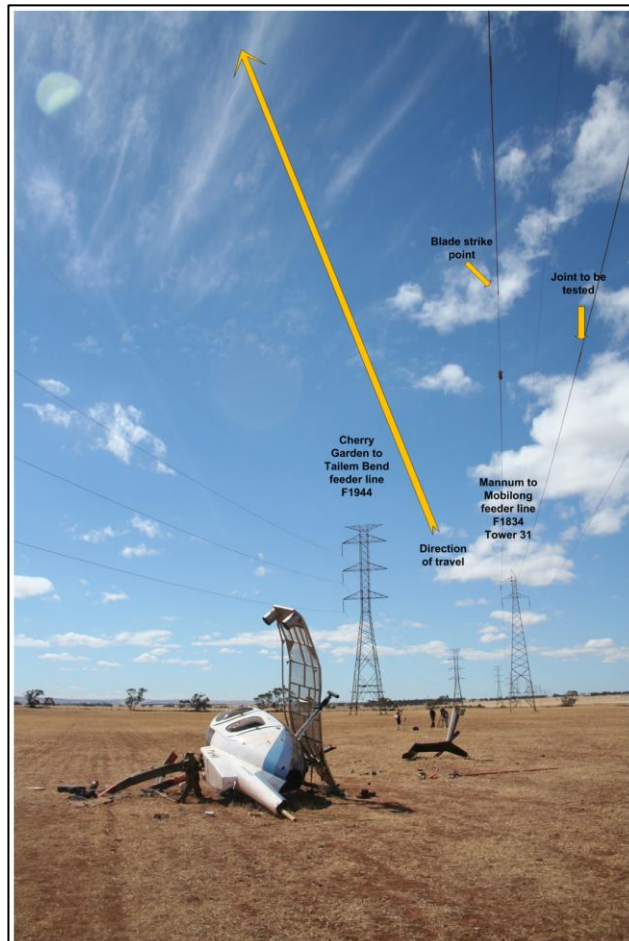
Figure 1: Accident site and powerlines

The platform was buckled in an 'S' shape and had partially detached from the skid landing gear (Figure 1). The forward left plexiglass cockpit window and part of the right side had burst outwards from where the pilot was seated.

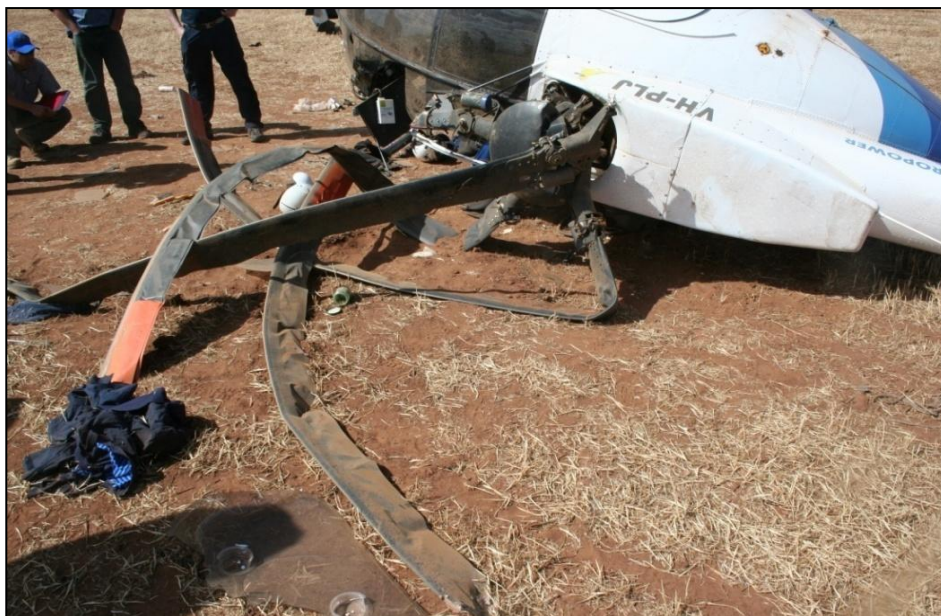
Figure 8: Main rotor blade and hub damage

The No 1 main rotor blade had separated from the main rotor hub and was found 126 m north-east of the main wreckage. The associated main rotor blade damper was found 147 m east of the main wreckage. Three main rotor blades remained attached to the hub, but exhibited significant damage consistent with contacting the ground while under power. The fifth blade separated 27cm outboard of the hub and was lying amongst the other blades in the wreckage (Figure 8).

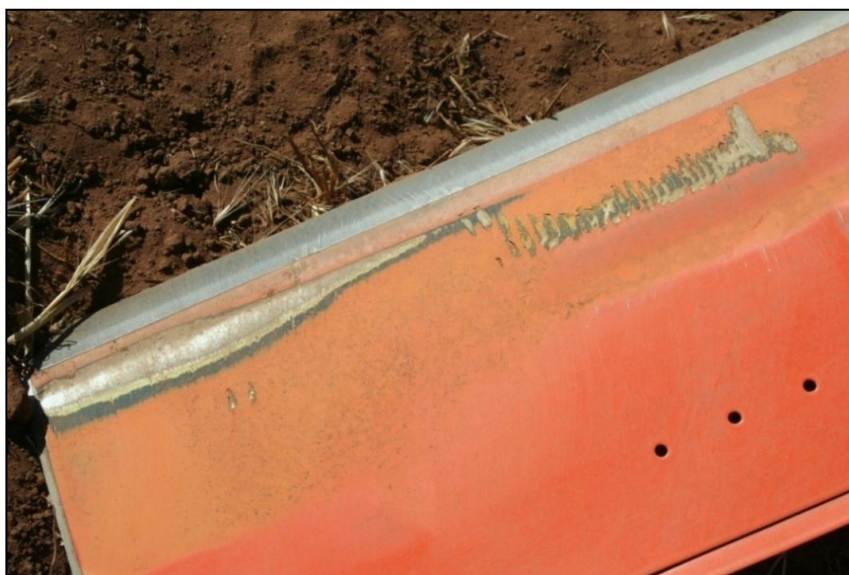
Figure 9: Main rotor blade witness mark tip damage

Wirestrike witness marks were evident near the tips of two of the main rotor blades (Figure 9).

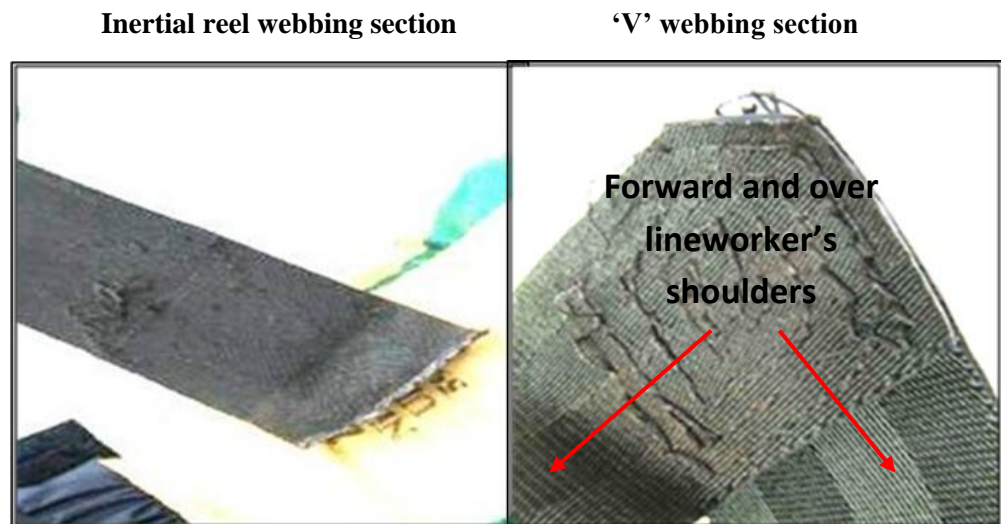
Figure 10: Separated sections of the recording lineworker's harness

The recording lineworker's shoulder harness was removed from the wreckage for technical examination. There were no deficiencies in the harness webbing; however, it was permanently rippled in some areas, indicating that it had been subjected to forces beyond its point of elasticity.

the accident site and no defects were found. The recording lineworkers harness had failed at the point where the shoulder harnesses joined the inertial reel section of the webbing.

In response to the failure of the recording lineworker's shoulder harness, the shoulder harness repair facility has upgraded relevant repair equipment and provided a replacement program for any incorrectly-stitched harness in the operator's helicopter fleet. In addition, the Civil Aviation Safety Authority took action to have a number of seat belt harnesses recalled and examined. No issues were found with any of the seat belts that were examined and they were able to be re-released without further rework.

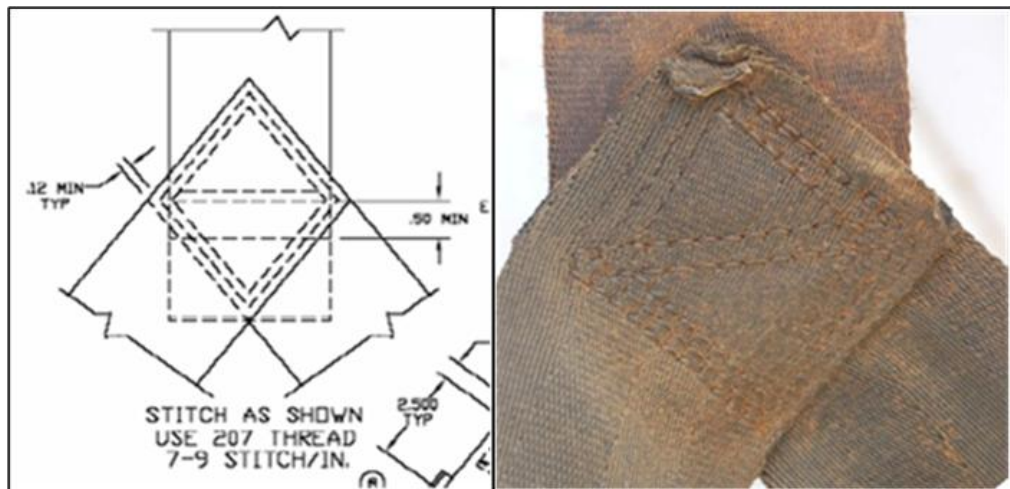
Figure 11: Stitch pattern as specified (left) and a correctly-stitched harness (right)

However, the repairer stated that when he received the harness for repair, the harness identification tag did not indicate whether a previous repair had been carried out. He stated that he copied the stitch pattern on the harness as he received it. The repairer could not recall if the restraint had, in accordance with the servicing requirements, been load tested to half its rated strength following the repair.

- restraint lap joint stitch pattern did not conform to [the] applicable [drawing] as the drawing specified a diamond pattern and the provided field article did not have the top of the diamond pattern completed [Figure 11]
- restraint lap joint stitch density did not conform to applicable drawings for the restraint and had less stitches per inch than the drawing specified
- correct thread material was used during the repair.

The testing facility fabricated a test sample of the joint using the stitch pattern and density that was found in the recording lineworker's harness. During testing, the average strength of the replicated harness joint was 1,009 lbs (459 kg). That was less than half the average strength of 2,500 lbs (1,336 kg) for a joint that was fabricated in accordance with the approved restraint drawings.

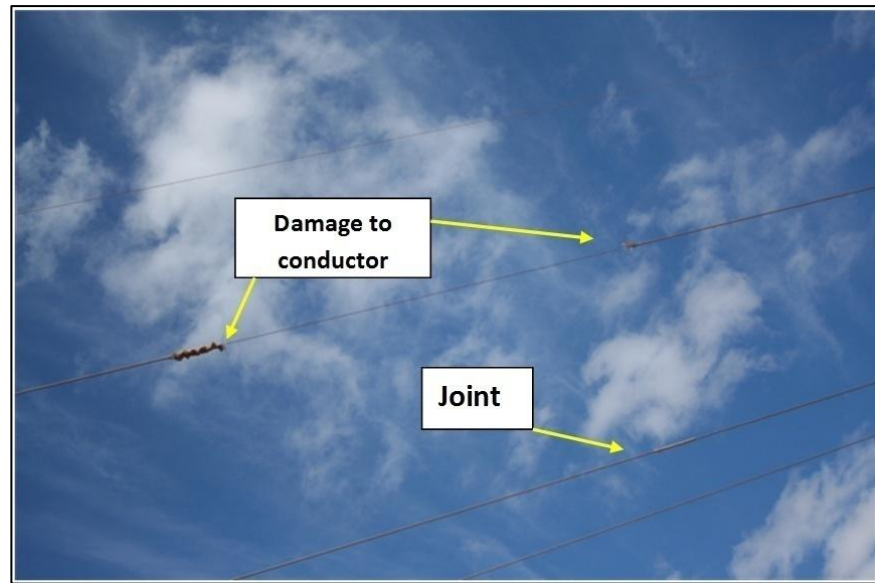
Figure 12: Damaged conductor

An examination of the powerline overhead the accident site revealed joints in close proximity to each other in all three conductors, of which one was damaged (Figure 12). The damaged conductor was 10 m above ground level.

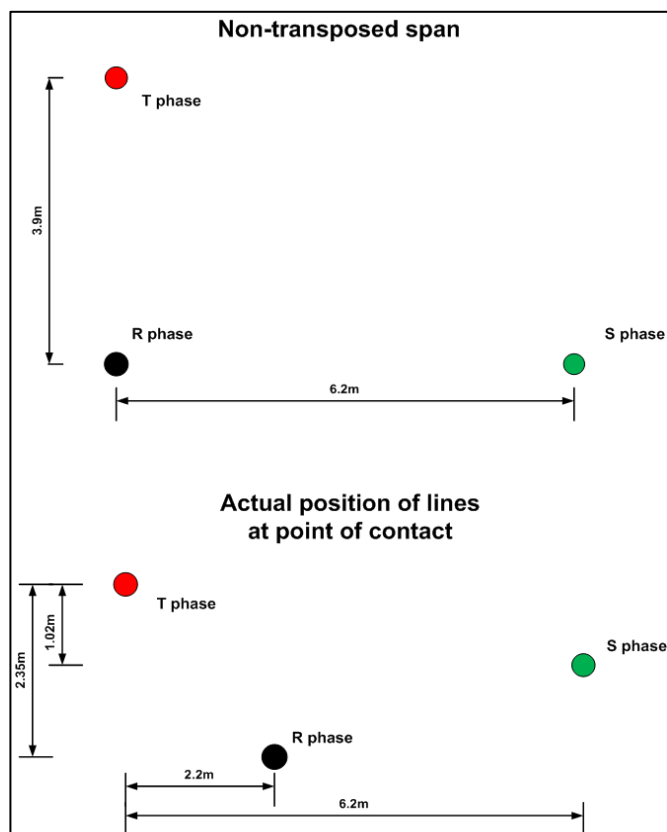
Figure 13: Comparison of mid-span conductor positions in the vertical plane

Before repairs to the conductor were undertaken, measurements were taken by the powerline maintenance provider to establish the relative positions of the conductors in the vertical plane (depicted in Figure 13). Also shown, is a vertical cross-section of the conductor positions at a typical non-transposed span, compared to the position of the damaged conductor.

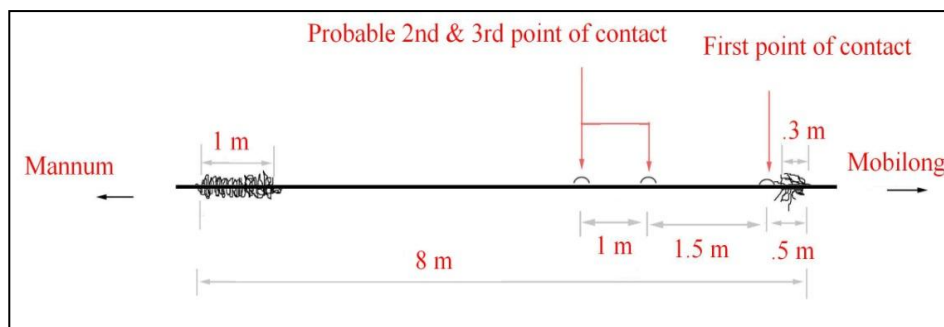
Figure 15: Profile of the damaged section of conductor

The majority of the damage to the conductor was to the outer and intermediate layers of aluminium wire. The aluminium wires at the Mobilong end were severed and splayed outward from the main weave, while those at the Mannum end were bunched into a loosely coiled, 1 m length (Figure 15). That damage was consistent with the anti-clockwise rotation (when viewed from above) of the helicopter's main rotor blades.

Two distinct failure modes for the aluminium wires were identified at the point of the initial contact with the main rotor. Fourteen of the aluminium wires were severed cleanly, while the remaining 16 wires failed from tensile overload. That was consistent with the first main rotor impact severing the 14 wires, while the remaining 16 were stretched until failure.

The high strength steel wire was kinked in three separate locations along the 8 m damage zone. Some deformation was observed to the steel weave at each kink. Due to the very high strength and tight weave of the steel wire, it was unlikely that the kinks were introduced from handling damage when the line was removed and transported to the Australian Transport Safety Bureau (ATSB) for technical examination.

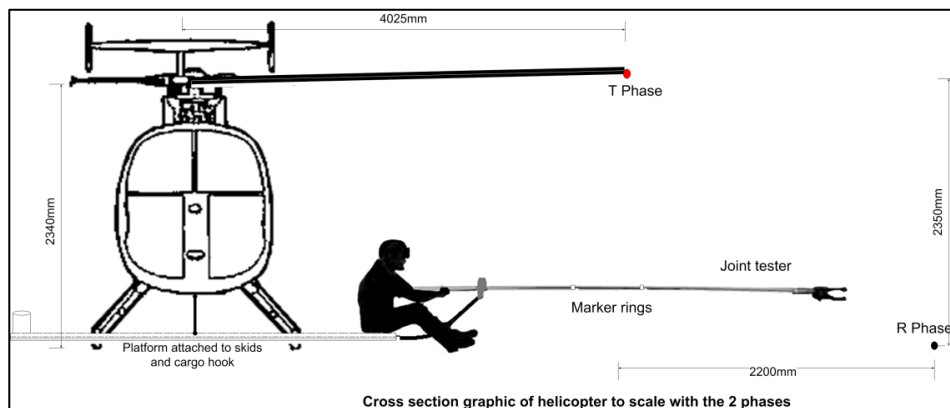
Figure 17: Front elevation showing the probable relationship between the helicopter and 'R' and 'T' phase conductors

However, the presence of the mid-span transposition meant that the ‘R’ phase conductor diverged away from its previous vertical alignment with the ‘T’ phase conductor. That required the pilot to approach closer than intended to the ‘T’ phase conductor in order to be able to test the ‘R’ phase joint. That increased the risk that the main rotor blade would contact the ‘T’ phase conductor as the pilot manoeuvred into position for the test (Figure 17).

The contact occurred near the main rotor blade tips, and the resultant out-of-balance forces destabilised the main rotor system to the extent that one of the main rotor blades detached from the rotor hub. That failure removed any prospect of the pilot being able to control the helicopter as it descended to the ground.
