ATSB TRANSPORT SAFETY REPORT
Marine Occurrence Investigation M0-2009-011
No. 271
Final

Engine room fire on board the container ship *Maersk Duffield* in Moreton Bay, Queensland 10 December 2009

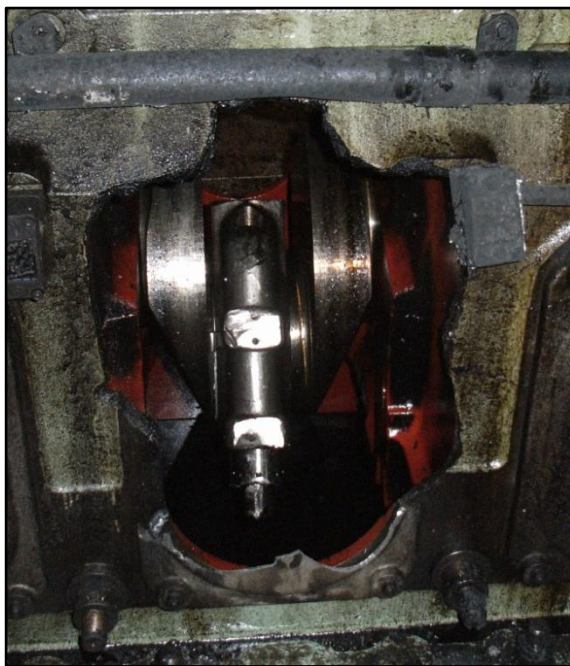
Figure 3: Damaged crankcase on 4DG

However, before 4DG had stopped, an explosion occurred and the number five cylinder forward counterweight, piston and connecting rod were

ejected from the engine (Figures 3 and 4), shattering the crankcase relief door.

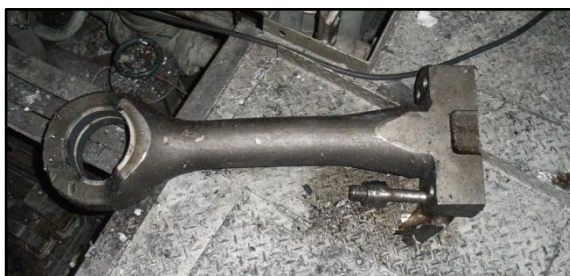
Figure 4: Connecting rod from 4DG

The connecting rod had separated from the bottom end bearing after all four of the palm studs had failed. Both of the forward counterweight's retaining studs had also failed (Figure 7).

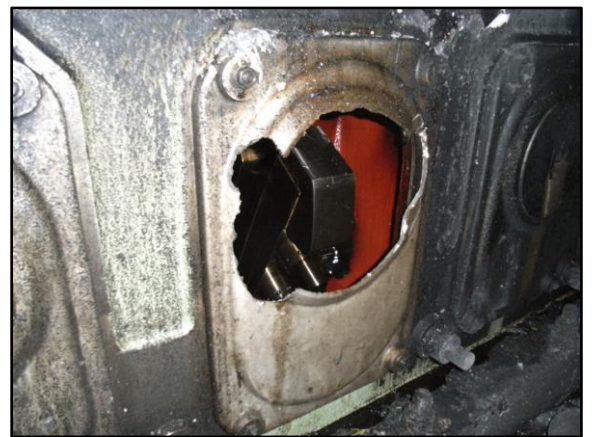
Figure 5: Crankcase door on 3DG

The heavy debris that had been ejected from 4DG struck 3DG, which was still running, and broke a crankcase door (Figure 5). The fractured door allowed more oil and vapour to be released, adding fuel to the fire.

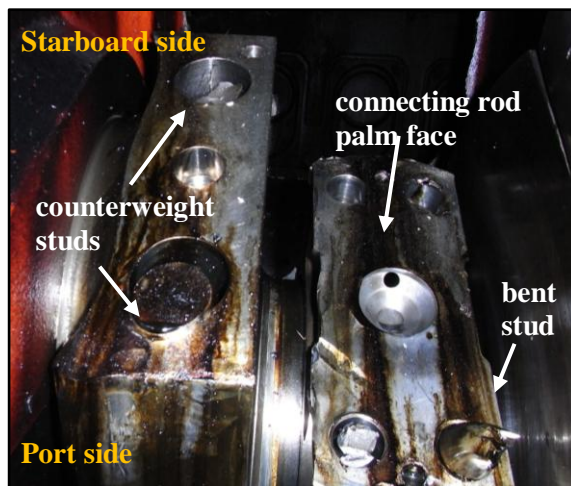
Figure 7: Number five cylinder crankcase

One of the port side palm stud ends showed signs of necking ⁶ and a degree of bending (Figure 7). These details indicate that it had been the last stud on the palm face to have failed. For the failure of that stud to have occurred last, the starboard side studs had to fail first.

It is possible that one or more of the starboard side studs had failed through fatigue cracking due to the action of joint movement and the associated bending loads as the nut progressively

While it could not be confirmed, it is possible that one or more of the connecting rod palm nuts had not been sufficiently tightened during this recent overhaul. Therefore, it is possible that an insufficiently tightened nut could have been the initiator of a fatigue related connecting rod palm stud failure.

A detailed examination of the starboard side counterweight stud (Figure 7) was not possible in situ. However, the fracture surfaces were angular in nature and the hole through which the stud passed was not distorted. This indicates that it

had not been subjected to the same shear forces as the adjacent stud. It is possible that the failure of this stud may have allowed the counterweight to shift and contact the connecting rod. This would have impeded the connecting rod's free movement and resulted in the failure of the other counter weight stud and the connecting rod palm studs.

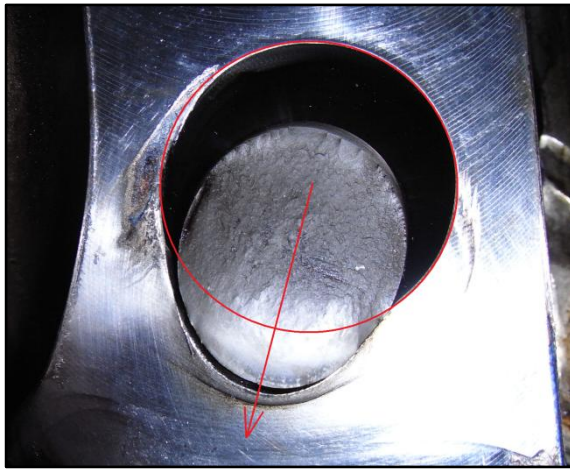
An inspection of the forward, port side, counterweight stud fracture surface revealed that it failed transversely in a flat manner (Figure 8). The stud hole was distorted from its original shape, which indicated that the stud fracture was related to a high degree of shear loading in the direction indicated in the diagram.

Figure 8: Sheared counterweight stud showing shear force direction and associated crank deformation

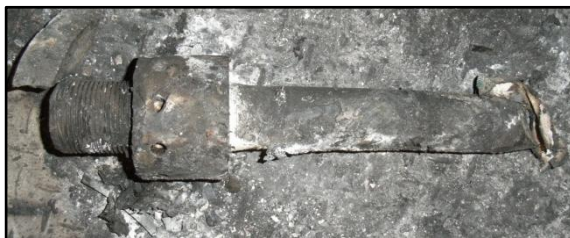
Two of the connecting rod palm studs that were found outside the crankcase showed signs of necking and elongation adjacent to the fracture face (Figure 9). This suggests that the studs may have failed suddenly through tensile overstress, which is consistent with the counterweight impeding the movement of the connecting rod.

Figure 9: Failed connecting rod palm stud

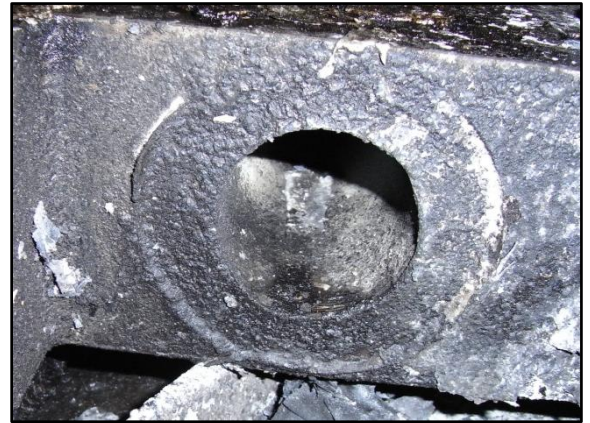
An examination of the one of the machined faces in the counterweight surface where the retaining nuts sat revealed a series of circular indentations (Figure 10). The counterweight had been severely affected by the fire and it is possible that the marks had been formed through plastic

deformation⁷. However, the shape of the indentations suggested that they may have been created by relative movement between the counterweight and the nut during the operation of the engine. This suggests that at least one of the nuts may not have been sufficiently tight.

Figure 10: Counterweight circular indentation
