**ATSB TRANSPORT SAFETY INVESTIGATION REPORT**

Aviation Safety Occurrence Report – 200503971

**Flight control system event  
Sydney Airport, NSW  
Boeing Company 737-700, VH-VBD  
09 August 2005**

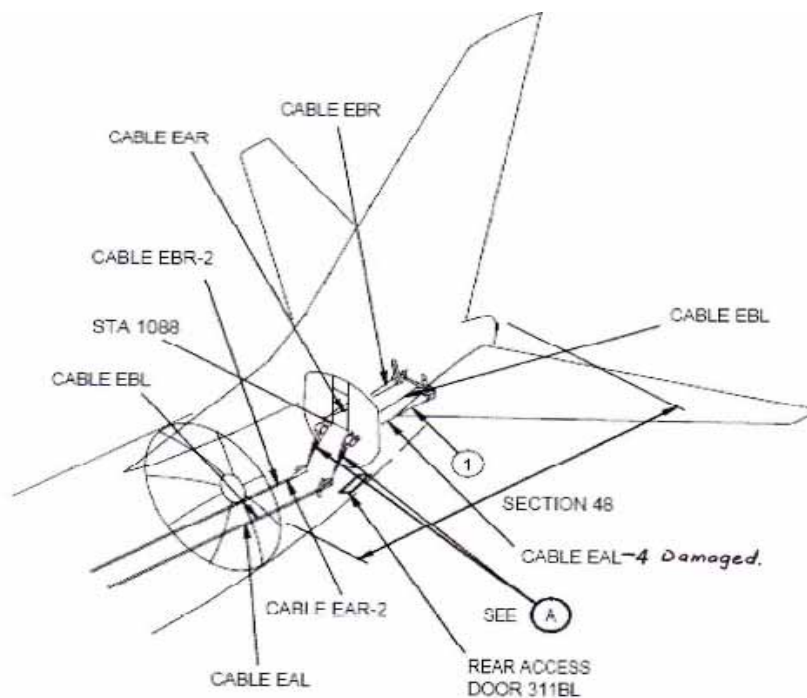
**Figure 1: Cable run of misrouted cable EAL-4**

At 2108 Eastern Standard Time<sup>1</sup> on 09 August 2005, a Boeing Company 737-700 aircraft, registered VH-VBD, completed a scheduled flight from Melbourne, Vic, to Sydney, NSW. The pilot subsequently reported that the aircraft had 'heavy' flight controls. An inspection by maintenance engineers revealed that the left lower rear elevator cable, EAL-4, was incorrectly routed around a stiffener and that the stiffener and cable section had been damaged as a result of contact between them (figure 1). The aircraft was withdrawn from service for repairs.

While preparing the rear elevator control cables for removal, a trainee engineer did not tie-off<sup>3</sup> the cable end at the lower left rear elevator input quadrant before removing the cable keeper<sup>4</sup>. When the cable keeper was removed, the unsecured cable section slipped from sight at fuselage station 1156.

While recovering the cable, the trainee and an aircraft maintenance engineer inadvertently misrouted the cable around the stiffener at fuselage station 1147. When the replacement cable was pulled into place, it followed the same incorrect route around the stiffener. The trainee and the engineer did not inform the team leader of the cable loss and made no record of the loss of cable run integrity. They also did not carry out an inspection to see if the recovered cable was routed correctly.

The mis-routing of the elevator control cable was the result of the original cable dropping from position following release of the cable keeper. The cable had not been tied off appropriately to retain the control run integrity. Subsequent control system inspections were not sufficient to ensure that the replacement cable had been routed correctly.

The aircraft was released to the aircraft operator on 1 August 2005 and remained in service until the pilot in command reported the 'heavy' flight controls on 9 August 2005. Following this occurrence, the aircraft operator repaired the stiffener, replaced the damaged cable section and completed the required inspections and tests. The aircraft returned to service on 12 August 2005.
