Aviation Occurrence Report – 200505808

Wheels-up landing – Birdsville, Qld – 12 November 2005

VH-DEQ

Piper Aircraft Corporation PA-31 Navajo

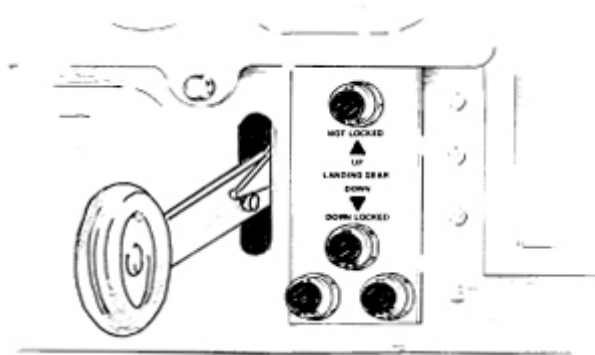
Figure 1: Landing gear selector (shown in a neutral position)

The pilot's operating handbook for the Navajo advised that to lower the landing gear, the gear selector handle is pulled aft and then lowered to the DOWN position. That action opens the inboard gear doors, illuminates a red Not-Locked light and extends the landing gear. When the landing gear legs are locked down, the three green Down-Locked lights illuminate. Once the inboard gear doors are closed, the extension cycle is complete and the gear selector automatically returns to a neutral position (Figure 1) and the red Not-Locked light extinguishes. In most other aircraft with retractable landing gear, the selector remains in the down position.

The investigation was unable to establish the reason why the landing gear did not extend during the approach to land at Birdsville. It was possible that the pilot flying did not fully engage the landing gear selector and used the position of the gear selector as an indication of landing gear extension. More importantly, it appeared that neither pilot confirmed that the landing gear was down and locked by checking that the three green Down-Locked lights were illuminated.
