ATSB TRANSPORT SAFETY INVESTIGATION REPORT  
Marine Occurrence Investigation No.231  
Final

Independent investigation into the grounding  
of the Vanuatu registered offshore tug/supply ship

# Massive Tide

on Rosemary Island, Western Australia

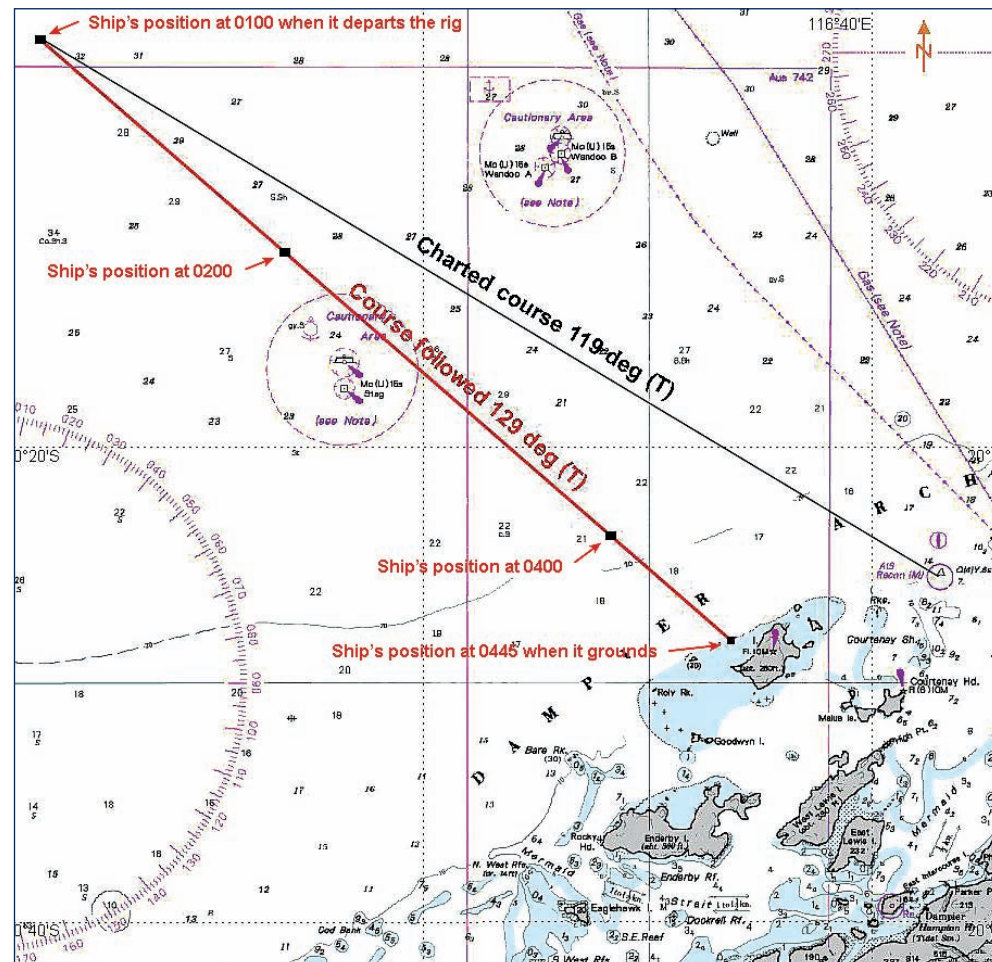
**Figure 3: Massive Tide's track between 0100 and 0445 on 29 August 2006**

When the master arrived on the bridge he immediately saw Rosemary Island Light fine on the port bow. He checked the ship's position and plotted it on the navigational chart. He also noted that the GPS unit, which was operating in the 'highway' display mode, showed the ship on track. The ship's position was 20° 28'S 116° 33.7'E, about nine miles from the charted course line.

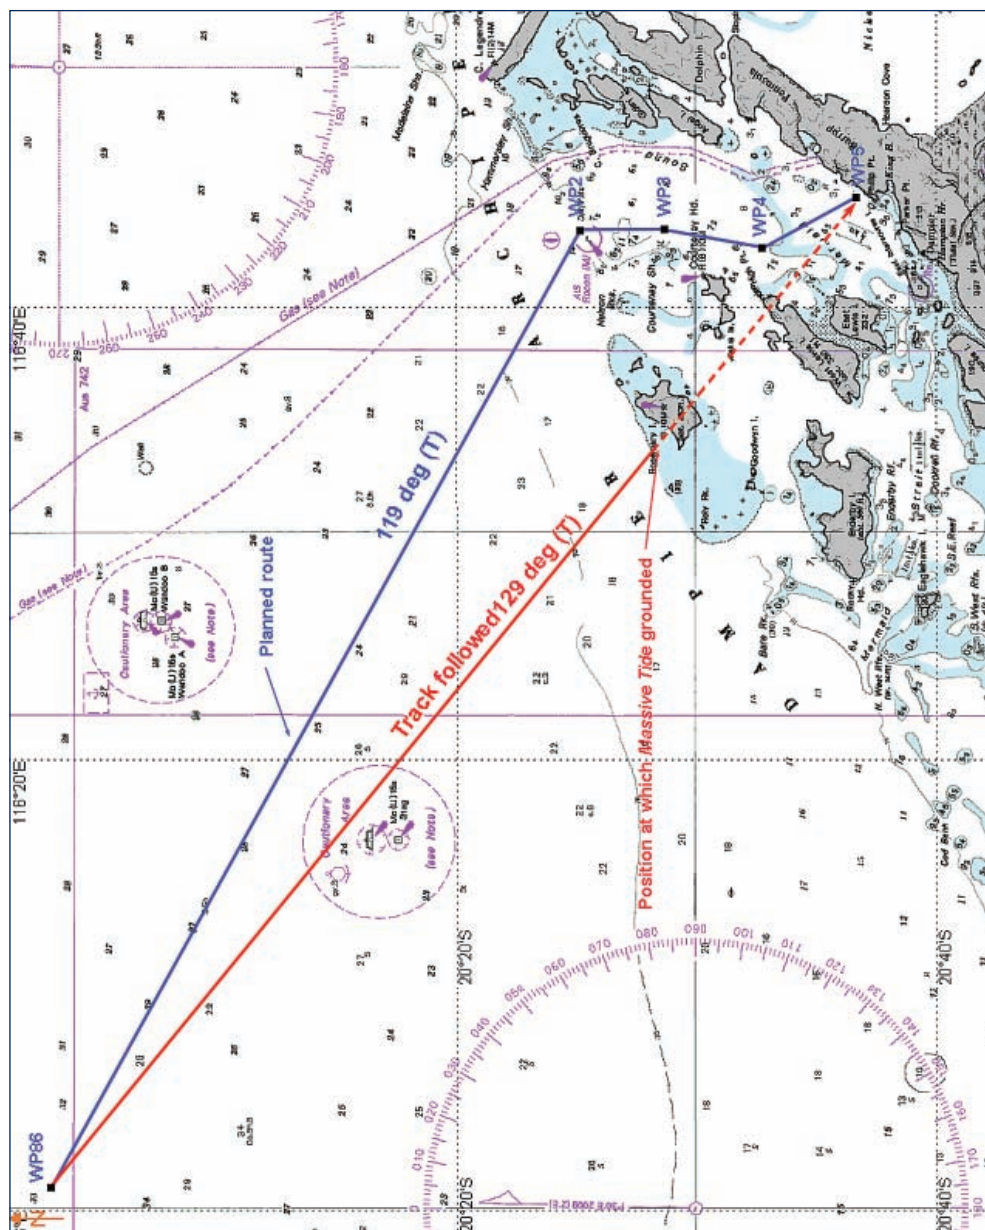
**Figure 4:** Section of navigational chart Aus 327 showing *Massive Tide's* planned route and the course followed on the morning of 29 August 2006

At about 0100 on 29 August, the morning of the grounding, the second mate recalls reversing the route in the GPS unit. However, the course he read off the GPS unit was 129° (T). This was not the course from his current position, in the vicinity of waypoint 86, to the Dampier Sea Buoy, waypoint two. It was the course directly to the Dampier cargo wharf, waypoint five (Figure 4).

The second mate had only navigated the ship from the drill rig to Dampier on one occasion before the morning of the grounding and he may have been confused by the similarity in the course that he obtained from the GPS unit, 129° (T), and the charted course, 119° (T). However, good navigational practice dictates that he should have cross checked the information he obtained from the GPS unit against independent sources of information. He could have checked the course against the charted course or the passage plan. However, he did not and, as a consequence, at 0100 on 29 August, the ship departed the drill rig and was set to follow a course of 129° (T).
