ATSB TRANSPORT SAFETY INVESTIGATION REPORT

Rail Occurrence Investigation 2006/001

Derailment of Freight Train 3AB6

Yerong Creek, New South Wales

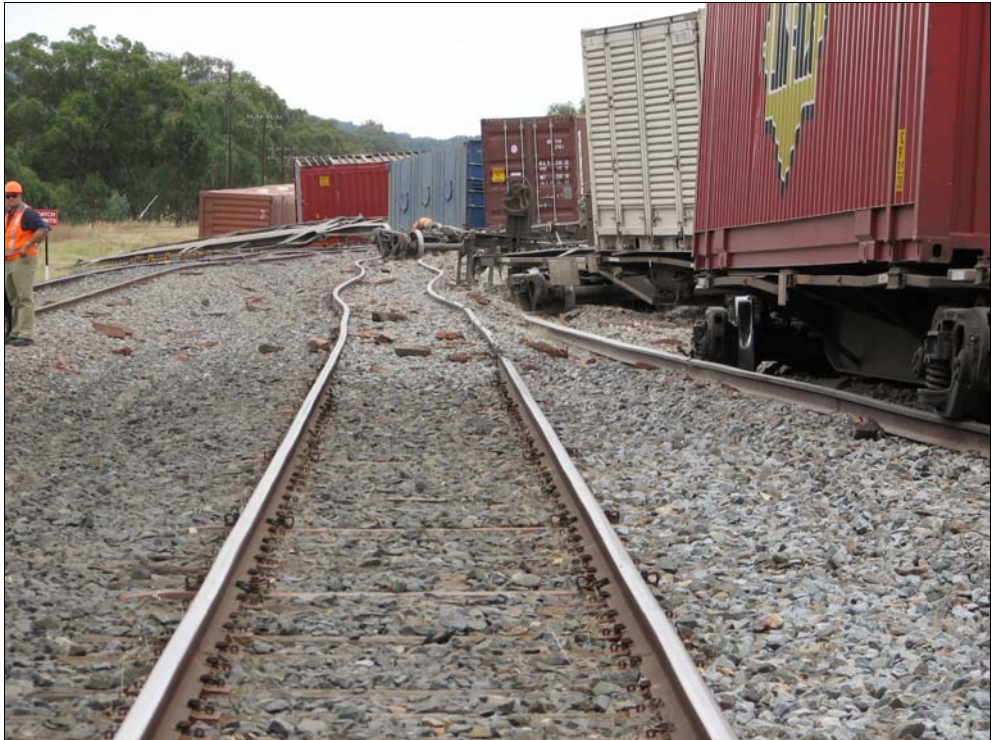
About 500 m of main line and about 200 m of the loop were extensively damaged by the derailment. Several poles supporting aerial communication lines adjacent to the rail corridor were knocked down and signal rodding associated with the silo loading road was damaged. The crossing loop was re-opened at 1804 on 6 January 2006 and the main line at 1746 on 15 January 2006.

Figure 4: View of accident scene towards Sydney

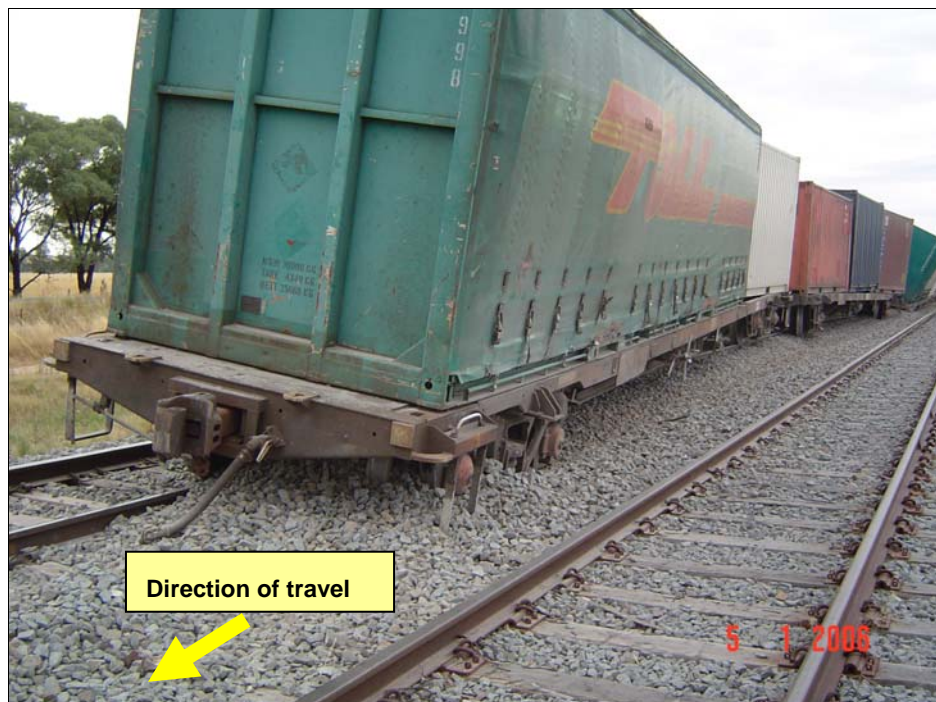
Figure 5: First derailed wagon

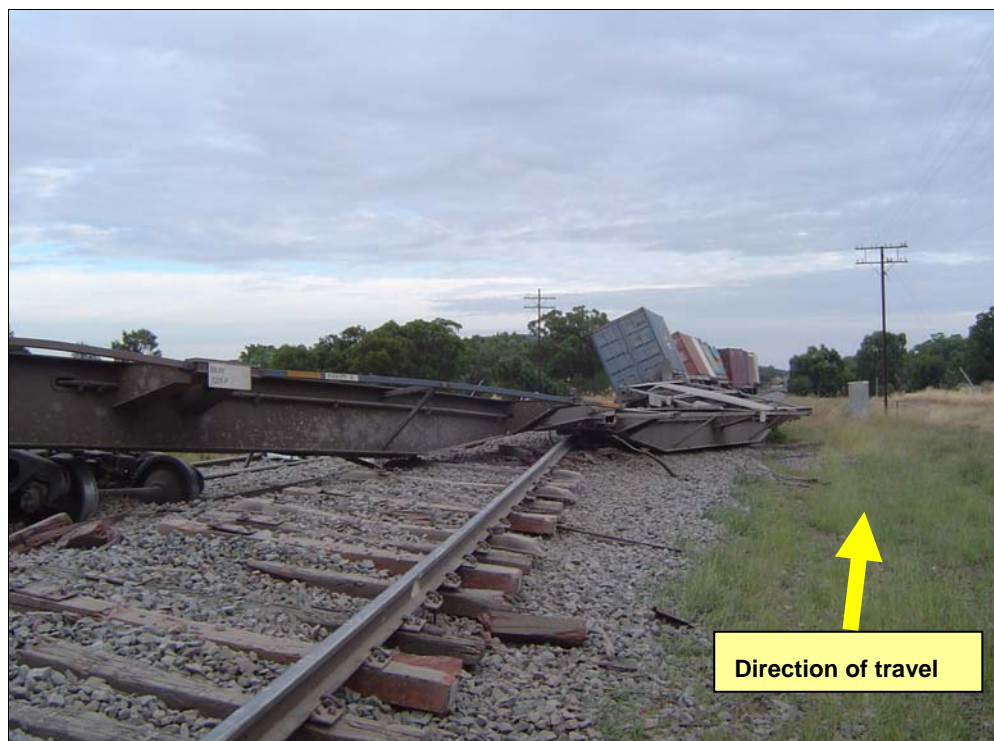
Figure 6: Concertinaed five pack wagons

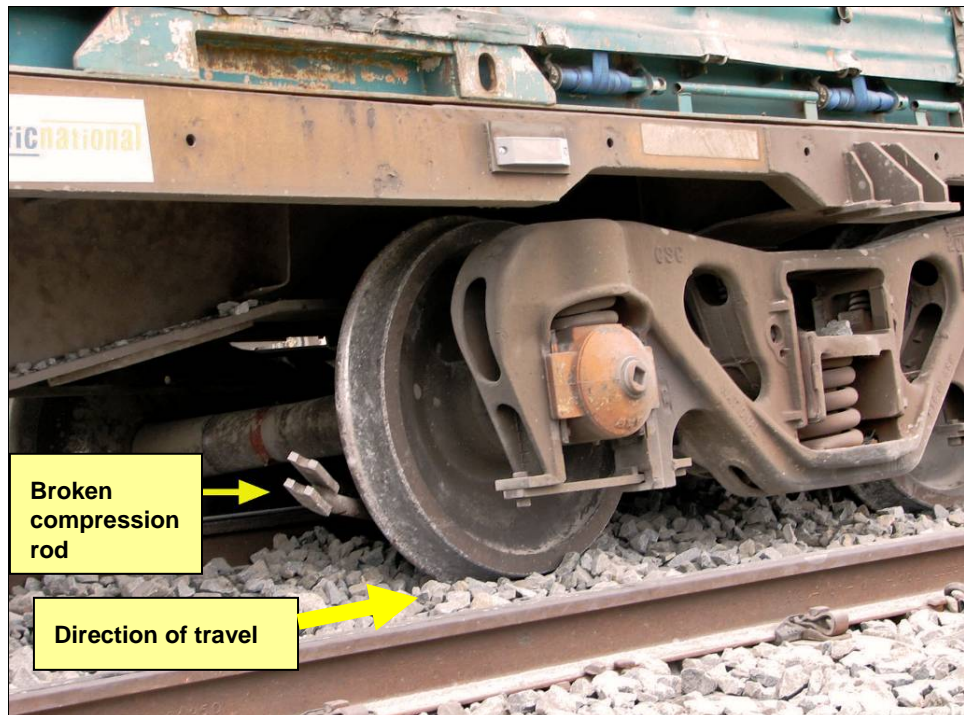
A fractured brake compression rod and three missing eye bolts on the first bogie to derail (RYCD 26426) were the only abnormal mechanical defects identified by the

initial site inspection of the derailed rollingstock (Figures 7 and 8). The fractured compression rod, which normally sits between the 'live' and 'dead' brake levers beneath the bogie (see Figure 8), was protruding rearwards (see Figure 7).

Figure 7: Broken compression rod, bogie RYCD 26426, rearwards of installed position

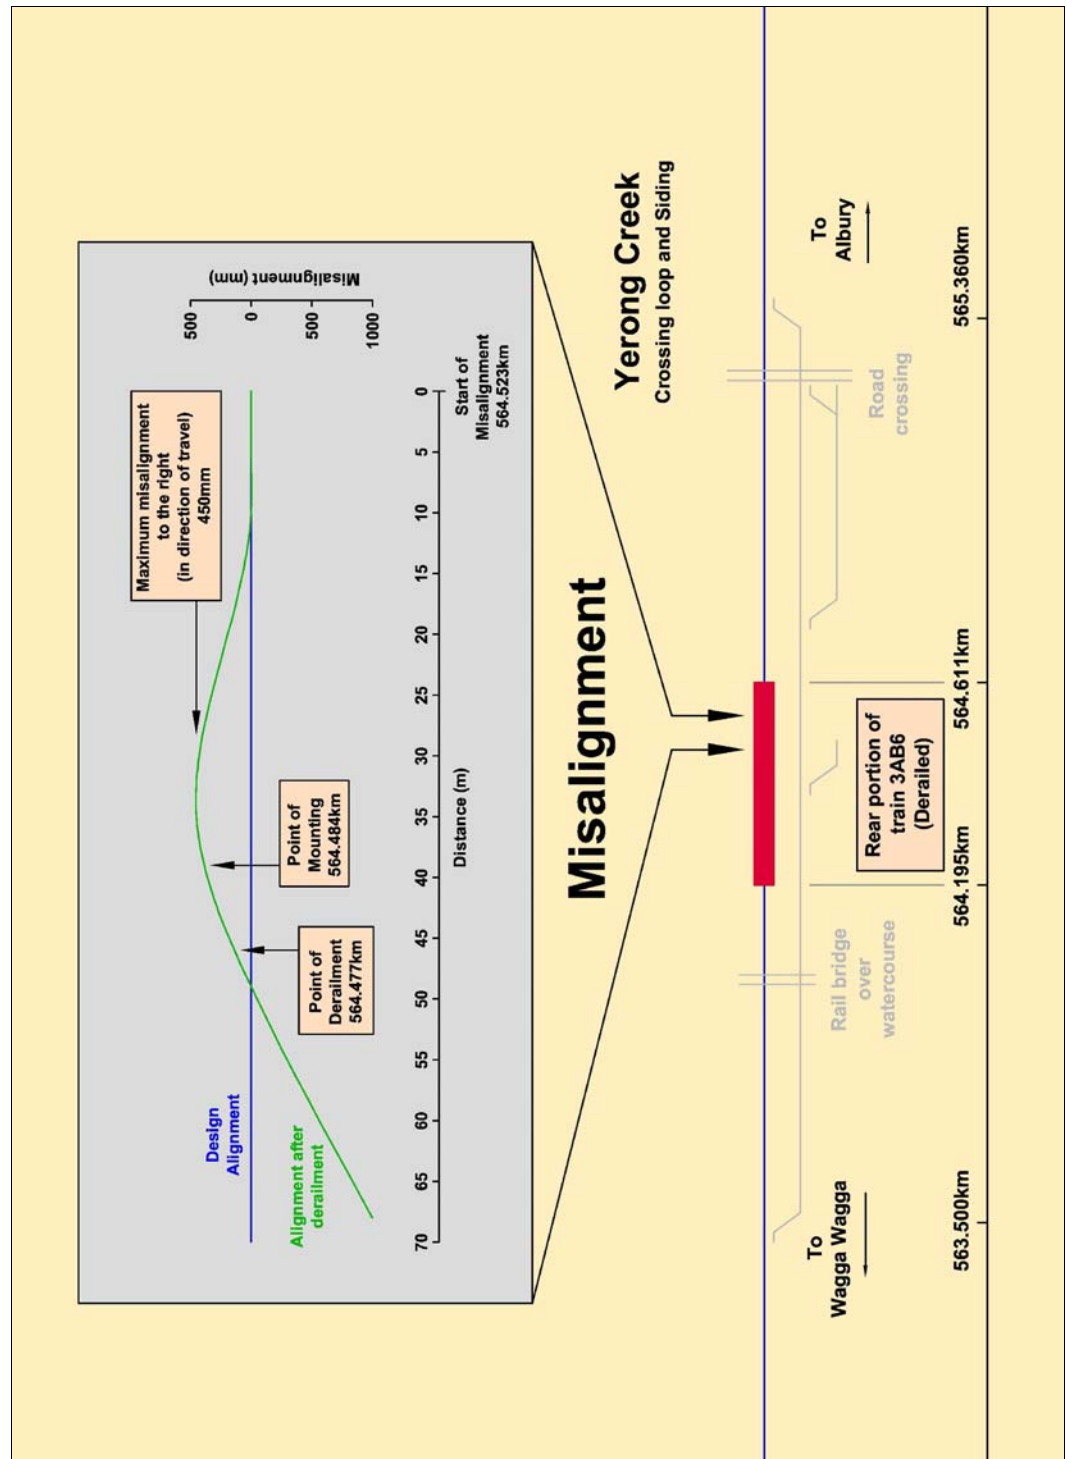
The main line was found to be misaligned for about 40 m before the point of mount. The southern 20 m of the misalignment had a maximum displacement of 30 mm to the Up side. The misalignment extended over at least 68 m and had a maximum lateral displacement of 450 mm to the Down side about four metres before the point of mount. To the north of the point of derailment the track was badly damaged and displaced by train wreckage.

Figure 9 depicts the location of the Up rail at the derailment site and reflects the centreline alignment of the track up until the point where gauge spreading starts to occur due to derailment damage, just after the initial point of derailment.

Figure 9: Schematic of Yerong Creek and misalignment

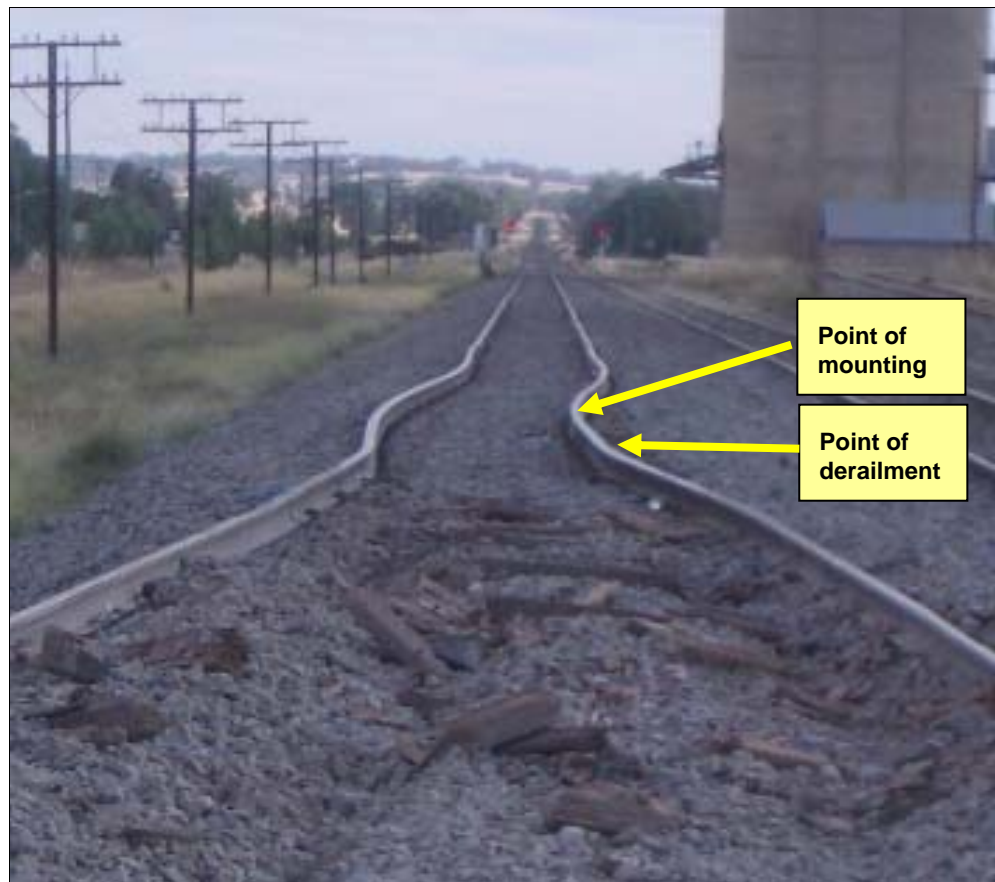
Markings observed by the ATSB investigators on the rail and sleepers indicated that a wheel had mounted the ‘up’¹⁵ rail at the 564.484 km mark and derailed to the six foot¹⁶ (left) side of the rail seven metres further along at the 564.477 km mark. These markings were consistent with a derailment on a developing misalignment; where a combination of marginal track geometry and in-train forces results in wheels derailing. For example, differences in individual wheel loads due to minor uneven distribution of the wagon load, as they pass the developing misalignment can derail a wheel or wheels.

Figure 10: Location of initial point of derailment, looking towards Melbourne

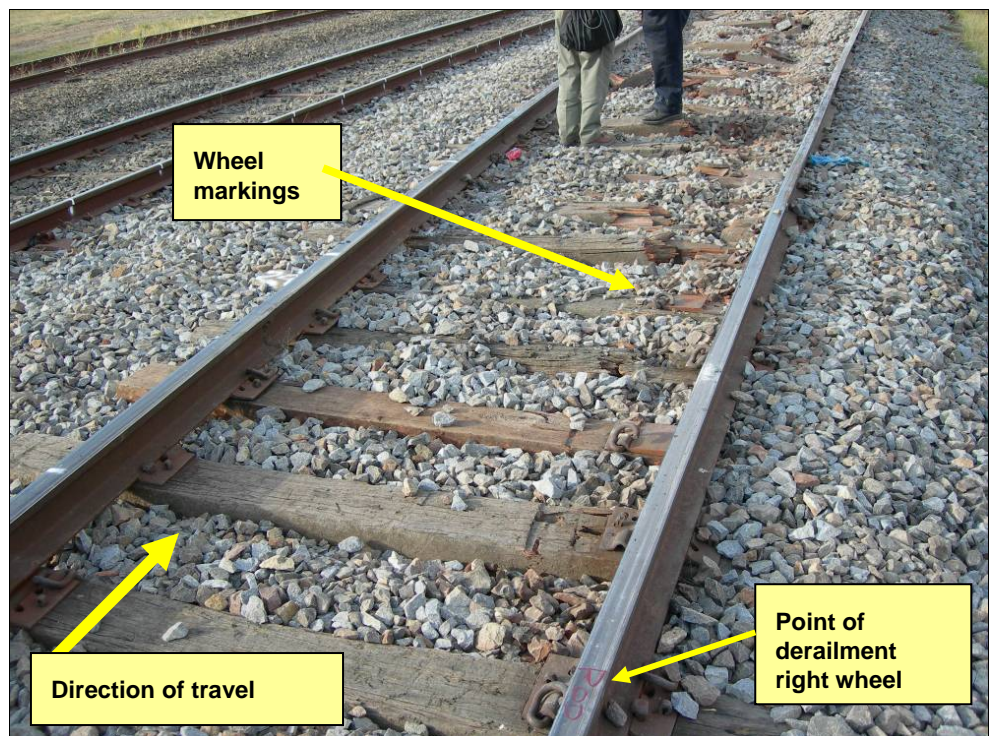
After the first wheels derailed to the six foot side of the Up rail, the corresponding right-hand wheels on those axles derailed to the inside of the ‘Down’¹⁸ rail, damaging sleepers in the four foot. As the derailment sequence escalated, fastenings were dislodged and sleepers were broken. The track structure was weakened to the

Figure 11: Vicinity of Down rail point of derailment, after removal of last wagon

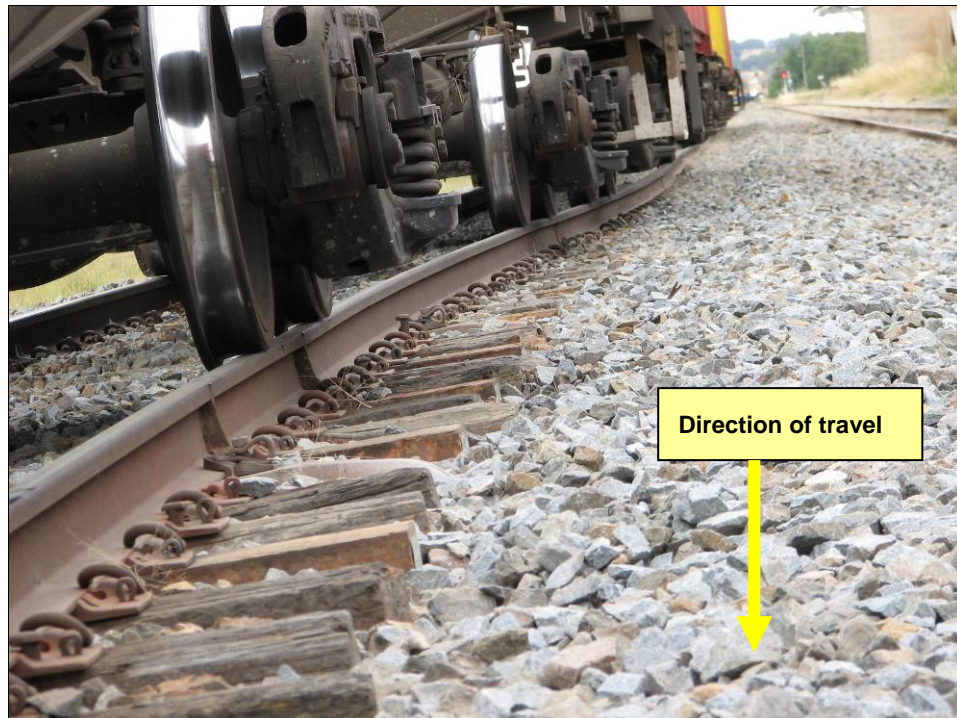
Figure 12: Misaligned track under last wagon of the derailed portion RRY 23

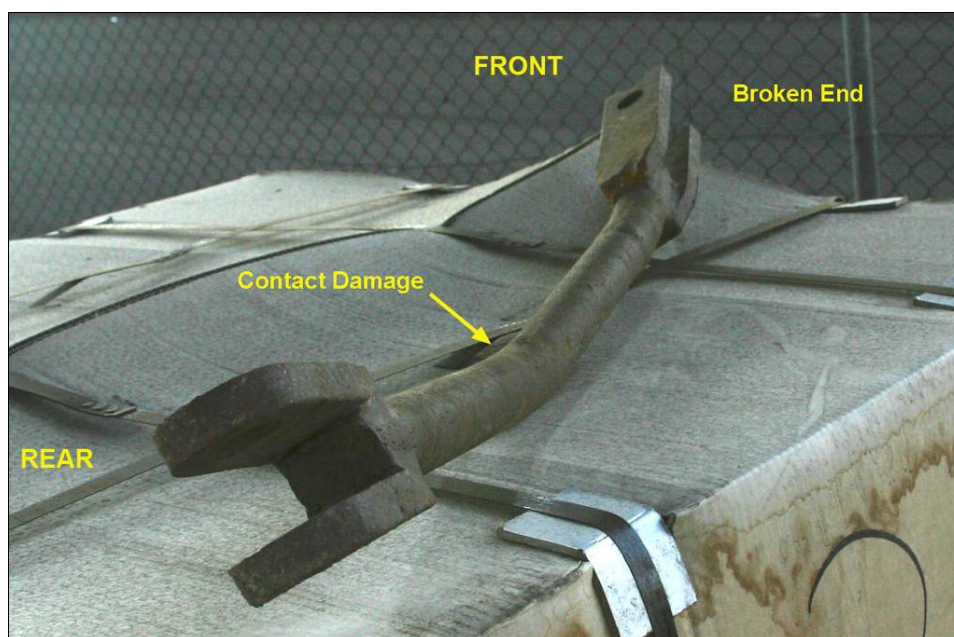
The examination also revealed that the compression rod had broken cleanly through the forward facing clevis. A significant bend in the rod was observed approximately 500 mm from the pin hole of the rear clevis. Close examination of the bend at the inner radius revealed a surface depression associated with a series of minor gouges from sliding-type contact present on the rod surface. The damage was observed to extend for approximately 50 mm.

Figure 14: Rear end of the compression rod showing an obvious bend

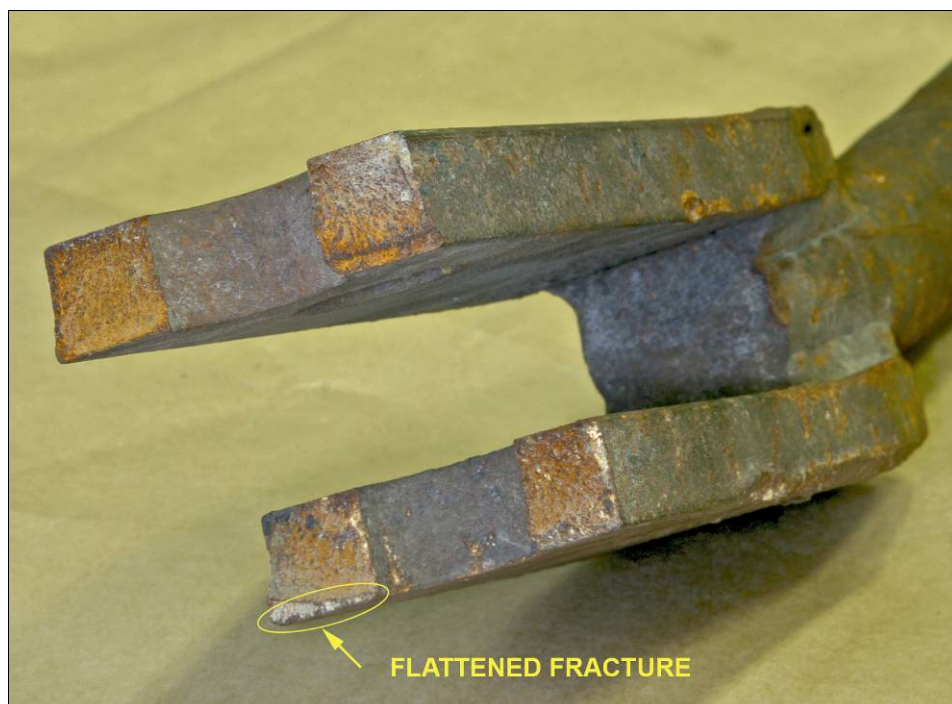
The examination also revealed clear and well defined scoring on one of the fractured clevis arms and one edge of the arm had been chamfered from impact damage. The general appearance of the surface damage indicated that at some time the clevis arm had made significant heavy contact with another metallic object or solid surface.

Figure 15: End view of the fractured surfaces of the compression rod

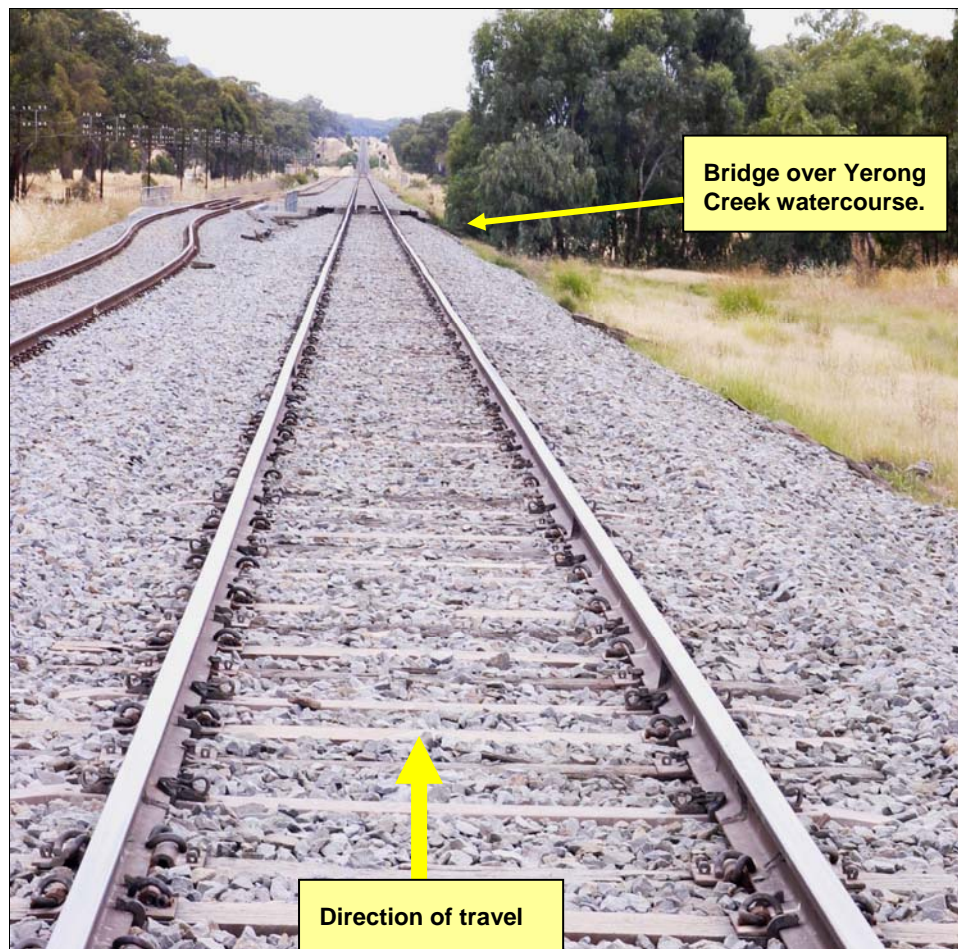
Figure 17: Lowest point at Yerong Creek station, to the north of misalignment

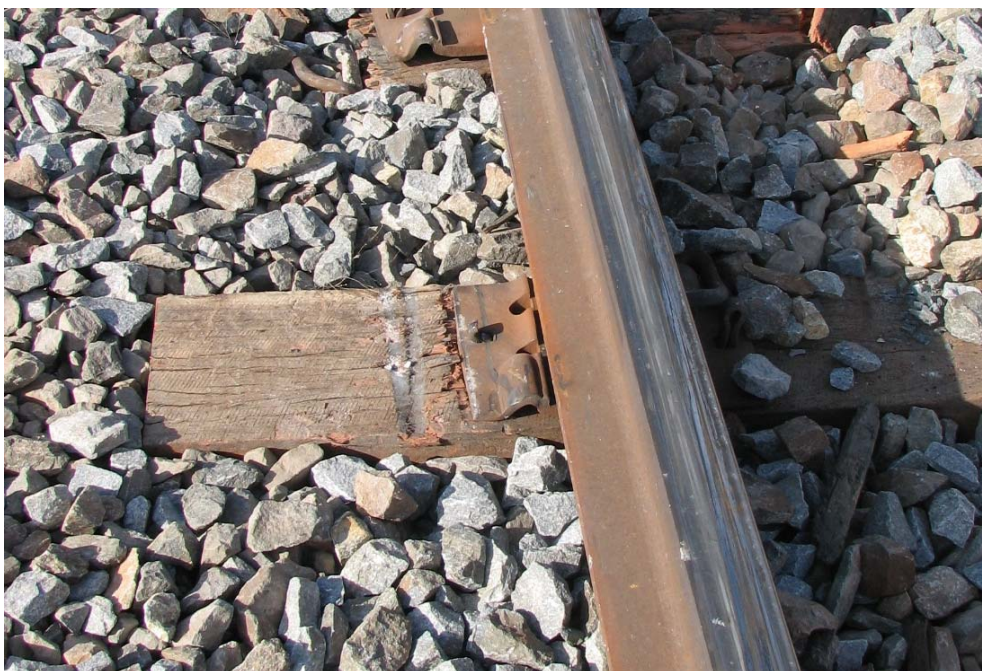
Figure 18: Marked sleeper referred to in ARTC submission

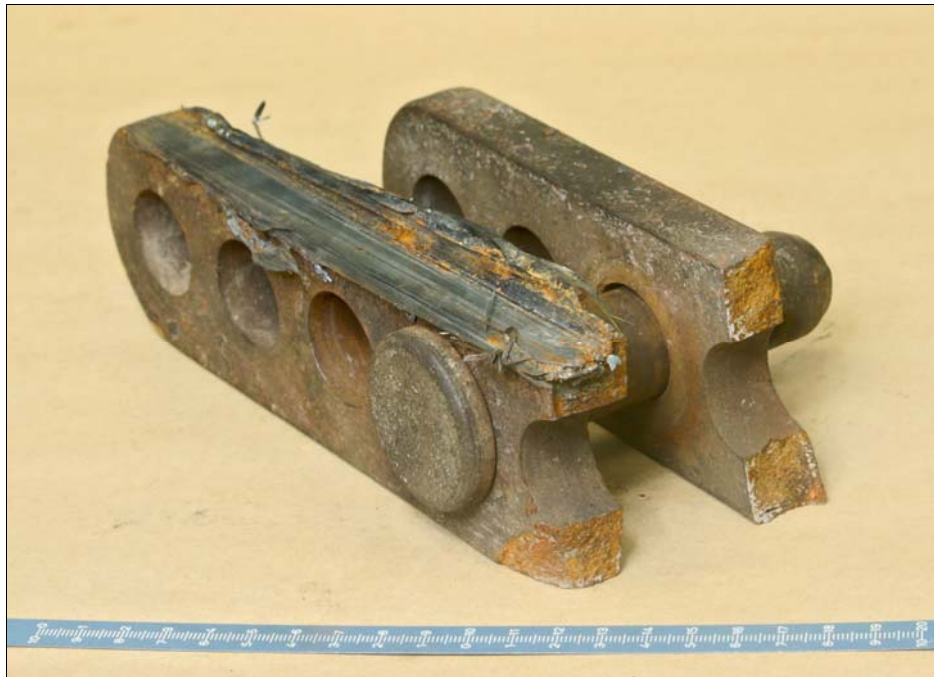
Figure A: General view of the broken end section from the compression rod as received by ATSB

A notable feature on the lower edge of one the clevis pieces, was the presence of mechanical damage that had been produced from severe metal-to-metal contact. Machining and material loss were clearly apparent on the lower surface, see Figure B. Through-thickness measurements indicated that approximately 4 mm of steel had been removed at this location. The fracture surface adjacent to the wear damage was discoloured from the heat generated during the contact event.

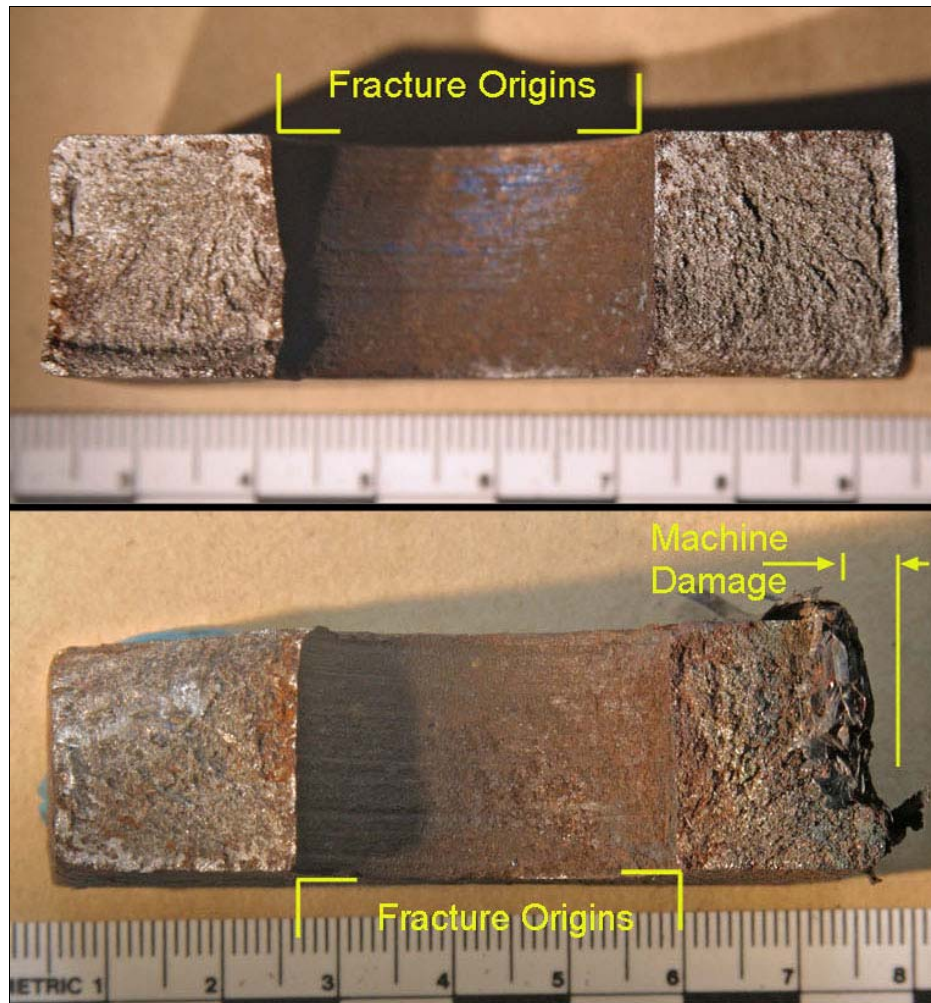
Figure B: View of the fracture surfaces from each half of the compression rod clevis. The fracture origins and machine-damaged area is labelled

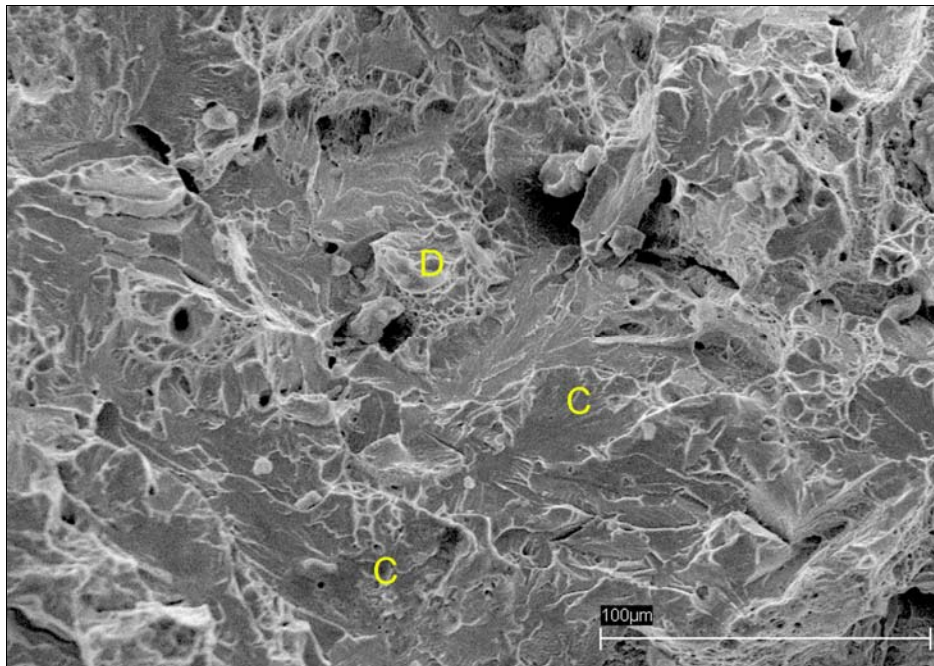
Examination of all four fractures of the broken compression rod was performed at high magnification using the SEM. The fracture examination revealed the presence of brittle cleavage facets over most surfaces, refer Figure C. Small patches of ductile overload were also observed as well as an intergranular region associated with the surface hardened outer layer of steel.

Figure C: The component broke in a brittle manner with mainly flat cleavage facets, labelled 'C', present on the fracture. Some regions of ductile overload were also observed, labelled 'D'

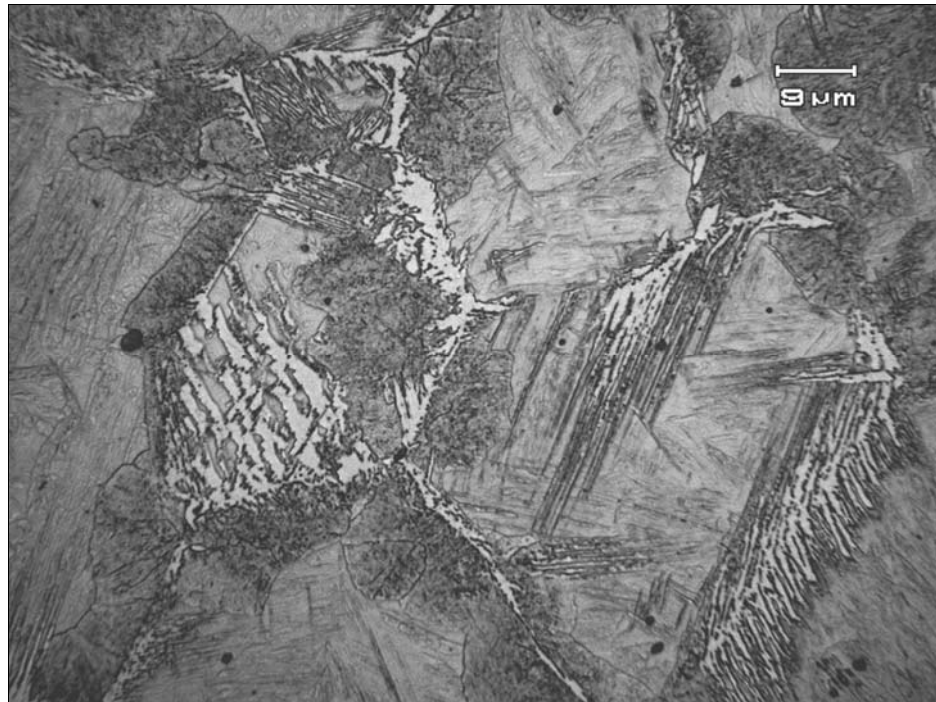
A microstructure different to the core was observed to extend from the outer surface of the component and then inward for approximately 1 mm. The micro-features indicated that it had probably been case-carburized during manufacture. This type of heat treatment is typically used to improve surface properties such as hardness and wear resistance.

Figure D: The compression rod microstructure was comprised mainly of ferrite and upper-bainite

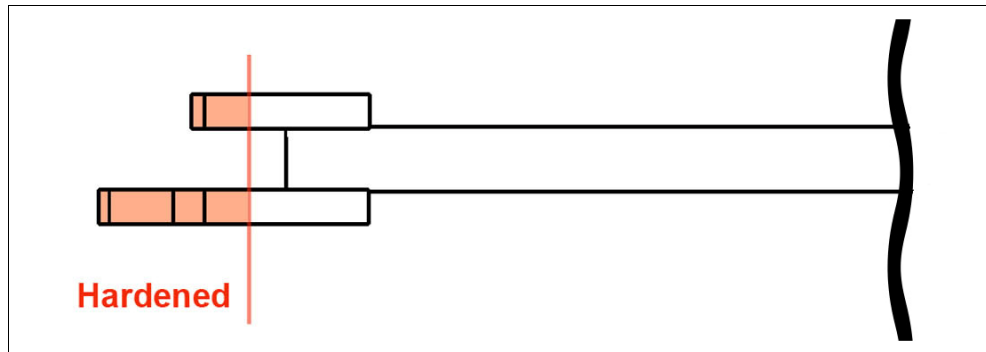
Hardness HV ₃₀	Distance from Surface (mm)	
887	0.0	Surface
763	0.4	
575	0.8	
508	1.3	
493	1.8	
481	2.3	
396	9.7	Core

Figure E: Illustration of the compression rod showing how the end of the fractured clevis section had been case-hardened with respect to the rest of the rod
