ATSB TRANSPORT SAFETY INVESTIGATION REPORT  
Marine Occurrence Investigation No. 240  
Final

Independent investigation into the collision  
between the Panamanian registered bulk carrier

# Silky Ocean

# Peter Crombie

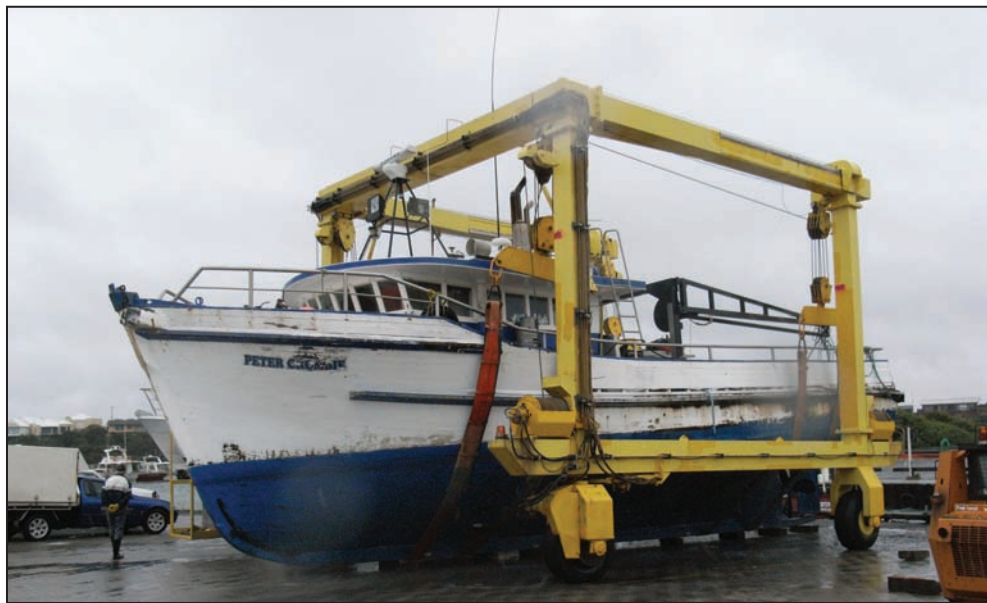
**Figure 2: *Peter Crombie* in Robe**

The vessel was built in 1977, in Ballina, New South Wales and was constructed of hardwood planks over hardwood frames. The hull and wheelhouse were painted white with blue trim and the decks had been sheathed with glass reinforced plastic.

*Peter Crombie* was possibly difficult to detect, either visually or by radar, because of the vessel's timber construction, paint scheme, lack of a radar reflector and the prevailing weather conditions.

The Australian Transport Safety Bureau advises that fishing vessel owners, operators and skippers should consider the safety implications of this safety issue and to take action where it is considered appropriate.

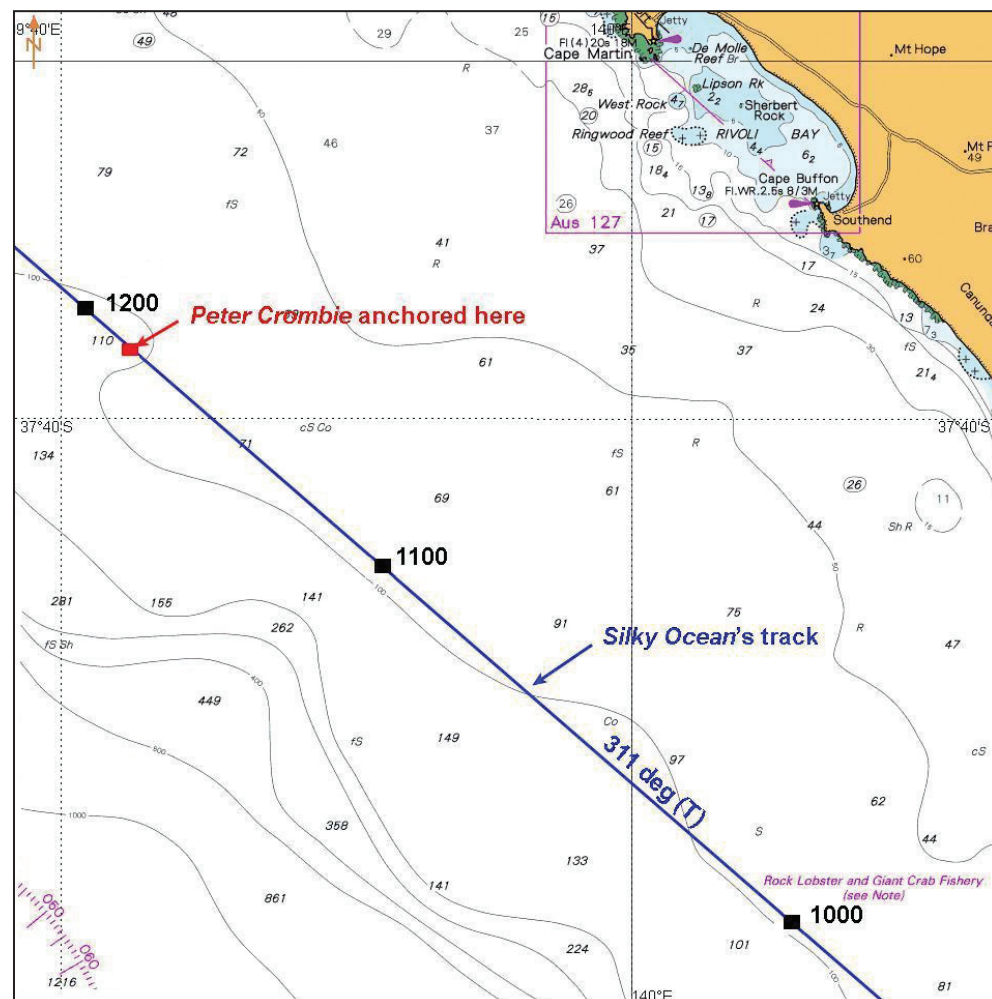
**Figure 4: Section of navigational chart Aus 348**

Neither the master nor the second mate appropriately considered all of the warnings noted on the charts, or in the Australia Pilot, when they planned for an intended track that would see the ship passing only eight miles to seaward of Cape Banks

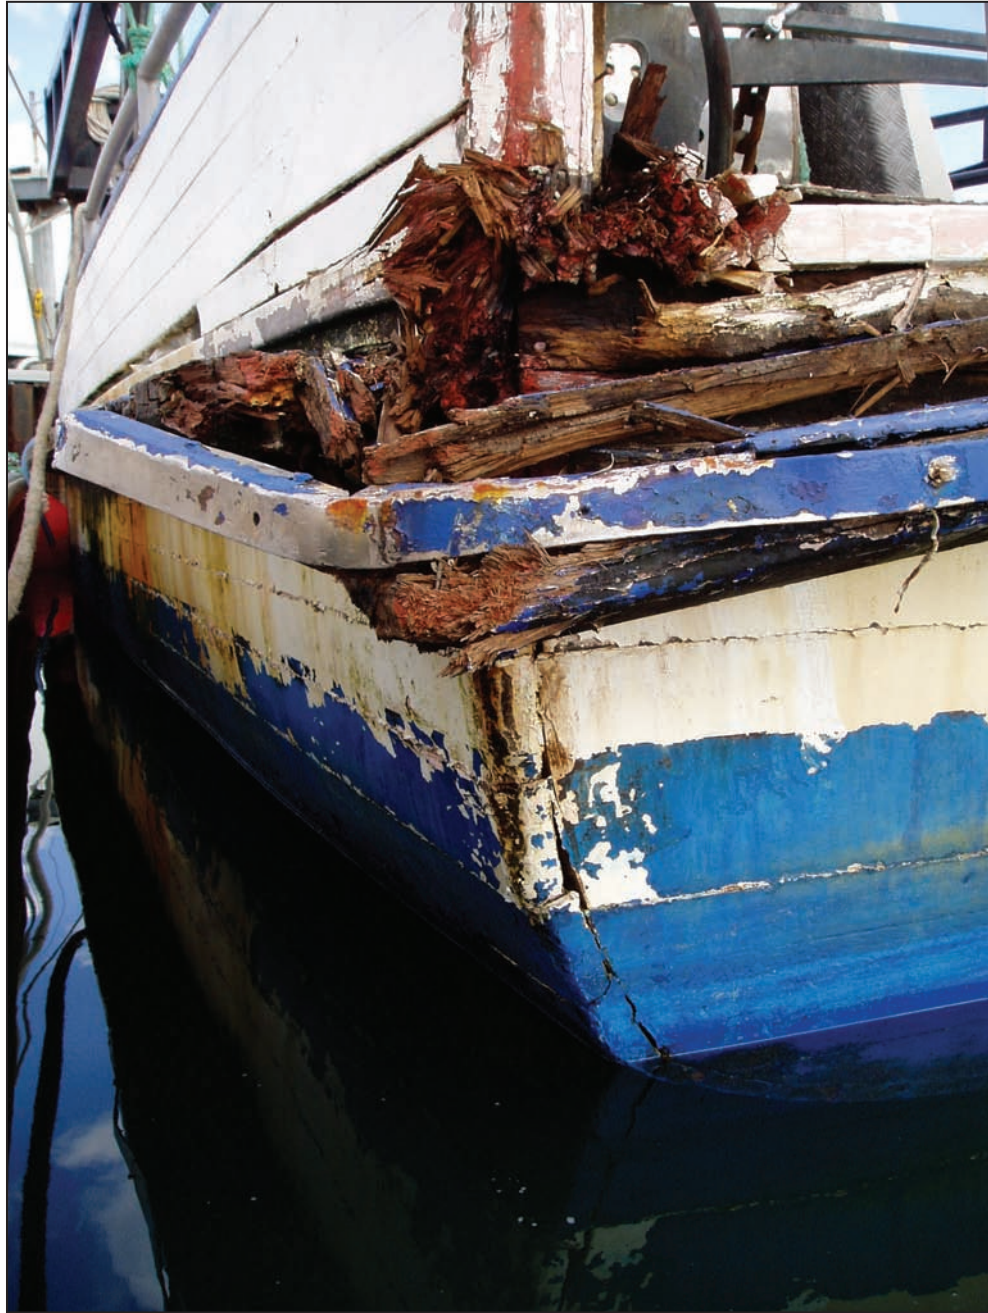
Figure 5: *Peter Crombie's* damaged port quarter

While *Silky Ocean* sustained no damage as a result of the collision, *Peter Crombie*'s hull had been severely damaged and the vessel was taking on water. Fortunately, the fishing vessel's bilge pumps were able to keep up with the ingress of water.

The skipper woke the second deckhand and together the three men began assessing the damage to their vessel. The stern had been seriously damaged (Figure 5). A number of planks had sprung and the vessel was taking on water at an alarming rate. The skipper started the fixed bilge pumps and a portable submersible pump was set up in the engine room. Together the pumps appeared to be keeping up with the ingress of water.

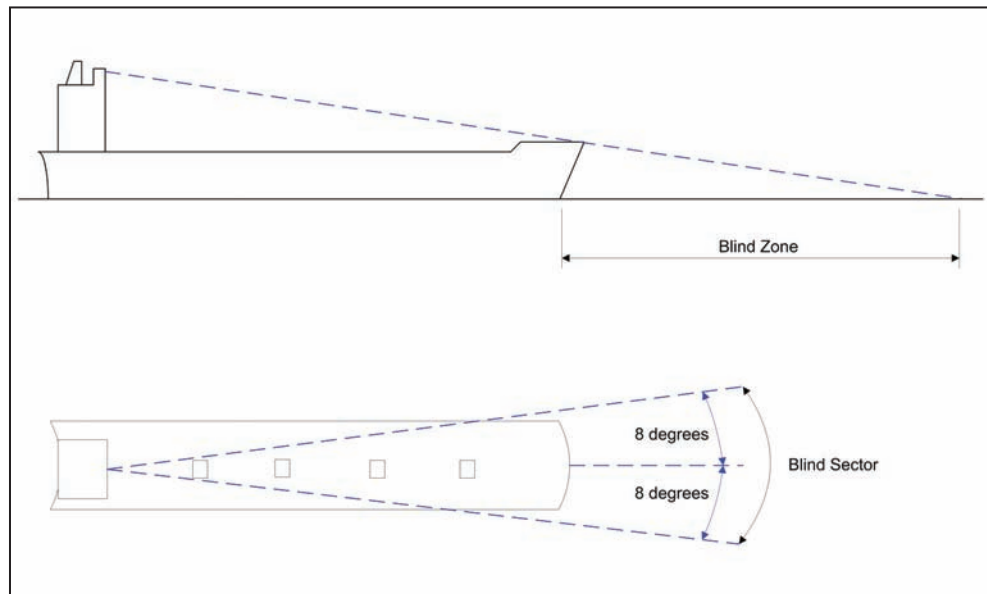
**Figure 6: Visibility diagram**

Since *Silky Ocean* was not carrying any deck cargo on 23 April, the only areas of obstruction to the bridge watchkeepers field of vision were the 'Blind Sector' (Figure 6) created by the four cargo cranes mounted on the ship's centreline and the 'Blind Zone' forward of the ship's bow.

When standing at the centre of the ship's bridge, the cargo cranes have the effect of obscuring, at most, an arc of about eight degrees on either side of ahead. It is normal practice for watchkeepers to move from side to side, across the bridge, to negate this blind sector.

*Peter Crombie* was almost directly ahead of *Silky Ocean* as the ship approached the anchored fishing vessel and the third mate stated that 'because of the glare from ahead' he had stationed himself at the radar, on the port side of the bridge. If this was the case, the ship's cargo cranes should not have obscured his view of the fishing vessel.

Allowing for *Silky Ocean*'s ballast condition on 23 April, the blind zone ahead of the ship would have extended about 175 m forward of the bow. Therefore, once *Silky Ocean* had closed to within 175 m of *Peter Crombie*, the third mate would not have been able to see the fishing vessel. It would have taken *Silky Ocean* about 23 seconds to travel 175 m.
