**ATSB TRANSPORT SAFETY INVESTIGATION REPORT**

Aviation Occurrence Report – 200606570

**Aircraft loss of control - Palmers Island, NSW**  
**2 November 2006**

**Bell Helicopter Company 206A**

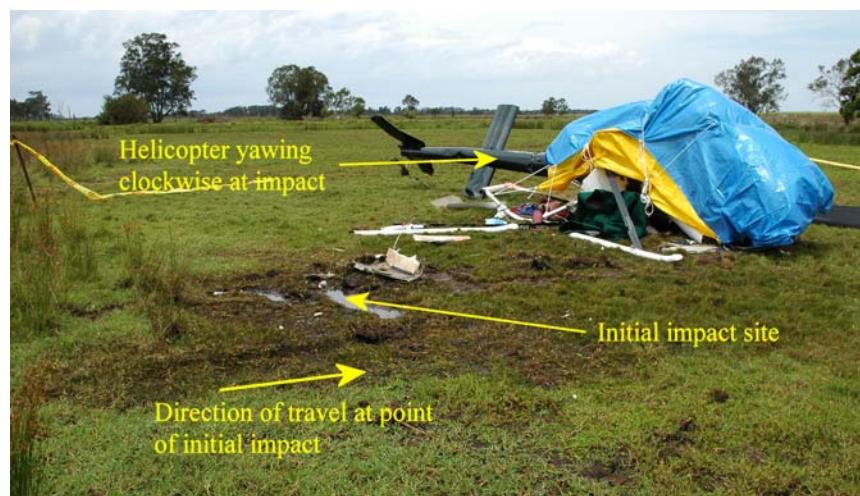
**Figure 2: Initial impact marks**

The helicopter impacted the terrain in an approximately 20 to 25 degrees nose-down attitude while banked about 10 degrees to the left, but rotating to the right (clockwise). The wreckage then bounced after impact and continued forward approximately 3.5 m, still rotating to the right, before coming to rest on its left side, about 90 degrees offset to the direction of the initial impact (Figure 2).

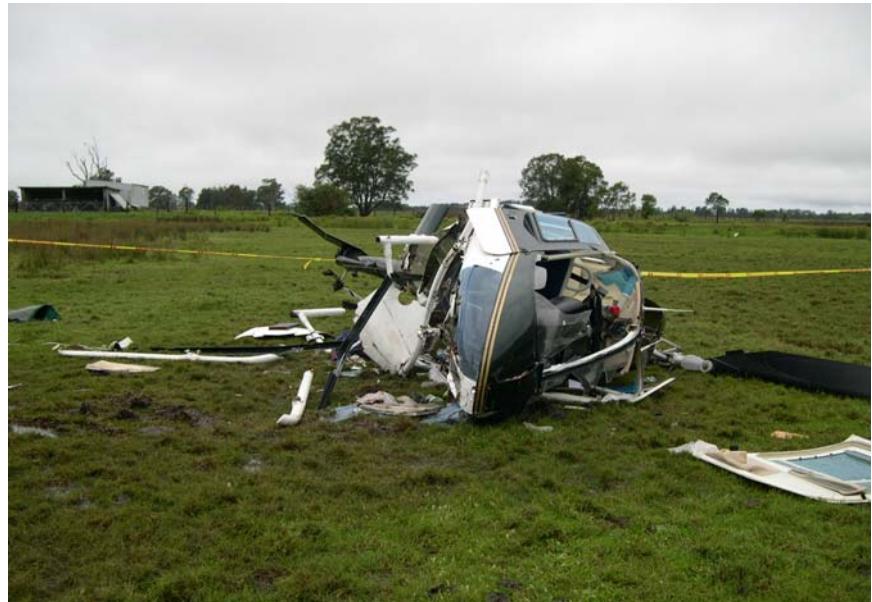
**Figure 3: Helicopter wreckage**

Impact damage to the skid landing gear and the forward left underside of the helicopter fuselage indicated high vertical impact forces. This resulted in the severing of the lower aft fuselage and damage to the fuel cell located immediately above. There was also forward (straight-line) compression damage to the tail boom which indicated that the horizontal forces were also high at impact.

Ground marks showed that a main rotor blade struck the ground after the initial fuselage impact, but before the helicopter came to rest on the left side. This contact caused the blade to separate immediately outboard of the laminated grip section. The separated blade sections showed clear evidence of impact overload and there was no evidence of fatigue cracking, corrosion or any pre-existing damage. The second main rotor blade remained attached to the rotor head. The ground impact marks for this blade showed that it came into contact with the ground along almost the full length of the blade leading edge as the helicopter was coming to rest on its side. It exhibited little impact damage.
