Piper PA31-350 Chieftain VH-MZK Spencer Gulf SA

SUPPLEMENTARY
AVIATION SAFETY INVESTIGATION REPORT
200002157-A

Piper PA31-350 Chieftan VH-MZK
Spencer Gulf SA
31 May 2000

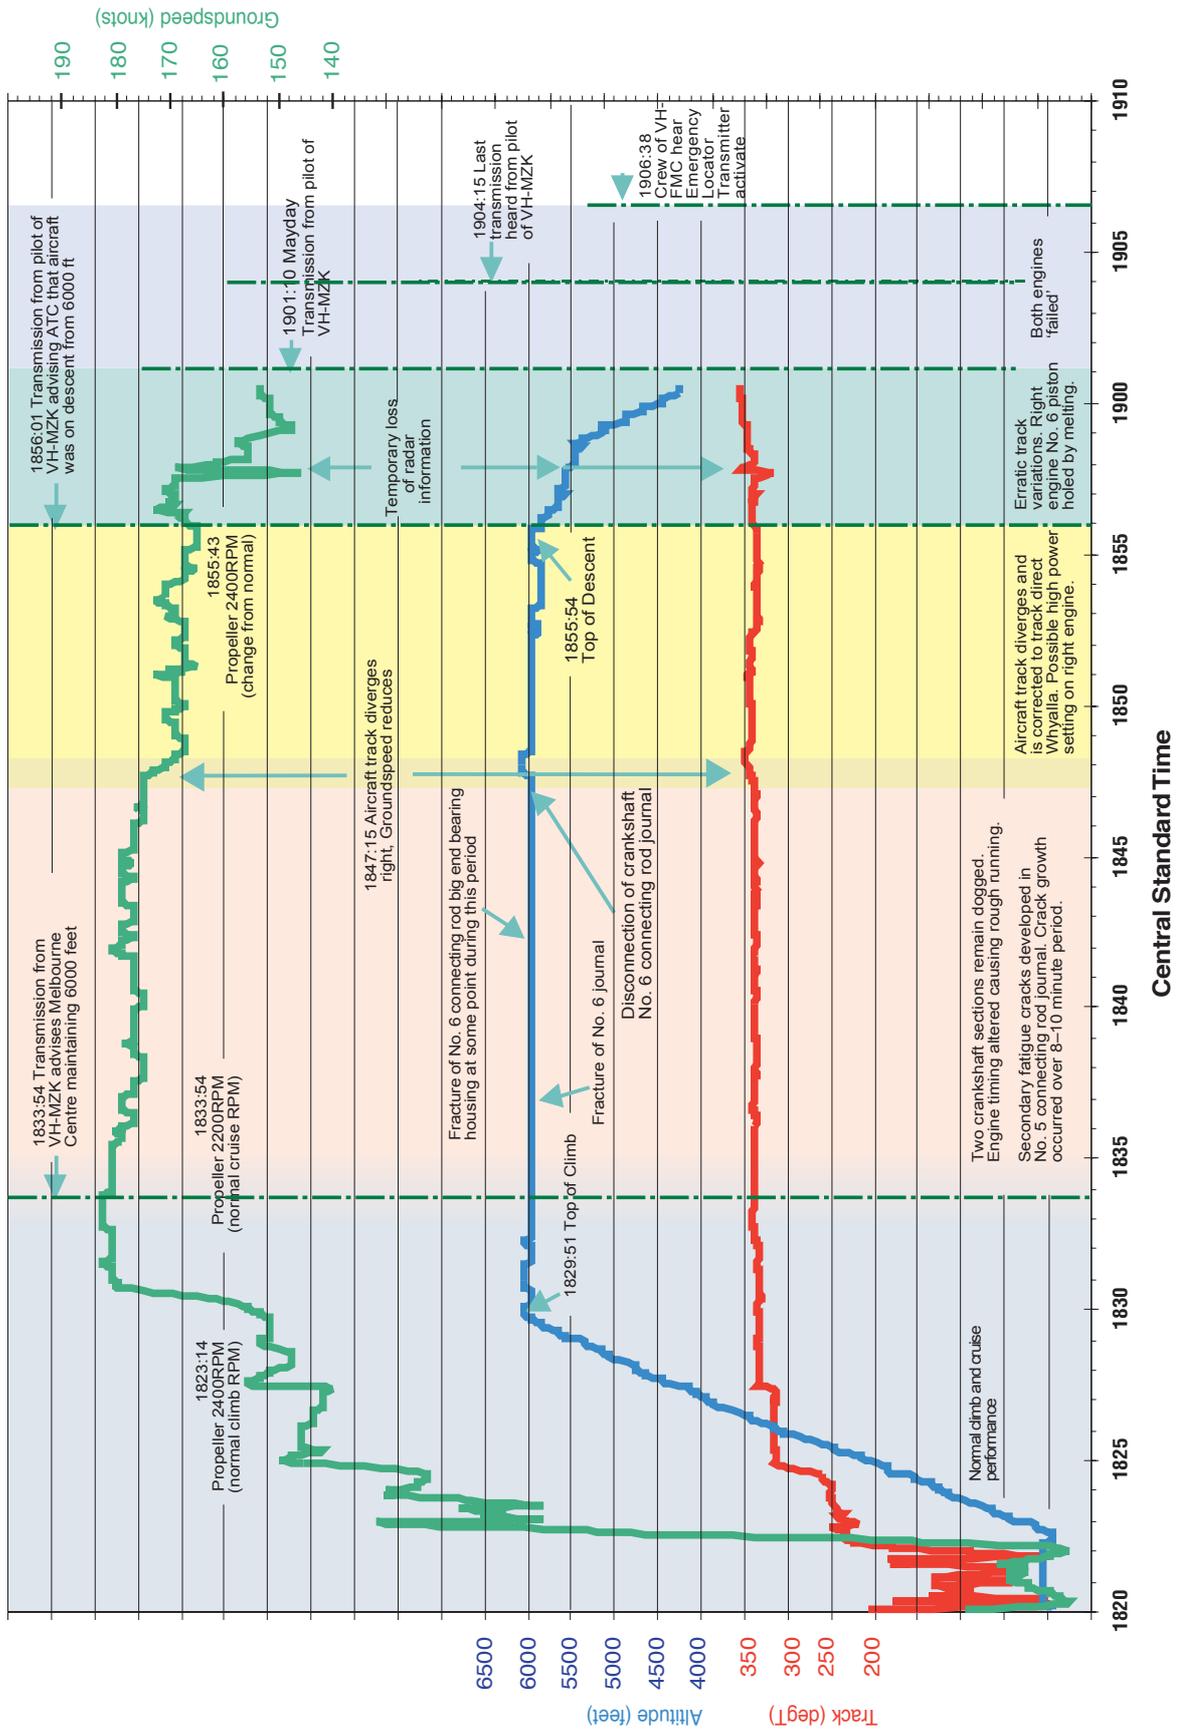
Figure 1:
VH-MZK sequence of events based on recorded radar and audio data and engine failure analysis

Copy of Fig. 53 from ATSB Report 200002157 amended to correct minor typographical errors.

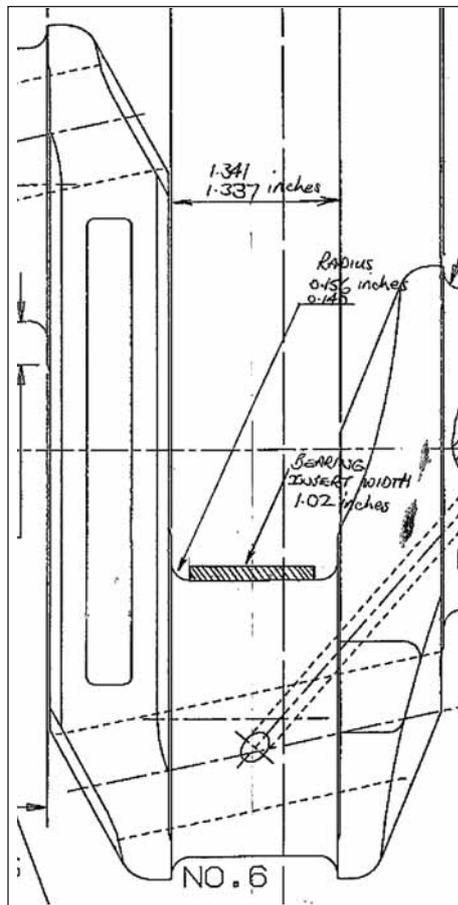
Figure 2:
Clearance between the bearing insert and the transition of the journal surface to the fillet radius

Contact between the bearing insert and the journal surface can create localised thermal strains in the journal surface causing short, axially oriented, cracks in the hardened surface of the journal.

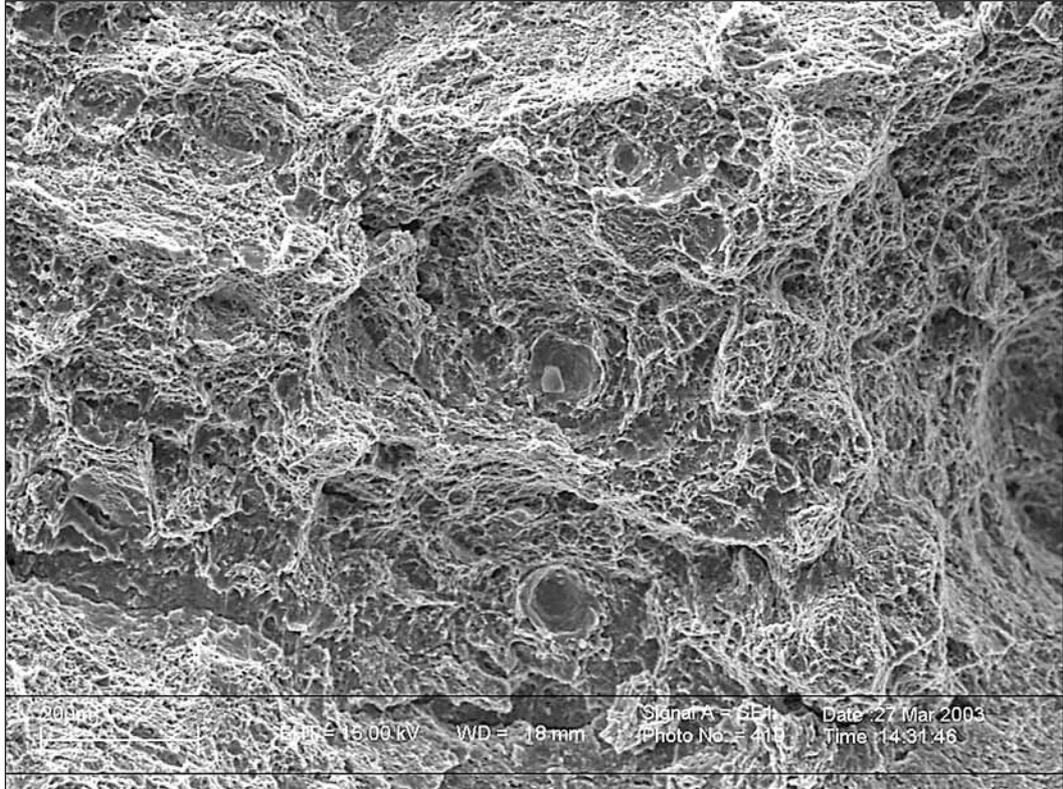
FIGURE 3:
Scanning electron micrograph showing the typical features of the fracture surface of Charpy V notch specimen PB (plane strain zone). The inclusion in the centre of the micrograph was identified as a complex sulphide. These features are typical of other ductile fractures created in crankshaft s/n V537912936

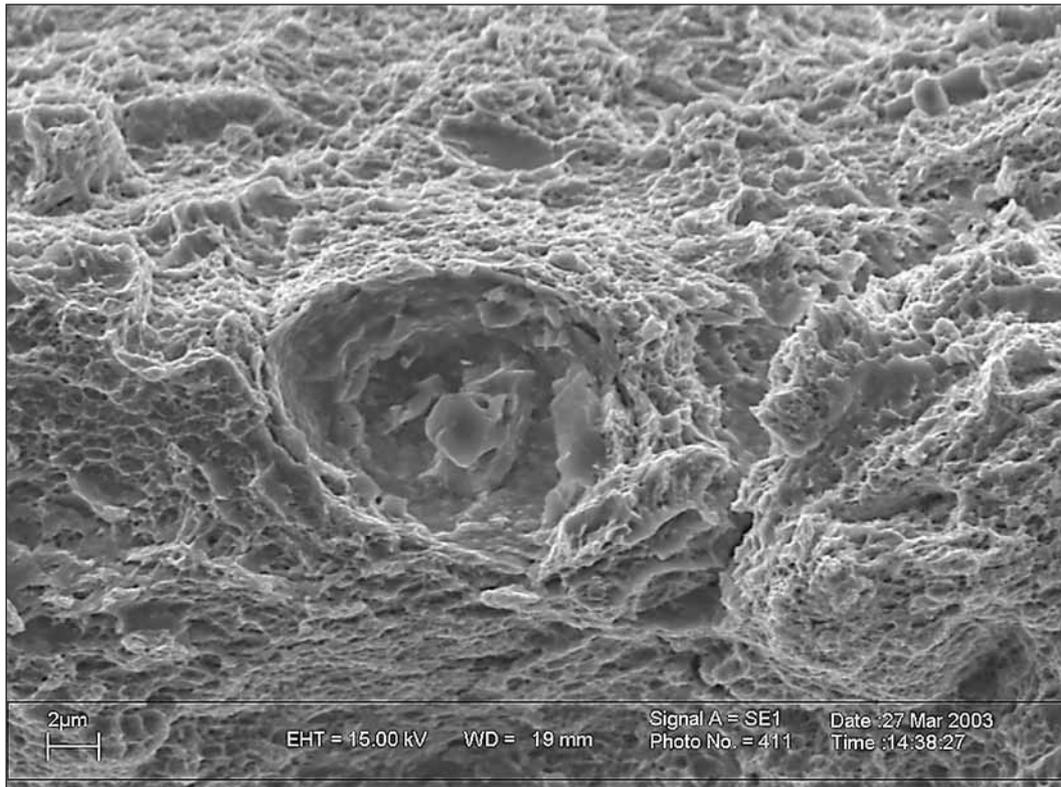
FIGURE 4:
Scanning electron micrograph showing another area of the fracture surface of specimen PB at higher magnification. Several small 'pullout' features were noted in the plane strain zone of the Charpy V notch fracture surfaces. Several of these features were examined more closely in an attempt to determine their nature

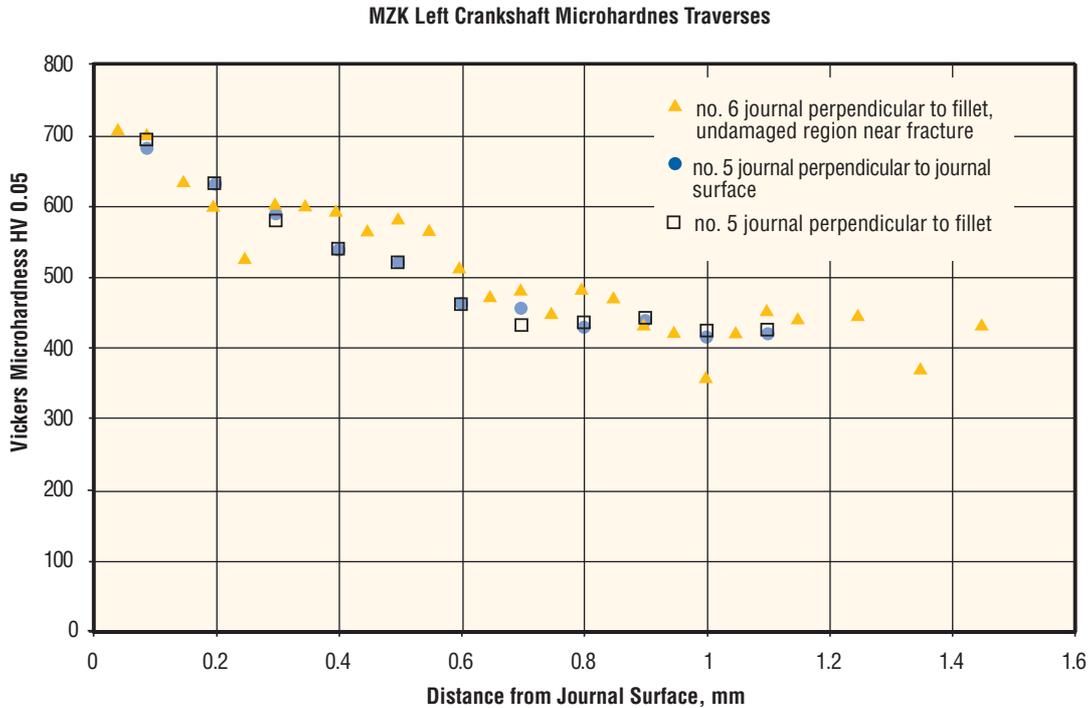
FIGURE 14:
Vickers microhardness traverses showing the extent of the influence of nitriding on journal hardness, crankshaft s/n V537912936.

The results show that the effect of nitriding extended to a depth of 0.8 mm. There is a gradual transition in hardness at the transition from the hardened case to the crankshaft core. Note: the microhardness results obtained for loads below 100 grams force are a function of load and cannot be compared with tests performed at loads greater than 1kgf¹⁷. Small loads were used to enable a closer spacing of the hardness test positions with respect to the journal surface and each other. The spacing of hardness indentations to avoid the influence of free surfaces and the effects of deformation created by adjacent indentations is an important factor in hardness testing.

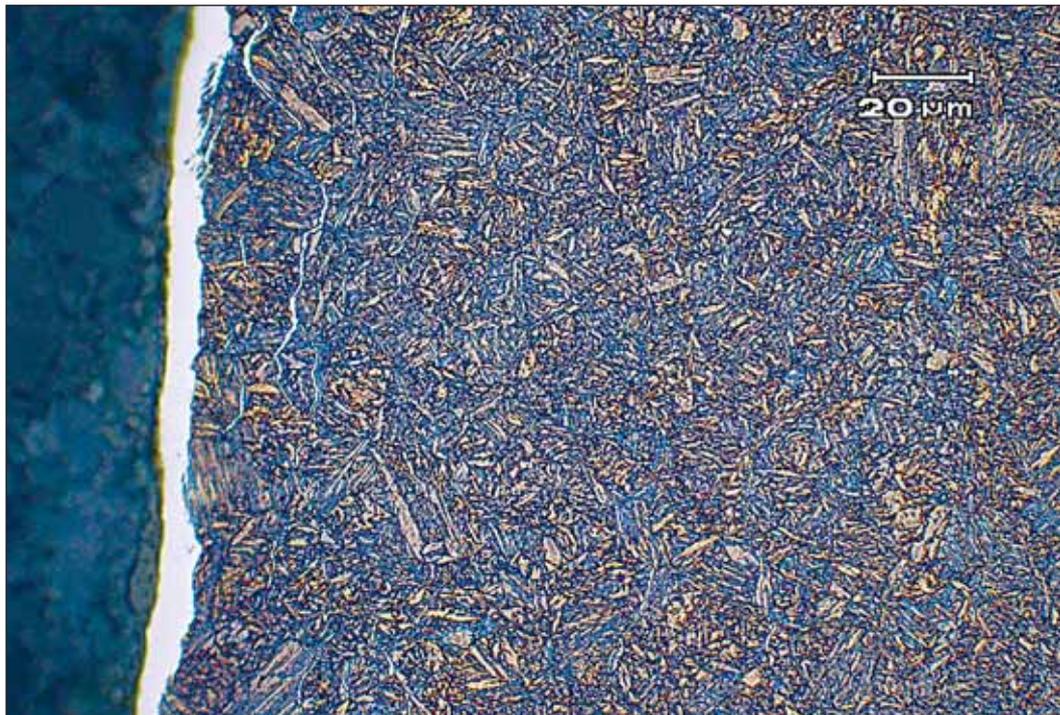
FIGURE 16:

Photomicrograph showing the case at the journal surface. The thin white etching zone at the surface is a region of iron nitride. The extent of the iron nitride zone is within the normal bounds for a crankshaft journal (metabisulphate etch)

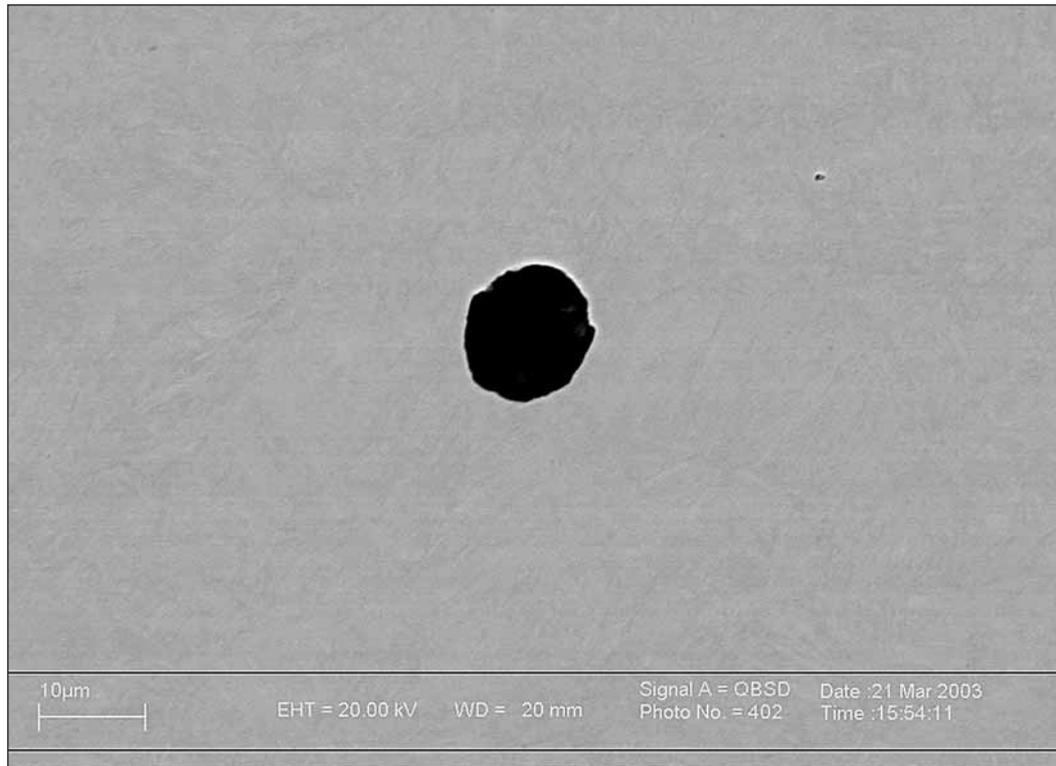
FIGURE 24:

The largest inclusion observed (maximum dimension approximately 13µm) during the current examination of a number of metallographically prepared sections from crankshaft s/n V537912936

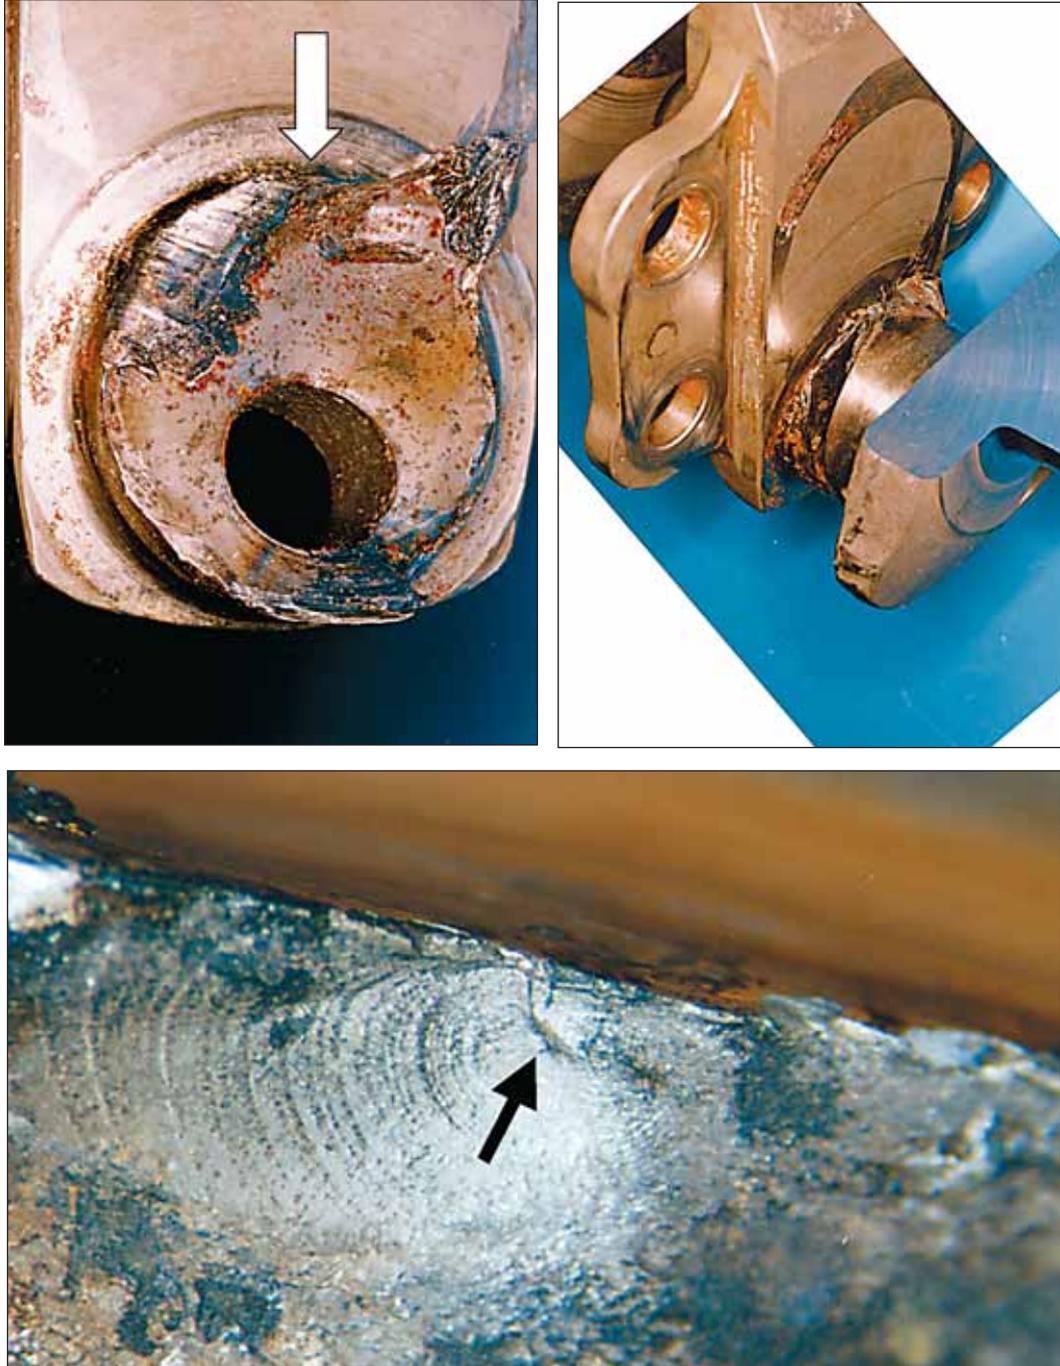
Views of the No. 6 Connecting Rod Journal, crankshaft s/n V536912936 showing the extent of damage to the crankarm (forward) side of the fracture. The location of the site of fatigue crack initiation, with respect to the crankarm, and the journal surface is arrowed

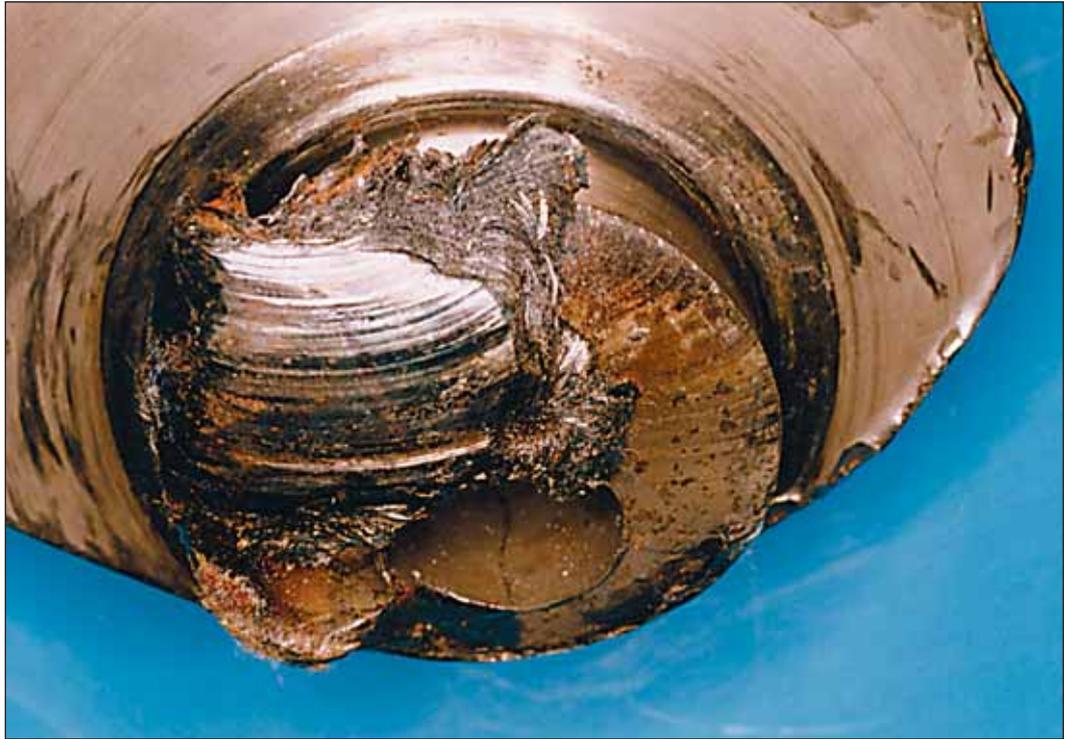
FIGURE 37:

The journal side (aft side) of the fracture, as recovered showing the extent of metal smearing over the region of the fatigue crack initiation site

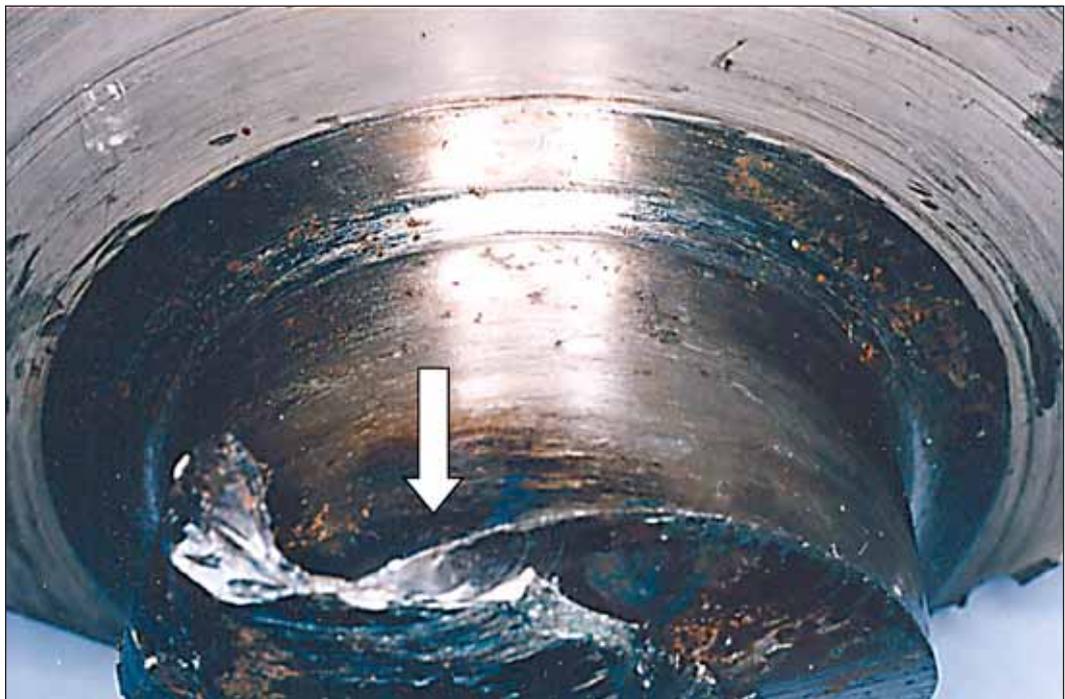
FIGURE 38:

The journal side of the fracture after a section of the smeared metal was broken away in the laboratory. The circumferential location of the fatigue initiation site is arrowed. It is clear that this region has been affected by the heat generated during the process of metal deformation and smearing

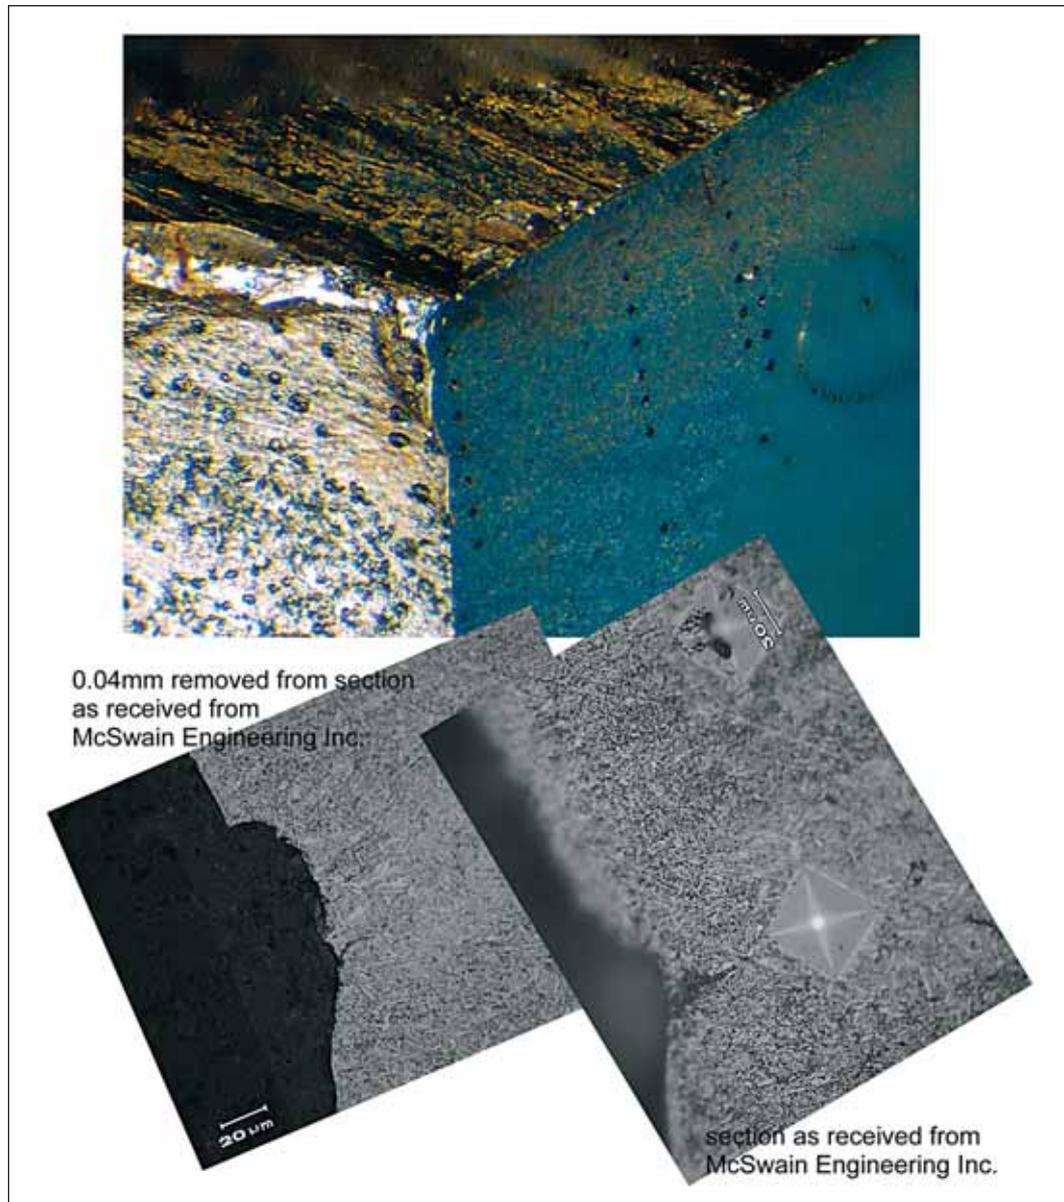
FIGURE 39:
Fatigue initiation site, crankarm side of the fracture

Note: the pitting evident on the fatigue fracture surface was created during the removal of the section by McSwain Engineering Inc.

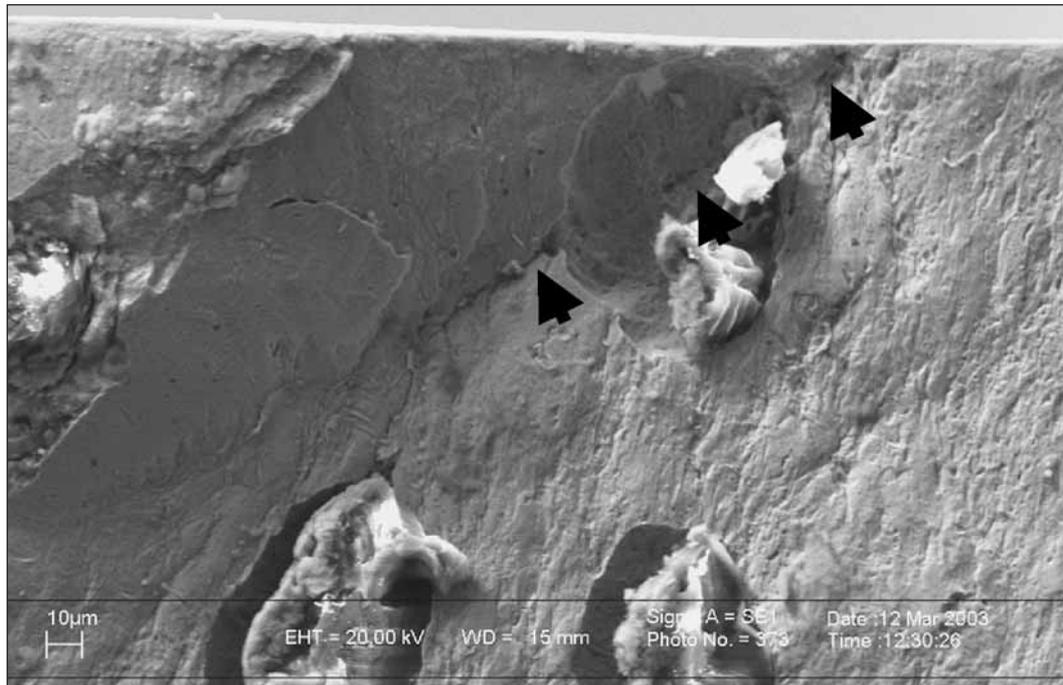
FIGURE 44:

The end of the step feature. Evidence of the cracking extending perpendicular to the plane of fatigue cracking is arrowed

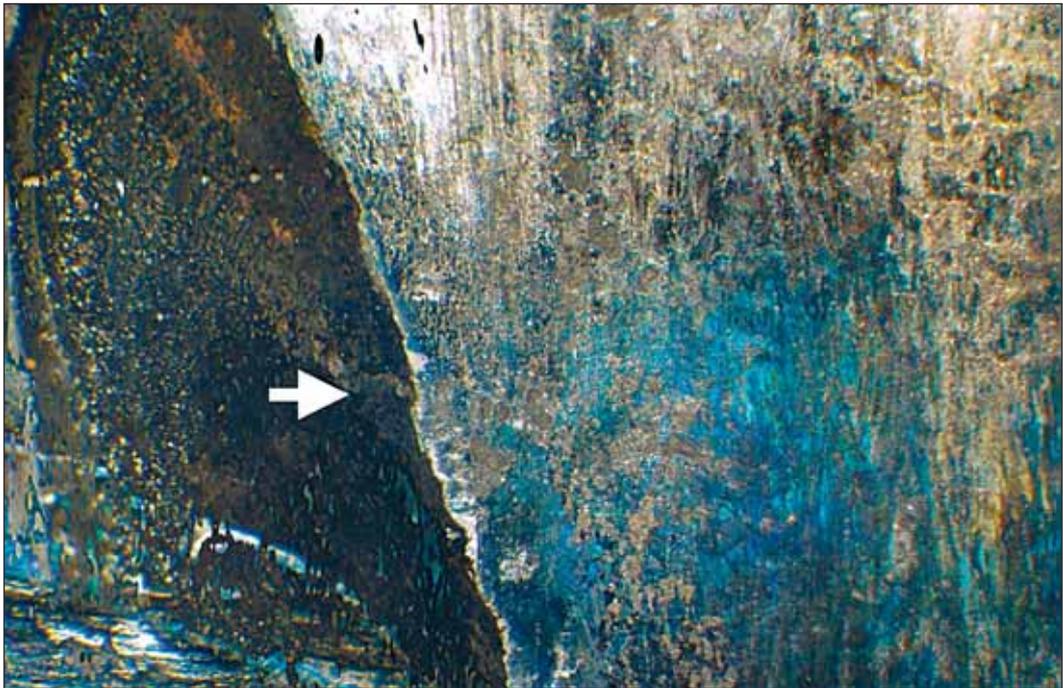
FIGURE 46:
The journal surface at the site of the step feature. The location of the step feature is arrowed

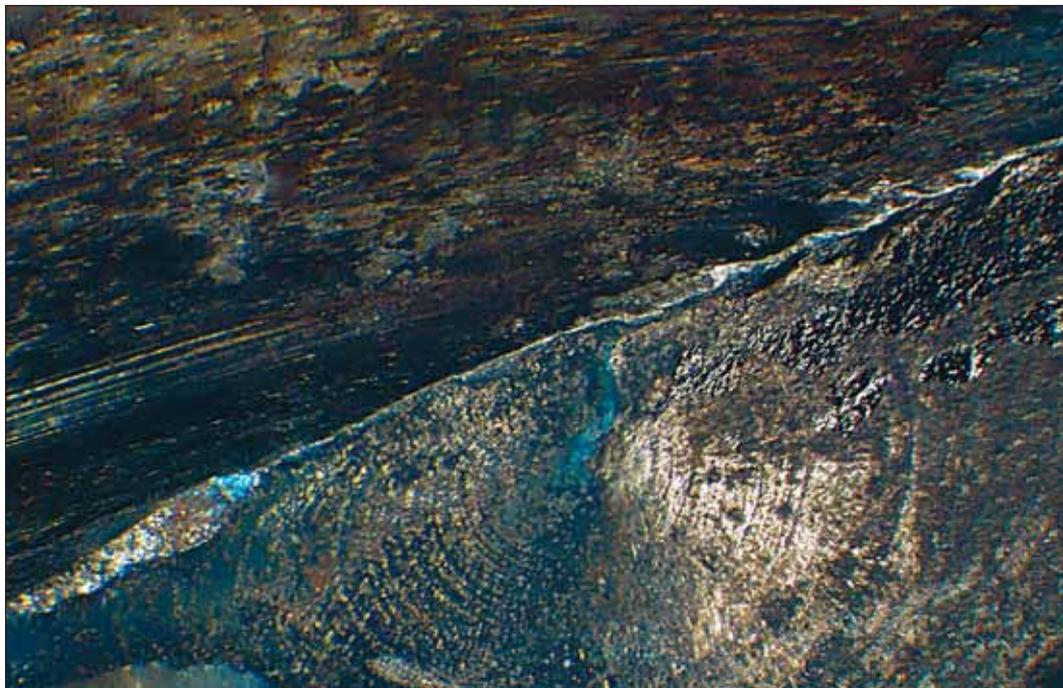
FIGURE 47:
Oblique view of the step feature, journal side of the fracture surface. The concentric fatigue progression markings on the fracture surface indicate that fatigue crack initiation occurred in the vicinity of the end of the step feature

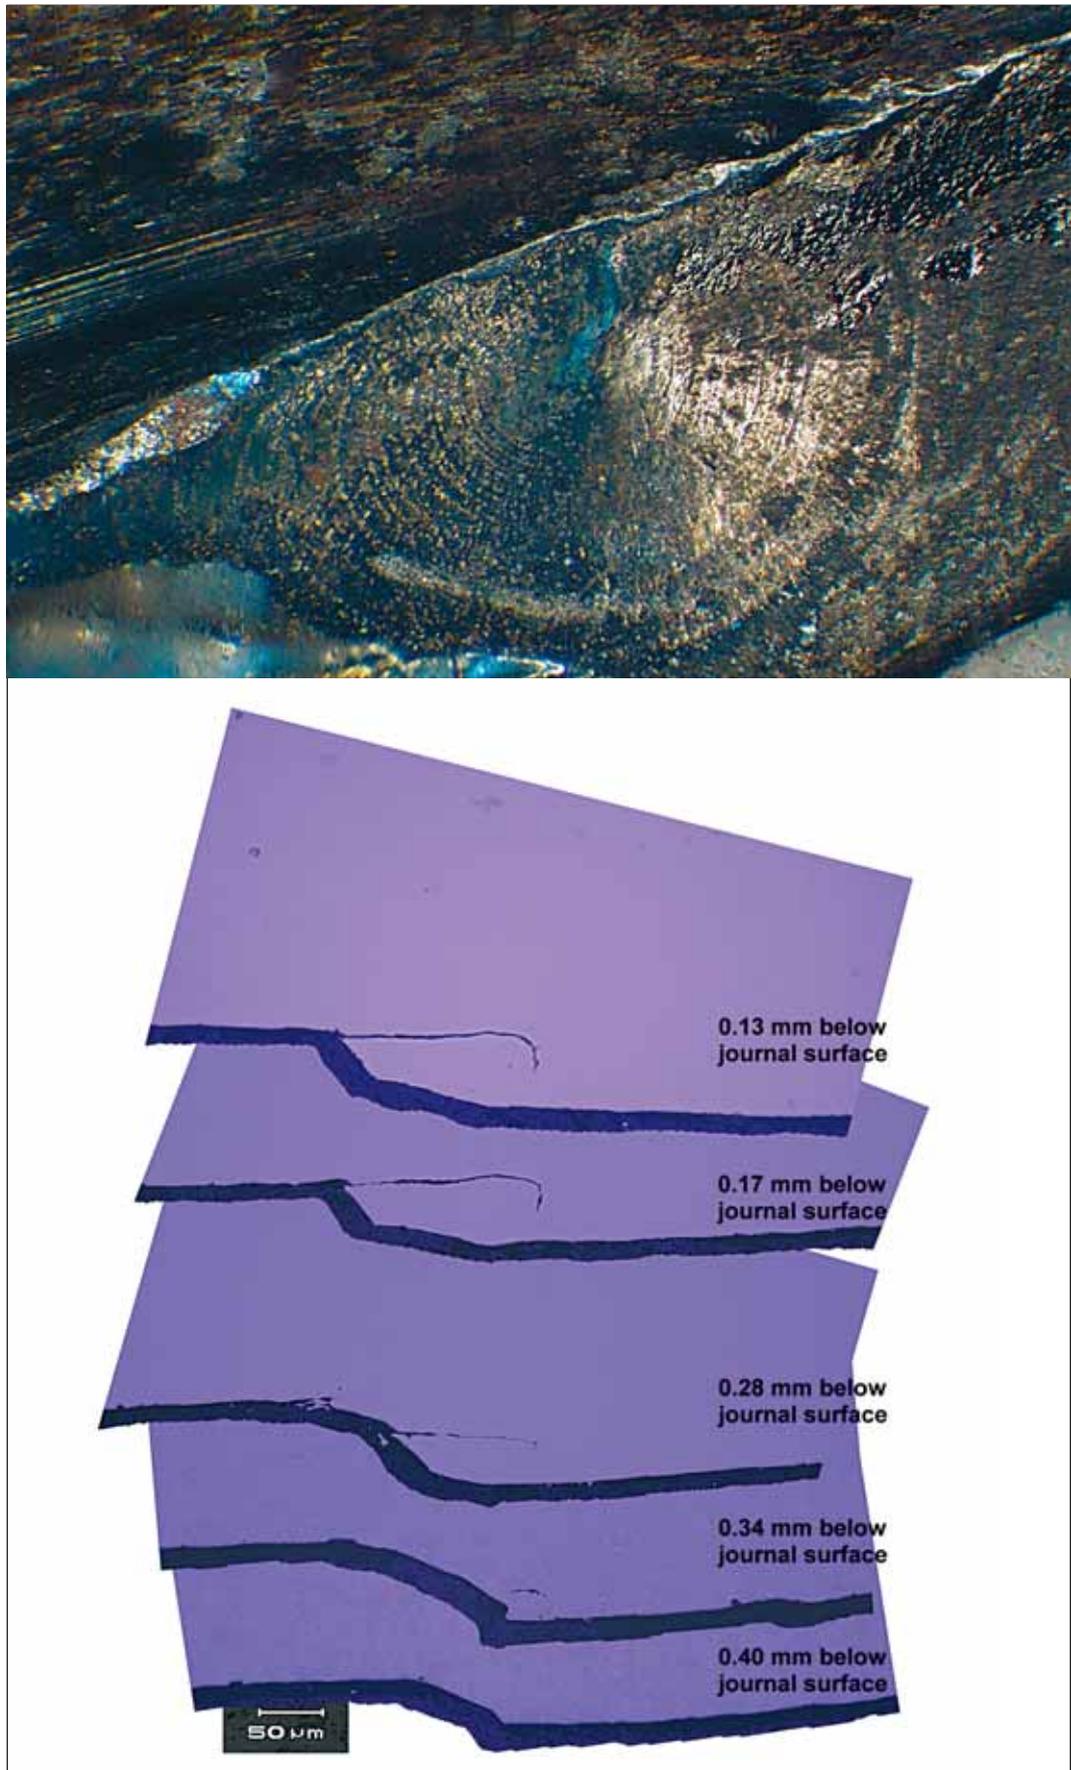
FIGURE 48:
Serial sections through the step feature showing the overall nature of the feature

It is evident from the nature of the features under the step that the feature is not a simple lap. The lack of correspondence of microstructural features across the lap, the deformation evident in the microstructure in the vicinity of the lap and the small cracks extending from the curved portion of the lap all indicate that the lap is not the result of overlapping fatigue crack growth.

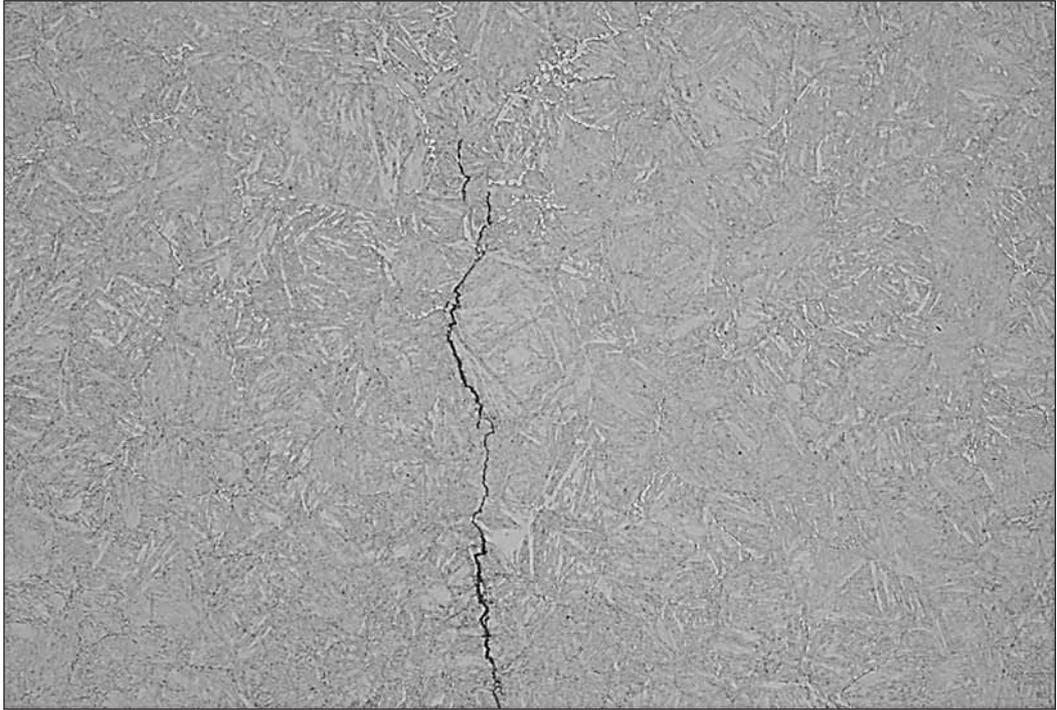
FIGURE 55:
Reflected light micrograph showing the nature of a thermal expansion crack in a nitrided surface

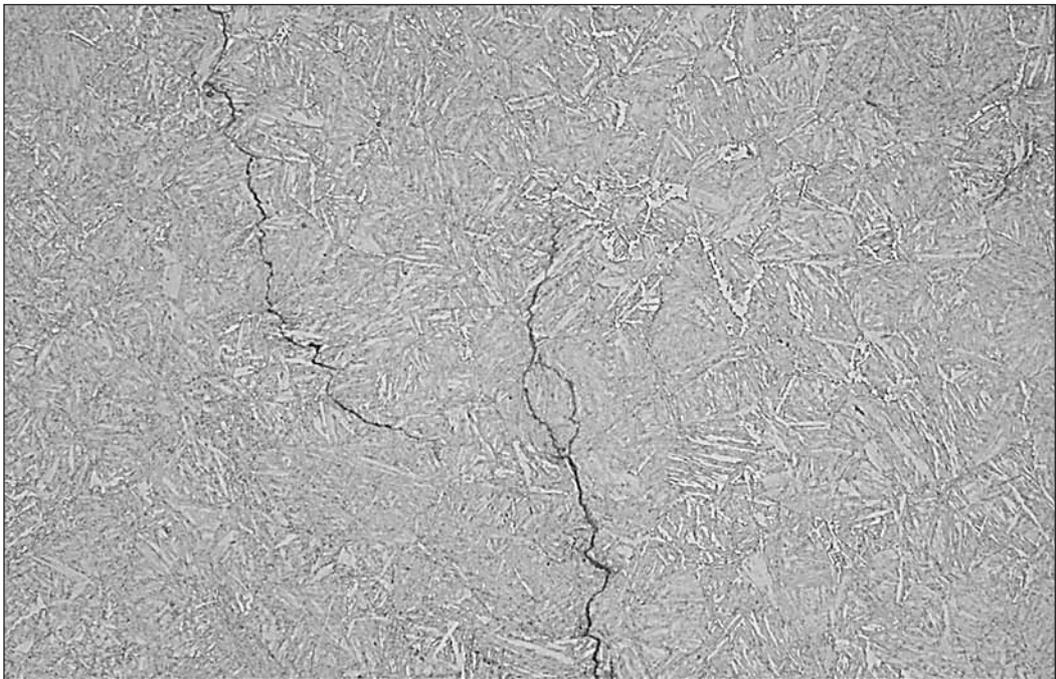
FIGURE 56:
Reflected light micrograph showing the crack path of a thermal expansion crack

Localised heating in the fillet radius of a surface hardened crankshaft journal may occur during grinding processes or during the unlubricated contact with other engine components during engine operation. The Textron Lycoming drawing notes for part number 13F27708 crankshafts state that no grinding is allowed on any connecting rod journal after nitriding.

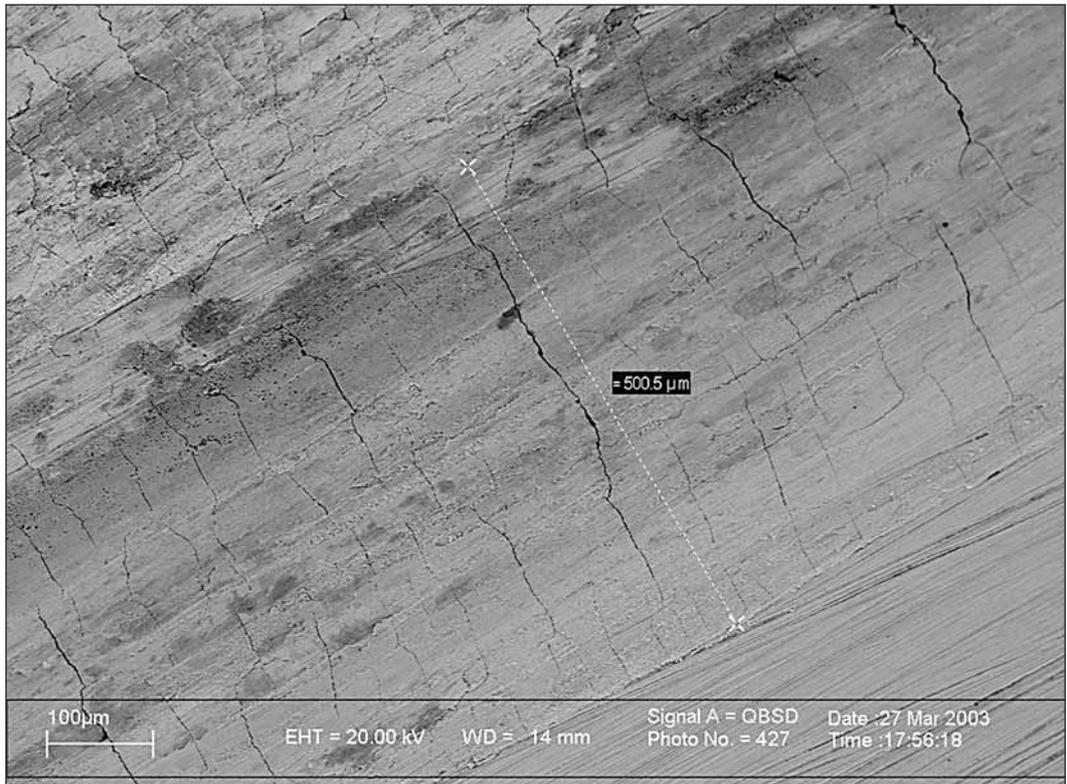
FIGURE 59:

Examination of the crankarm side fillet radius of the No. 6 connecting rod journal revealed that a small region on the outer side of the crank had not been damaged extensively by the final fracture and separation processes. Examples of thermal expansion cracks in the journal surface created by bearing surface contact were found, see figs. 58–60. Bearing contact was established by the detection of the metals used in bearing construction, aluminium and tin, in the metal smeared on the journal surface in the region of the cracks.

Scanning electron micrograph showing the maximum length of the cracks
