**ATSB TRANSPORT SAFETY INVESTIGATION REPORT**

Aviation Occurrence Report – 200506650

**AIRPROX: 9 km south of Williamtown Airport, NSW**

**18 December 2005**

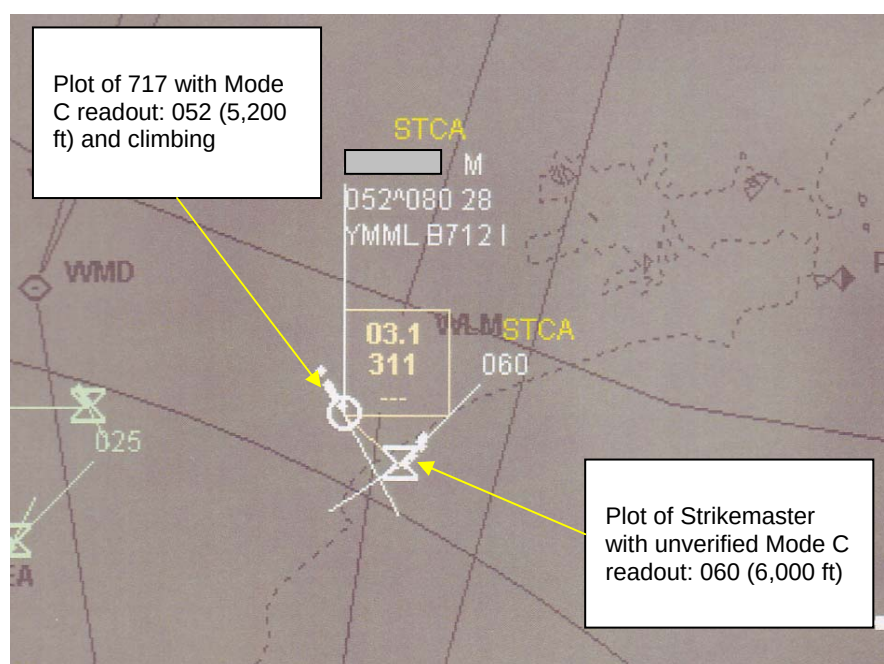
**Figure 1: Replay of recorded radar data at 0953:30<sup>9</sup>**

The sector controller was aware of the departure of the 717 as The Australian Advanced Air Traffic Control System (TAAATS) had correlated the aircraft's flight plan with the secondary surveillance radar (SSR) code assigned to the flight as that aircraft passed 2,400 ft AMSL. The controller reported to the pilot of the 717 that there was a radar return of an unidentified aircraft 3.5 NM in his eleven o'clock position<sup>7</sup> (see Figure 1) and its altitude was an unverified<sup>8</sup> 6,000 ft AMSL. The controller also received a short term conflict alert (STCA) on the radar display indicating that the 717 and the unidentified were in potential conflict. The unidentified aircraft was operating on SSR code 1200. That code is designated for use by pilots of aircraft operating a VFR category flight in Class G airspace. About 8 seconds later, the pilot of the 717 received a TCAS RA to adjust the rate of climb of the aircraft to no greater than 2,000 feet per minute. The pilot complied with the advisory and at 0953:40 the RA ceased.

9 The orange text box lists the distance between the aircraft plots (3.1 NM) and the bearing from the unidentified aircraft to the 717 (311 degrees M).
