AVIATION SAFETY INVESTIGATION  
200105618

**Beech Aircraft Corporation C90  
VH-LQH  
Toowoomba, Qld**

**Beech Aircraft Corporation C90**  
**VH-LQH**  
**Toowoomba, Qld**  
**27 November 2001**

June 2004

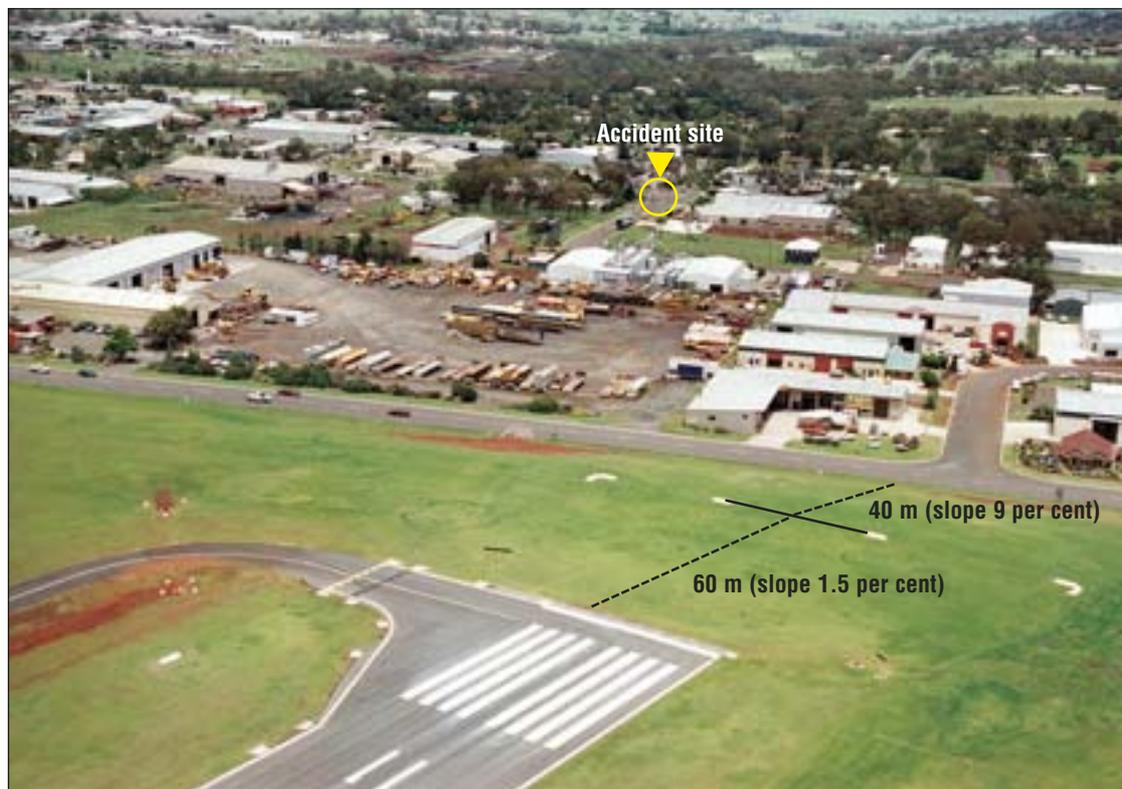
**FIGURE 7:**  
**Aerial view of the runway 29 RESA**

about 1.5 per cent. There was about an extra 40 m of open ground between the end of the runway strip/RESA and an adjacent roadway (see Figure 7). The additional 40 m sloped down at about 9 per cent.).

The International Civil Aviation Organization (ICAO) standard for a runway strip for a code 2 runway was 60 m.<sup>22</sup> The ICAO standard for a RESA for a code 2 runway was 90 m. The ICAO standard also stated that the RESA shall extend from the end of the runway, not the actual runway. For Toowoomba aerodrome to have complied with ICAO standards, runway 29 needed a minimum of 150 m of clear area beyond the end of the runway. At the time of the accident there was about 100 m of clear area. ICAO also recommended that the RESA be 120 m, the longitudinal slope of the RESA should not exceed a downward slope of 5 per cent, and abrupt changes in slope should be avoided.

As a result of this accident, the ATSB has issued a recommendation to the aerodrome operator for it to liaise with CASA to evaluate an engineering solution to enhance aircraft deceleration in the runway end safety area of runway 11/29 at Toowoomba aerodrome.

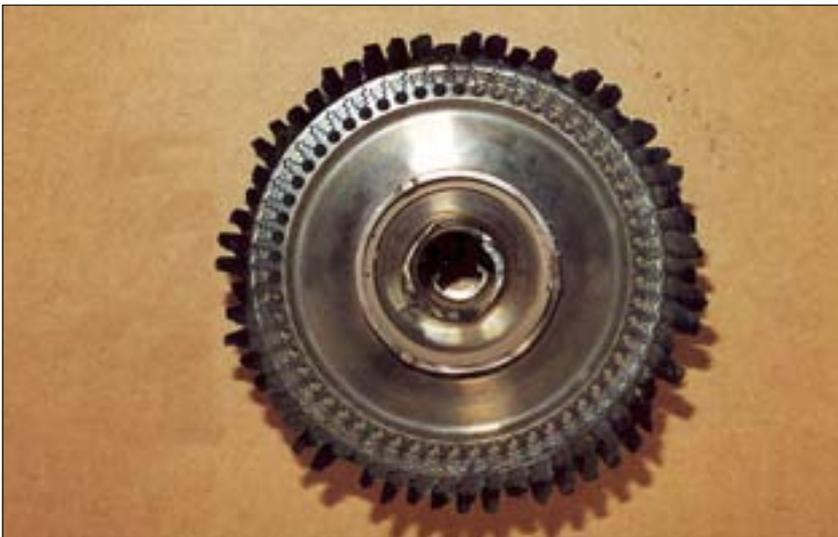
**FIGURE 11:**  
LQH left engine compressor turbine assembly

The central event in this accident was the failure of the left engine, which was the 'critical' engine on the aircraft in terms of aircraft performance considerations. Examination of the left engine showed internal damage that was consistent with the fracture and release of one or more compressor turbine blades into the engine gas path, resulting in a significant reduction in power from the engine. There were no indications that the engine failure was due to manufacturing defects, metal fatigue, foreign object damage during the flight, or the quality or quantity of fuel on board the aircraft. Examination of the compressor turbine blades indicated that they had been exposed to higher than normal operating temperatures in the period leading up to the accident.

The pattern of evidence suggested that a problem with the efficiency of the cold section of the engine probably led to temperature-related damage to the compressor turbine blades, which probably resulted in the failure of one of those blades. However, some other explanations for the failure, such as a previous hot start leading to or exacerbating the temperature-related damage, could not be discounted.

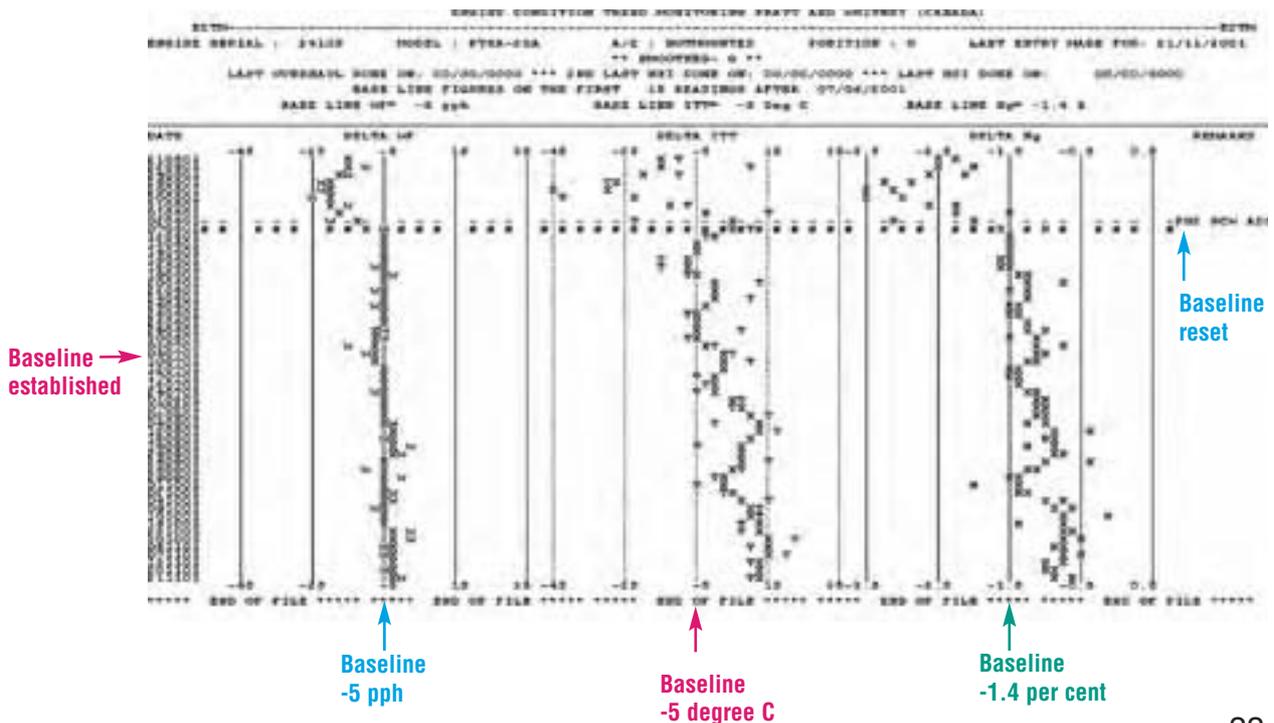
**FIGURE 15:**  
Left engine ECTM data

The delta Ng trend line followed a similar pattern to the delta ITT trend line. It reached 0.5 per cent above baseline by 12 September, and reached 0.75 per cent above the baseline by late October. There was a small increase over time in the trend line for Wf.

The data patterns for the left engine showed a temporary decrease in delta ITT and delta Ng in late September/early October. The data pattern for the right engine showed a similar trend, with a temporary decrease in delta Ng and ITT remaining constant. The investigation noted that the data recorded for 1 October provided values for delta ITT and delta Ng for both engines that were very low compared to other values for these parameters in the weeks before and after this date.

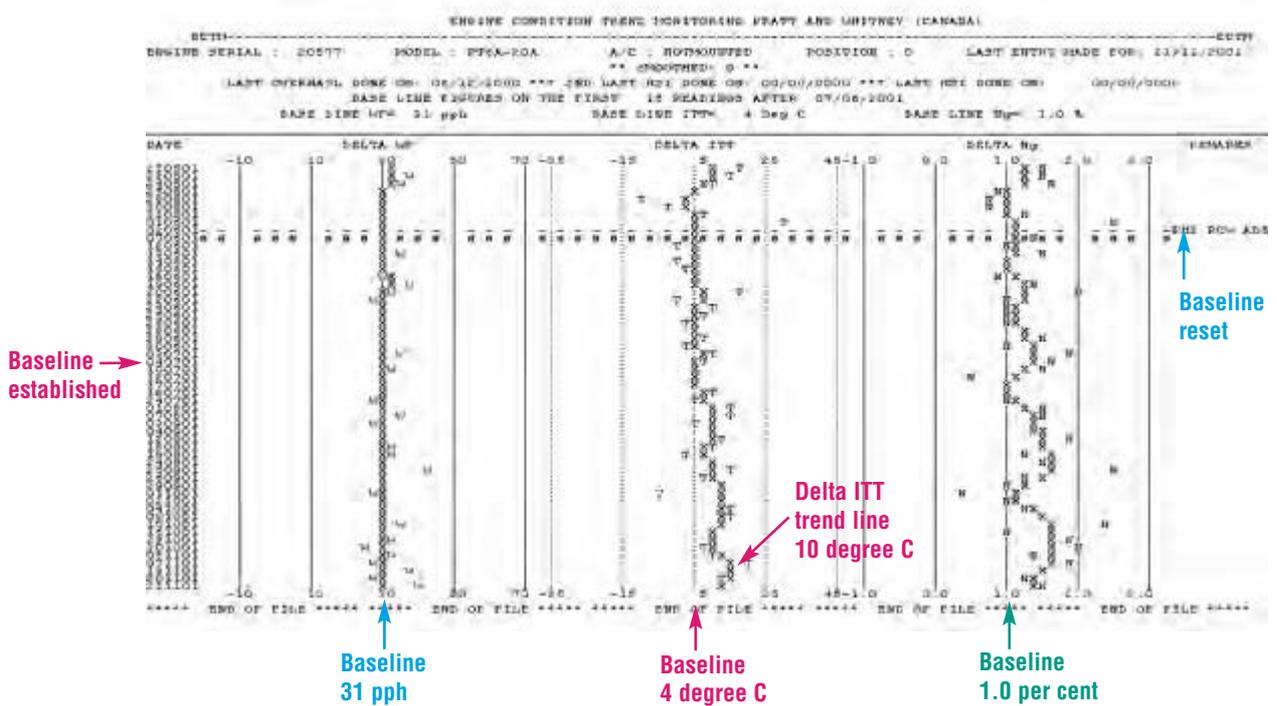
**FIGURE 16:**  
Right engine ECTM data

The data pattern for the right engine showed a gradual increase in the delta ITT trend line, which reached 10 degrees above baseline in November 2001 (see Figure 16). The delta Ng trend line was variable, but also appeared to show an upward trend over time and had values of over 0.5 per cent above baseline in November 2001. There was no change in the Wf trend line.
