**ATSB TRANSPORT SAFETY INVESTIGATION REPORT**

Aviation Occurrence Report – AO-2007-001

Preliminary

**Microburst event  
Sydney Airport, NSW  
15 April 2007  
VH-OJR  
Boeing Company 747-438**

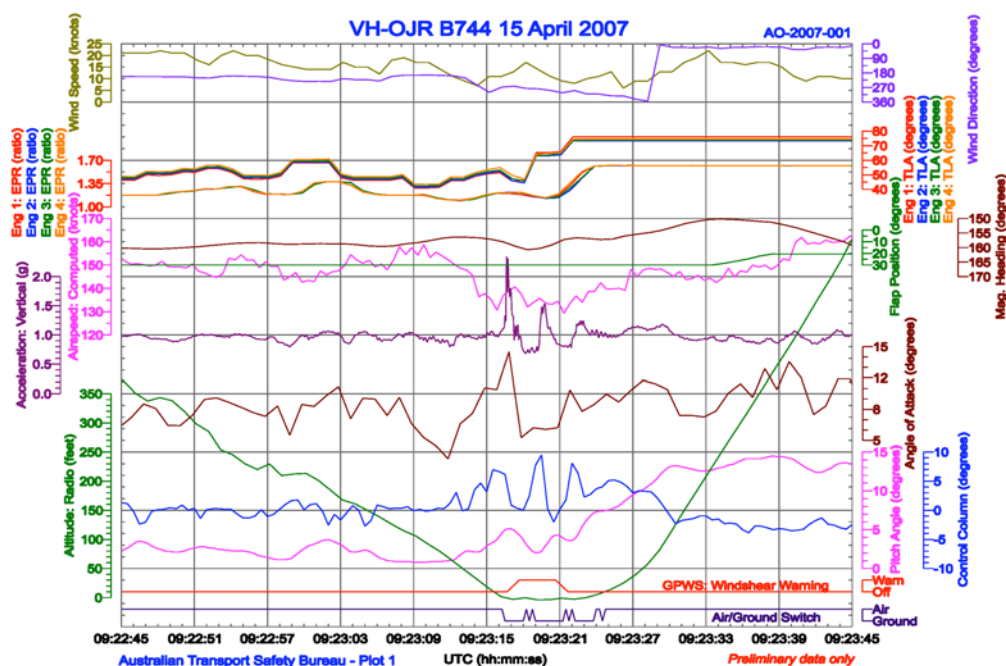
Figure 1: Preliminary QAR data plot

2 The maximum vertical acceleration recorded by the aircraft recorders (see Figure 1) was above the value at which a hard landing maintenance inspection was required.

The maximum vertical acceleration recorded by the QAR at the initial touchdown was 2.34 g.

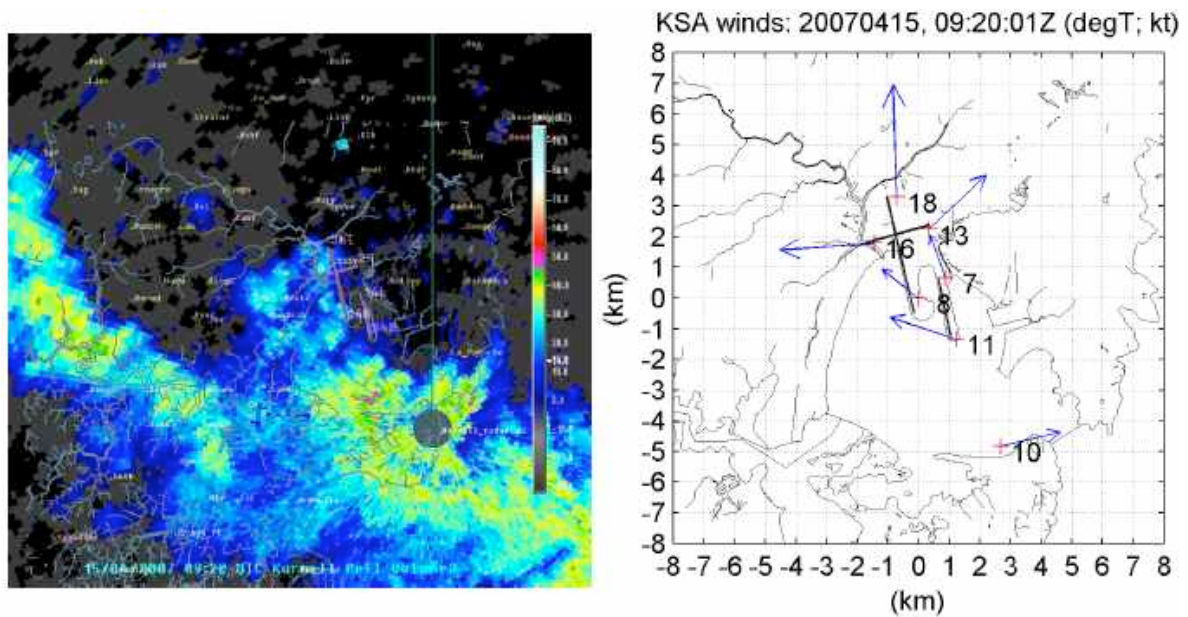
**Figure 2: Doppler radar and threshold winds at 1920:01**

At 1920, the leading edge of the line of showers and storms was over the aerodrome, and the anemometer data showed an intensifying divergent flow over the threshold of runway 16R, which was associated with a developing microburst.

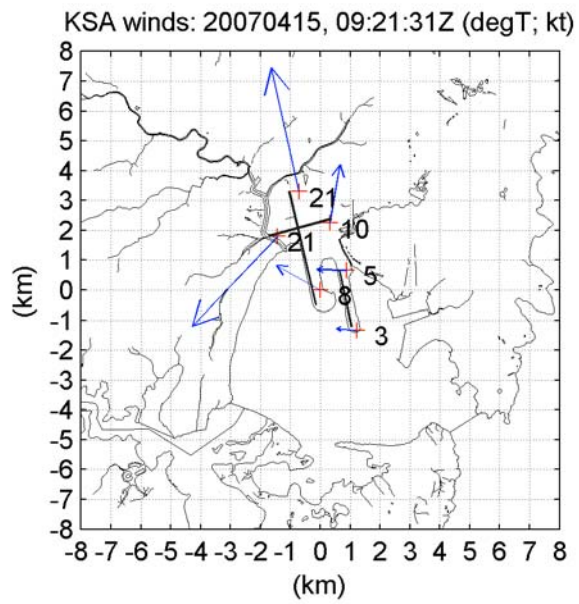
**Figure 4: Threshold winds at 1921:31**

The microburst over the threshold of runway 16R was most intense between 1921:31 and 1922:01.

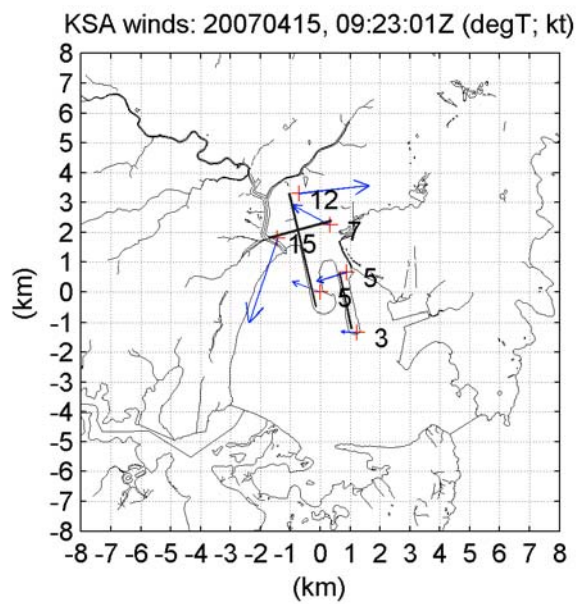
**Figure 7: Threshold winds at 1923:01**

At 1923:01, the wind at the threshold had changed to a westerly at 12 kts, suggesting that the microburst had moved to the west of the runway 16R threshold.
