**ATSB TRANSPORT SAFETY INVESTIGATION REPORT**

Aviation Occurrence Investigation – AO-2007-013

**Engine power loss – 91 km E Hamilton Island, Qld**

**Bell Helicopter B206B**

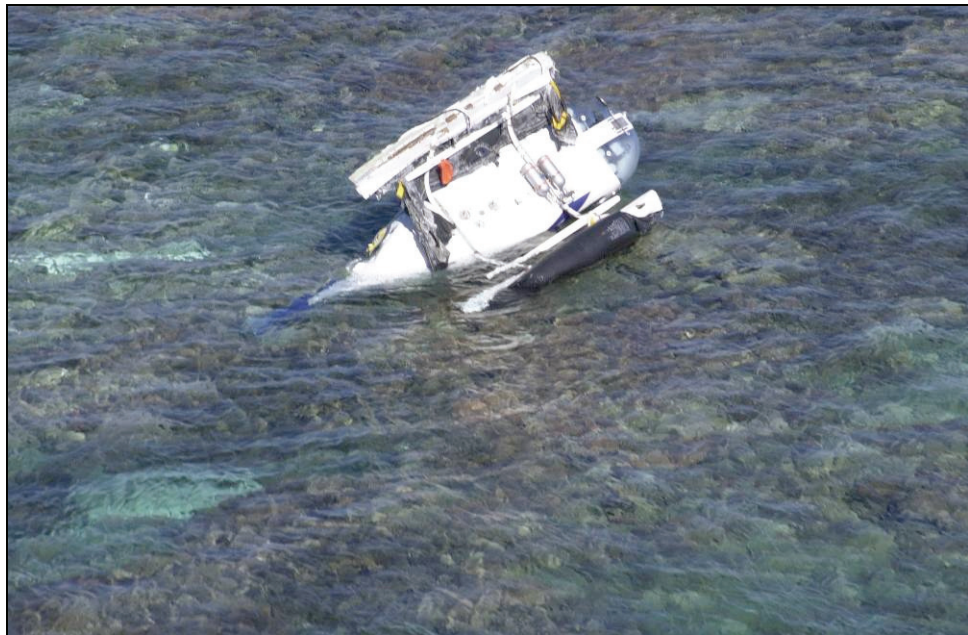
**Figure 2: The helicopter when located near Rafter Reef**

On 7 July 2007, an Australian Customs Service Coastwatch aircraft overflew and photographed the semi-submerged helicopter, which was located at a position of 19°37'00" S 149°38'00" E (near Rafter Reef). The flight crew reported that one emergency pop-out float was completely deflated and that the opposite side float was partially inflated (Figure 2).

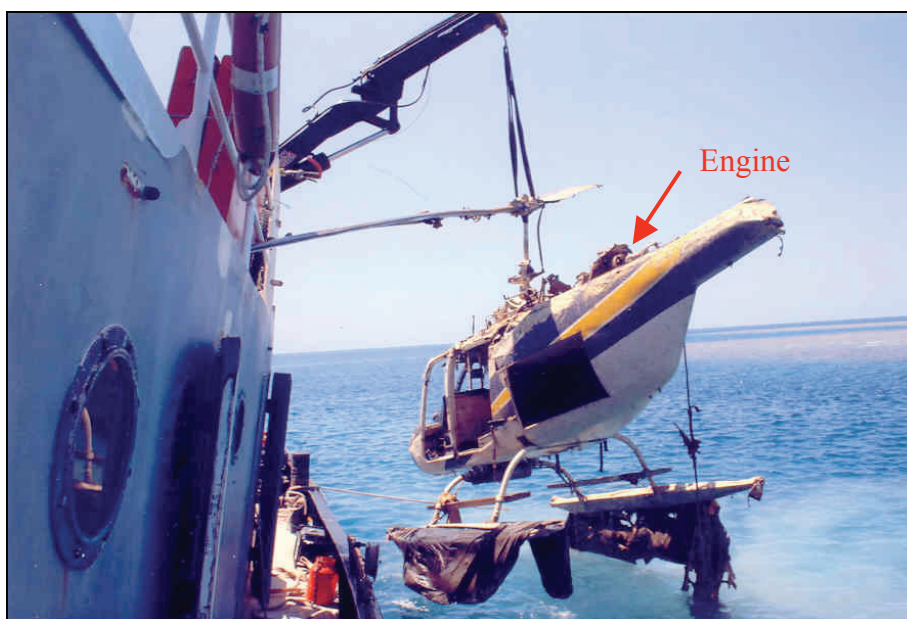
**Figure 3: Recovered helicopter wreckage**

On 26 September 2007, a salvage organisation working on behalf of the helicopter insurers salvaged the helicopter. Damage to the airframe, engine and all components was extensive because of salt-water immersion and exposure (Figure 3).

Because of the prolonged salt-water immersion and ensuing corrosive damage to the engine and its components, the investigation was unable to examine or test the engine or its ancillary components. Therefore, the investigation was unable to determine the reason for the engine power loss.
