**ATSB TRANSPORT SAFETY INVESTIGATION REPORT**

Aviation Occurrence Investigation – AO-2007-014

**VFR into IMC**  
**83 km north-east of Broome Airport, WA**  
**20 June 2007**  
**VH-NRT**  
**Cessna Aircraft Company C208 Caravan**

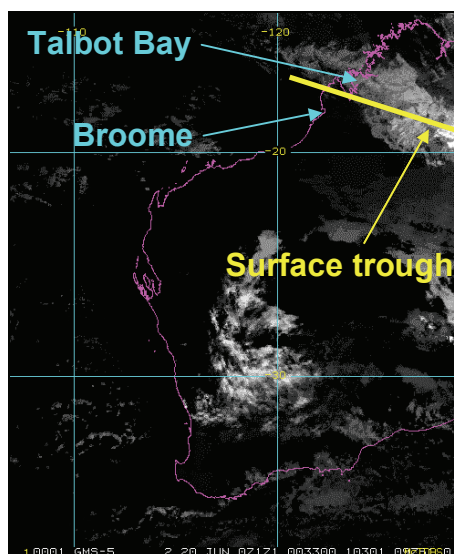
The Bureau of Meteorology (BoM) advised that, at the time of the incident, a surface trough that was orientated north-west to south-east was located about 130 km to the north-east of Broome, across the intended flight path (Figure 2).

**Figure 2: Infrared satellite picture at 0830, showing the main cloud band and associated widespread areas of low cloud.**

The overnight passage of a cloud band and associated area of rain increased the humidity throughout the area, creating an environment conducive to widespread areas of low cloud (Figure 2) and isolated showers.
