ATSB TRANSPORT SAFETY REPORT

Aviation Occurrence Investigation AO-2007-061

**Collision with water (VFR into IMC)
Approx 24 km SE Inverloch, Vic.
17 November 2007
VH-CHU
Cessna Aircraft Company C337G**

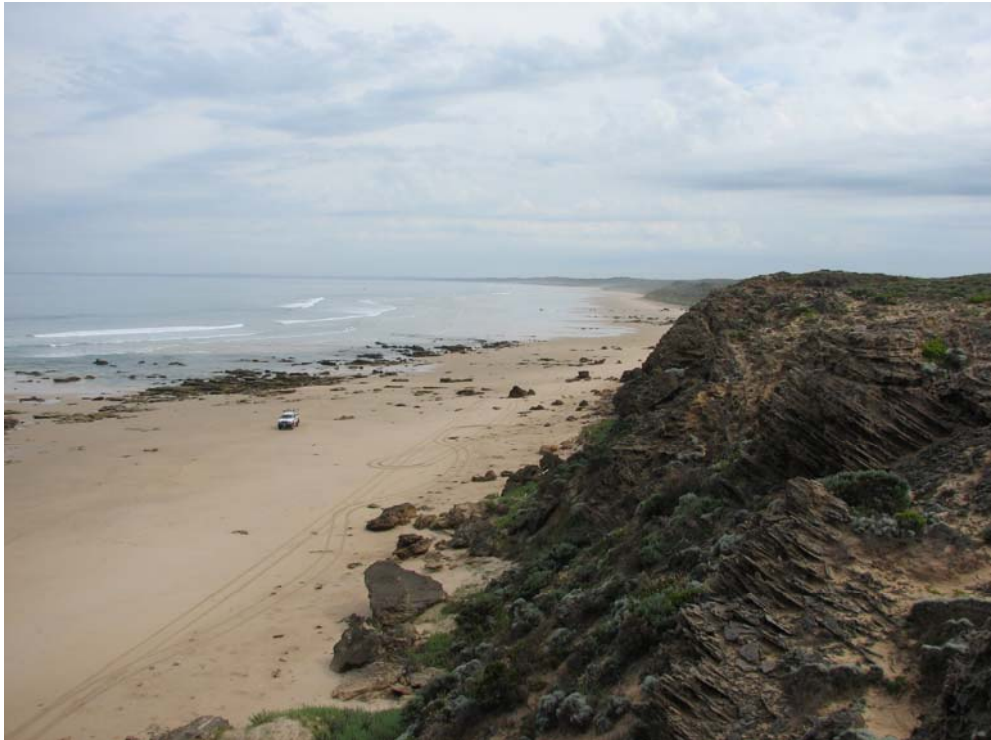
The only sighting south or east of Venus Bay likely to be the aircraft was shortly after 1238 by two people on the beach about 13 km south-east of Venus Bay (Figure 2 and 3). They reported that they heard and then suddenly saw the aircraft coming from the Venus Bay direction. The aircraft emerged from fog at low level and was flying above the water line on the beach with the wings level. Within seconds it turned right to head out to sea. It turned through about 90 degrees at a steep angle of bank while maintaining height before disappearing from sight into the fog. The witnesses reported no apparent problem with the engines and the aircraft appeared to be under control. About 2 seconds after the aircraft disappeared from view, they heard a 'bang'. Witnesses did not hear any further noises that could be associated with the aircraft.

Figure 2: View along beach towards north-west and Venus Bay. (Vehicle is located at approximate witness position)

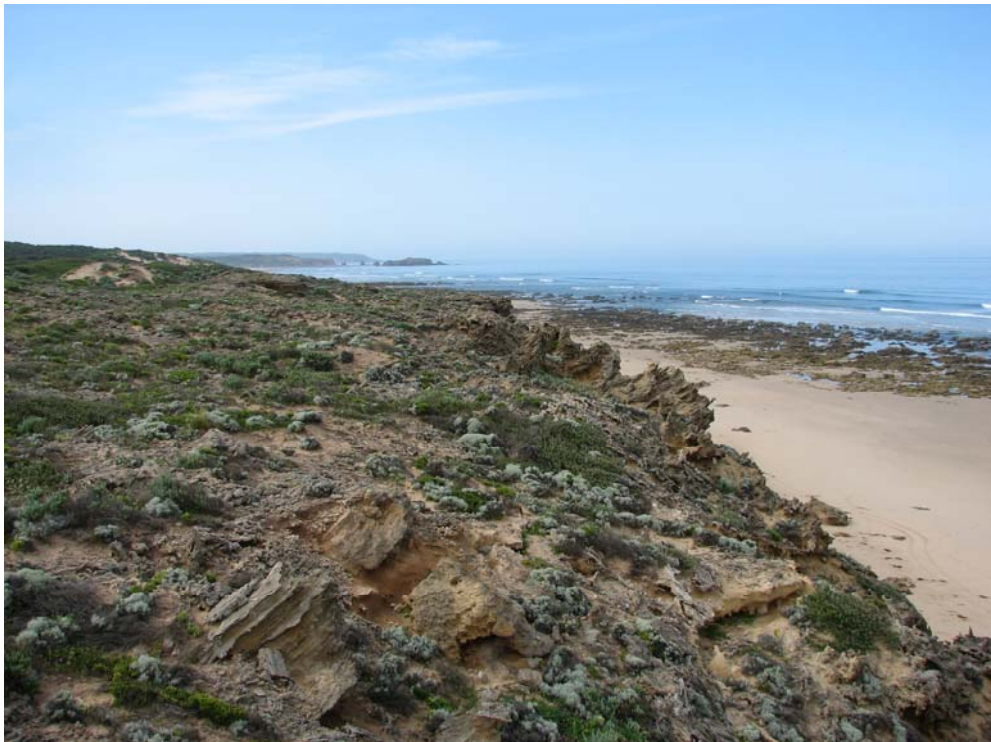
Figure 3: View along beach to the south-east (From position adjacent to witness location)

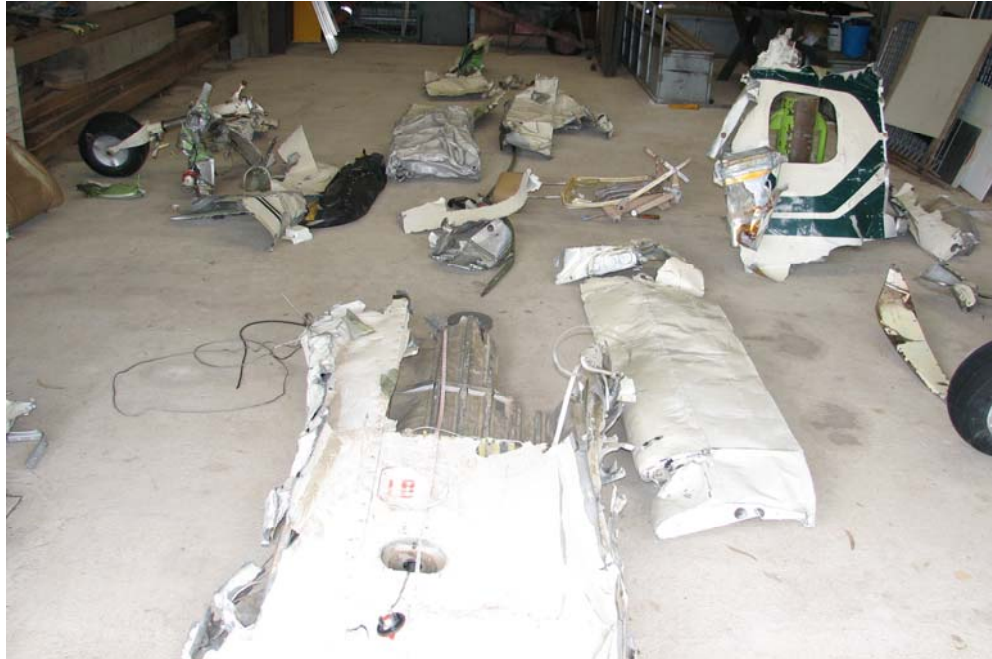
Figure 4: Wreckage loosely assembled in aircraft configuration

On 19 February 2008, investigators examined all the wreckage found to that date. The wreckage comprised about 2/3 of the airframe, including most of the left wing, about half of the right wing, right vertical fin, landing gear and parts of the fuselage and tail section.

All of the pieces of recovered wreckage were bent, twisted or torn, consistent with gross overload failure. There was no evidence of any pre-existing fatigue, corrosion or any other defect that could have contributed to the accident. The electric flap actuator was in the flap-retracted position. The landing gear had separated from the fuselage and it was not possible to establish if the landing gear had been extended or retracted at the time of impact with the water.

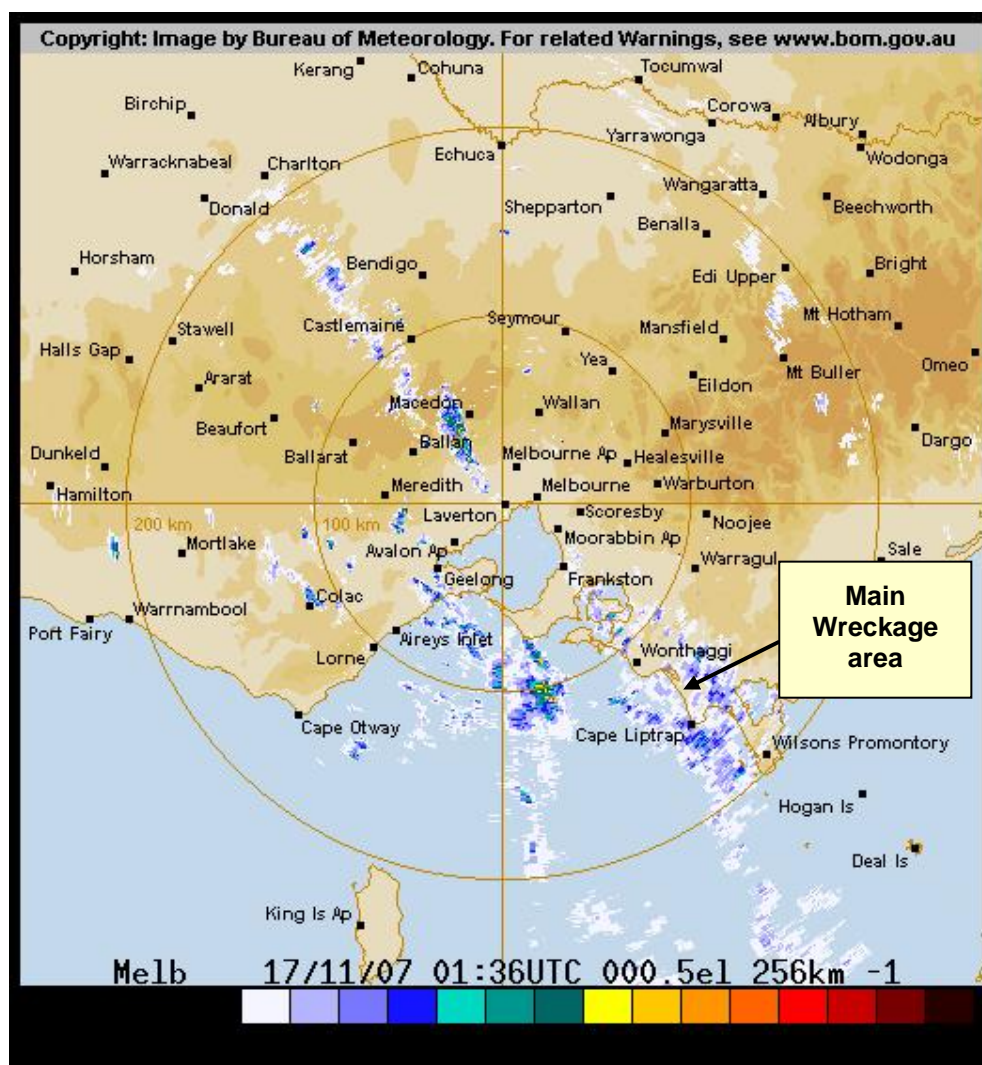
The Bureau of Meteorology produced a visible satellite picture (taken at approximately 1233) and radar imagery from the Melbourne Airport radar (Figure 6). The images show a band of scattered showers affecting the area between Wonthaggi and Wilson's Promontory between 1200 and 1300.

Figure 6: Weather radar image captured at 1236
