**ATSB TRANSPORT SAFETY INVESTIGATION REPORT**

Aviation Occurrence Report – 200601640

Interim Factual

**Collision with terrain  
4 km ENE Archerfield Aerodrome, Qld  
31 March 2006  
VH-BST  
Amateur built Lancair 320**

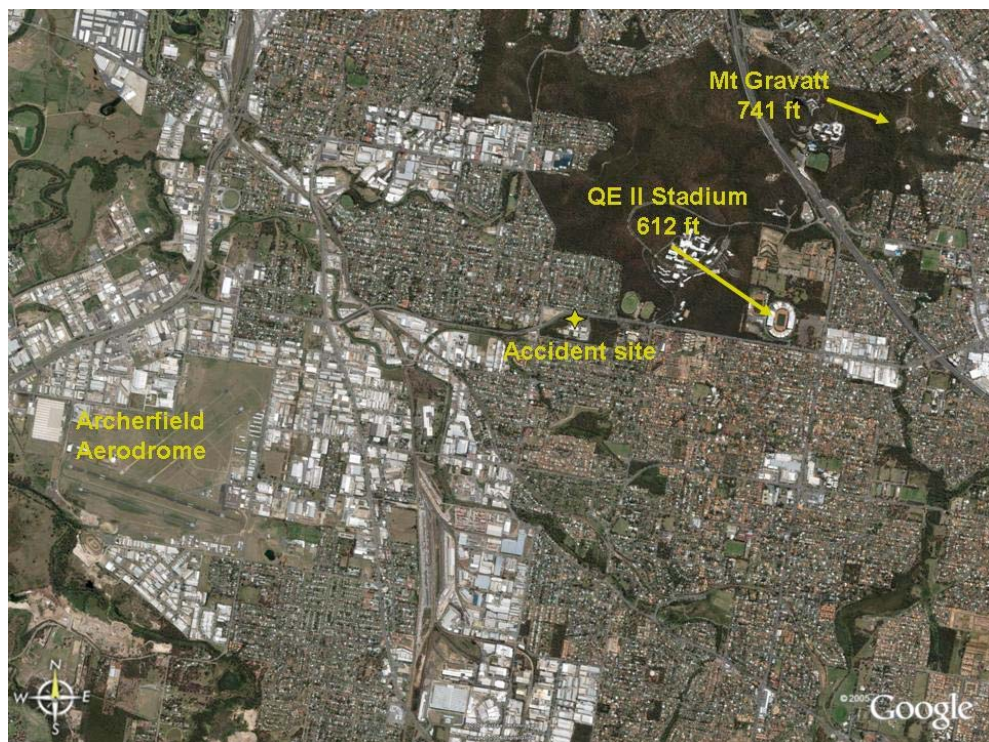
**Figure 1: Accident location**

A witness located about 4 km north-east of Archerfield aerodrome saw the aircraft fly low over her house in straight and level flight tracking east-north-east towards the Queen Elizabeth II Stadium (612 ft AMSL) and Mt Gravatt (712 ft AMSL) (see Figure 1). She reported that as she watched the aircraft fly away from her, she heard the engine noise stop. The aircraft's left wing then dropped and it appeared to enter a spin to the left. Another witness, who was working in the grounds of the Queensland Health Scientific Services facility, reported seeing the aircraft flying straight and level, and low, directly towards him. He said the engine noise did not miss or change pitch. He then saw the aircraft bank right, then flip onto its left side and descend straight down, colliding with a tree and then a creek running parallel to Kessels Road, Coopers Plains.

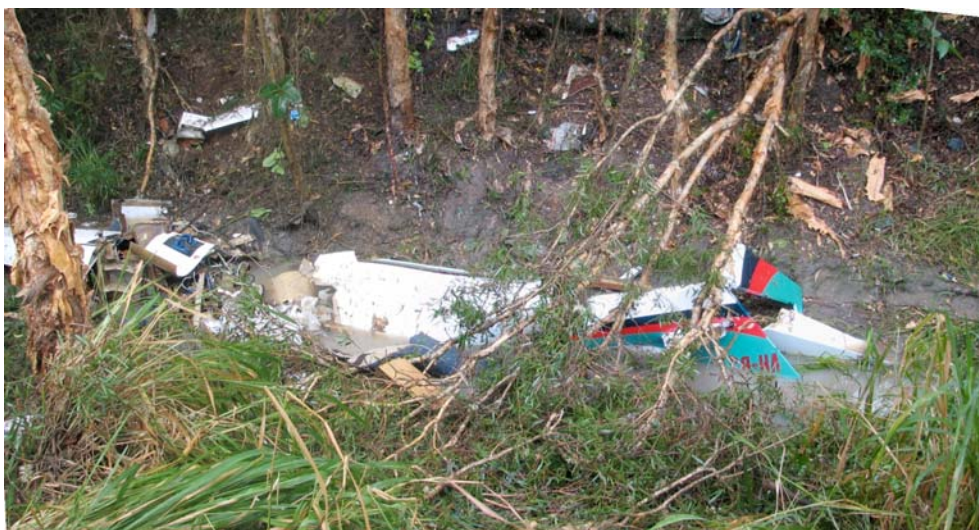
**Figure 2: Accident site**

The accident site was near the northern boundary of the grounds of the Queensland Health Scientific Services facility. The aircraft initially collided with trees before coming to rest in a creek. Most of the aircraft components were located in or on the banks of the creek, with a few components recovered from Kessels Road (see Figure 2).

- the aircraft was in a steep nose-low, near vertical pitch attitude at the initial impact point
- damage to the propeller was consistent with the engine delivering power at the time of impact
- the frangible plastic drive shaft of the engine-driven vacuum pump was intact
- there was no evidence of any pre-impact structural or flight control defects
- the wing flaps were positioned at the cruise flight setting of -7 degrees<sup>4</sup>
- the aircraft altimeter subscale was set to 1015.

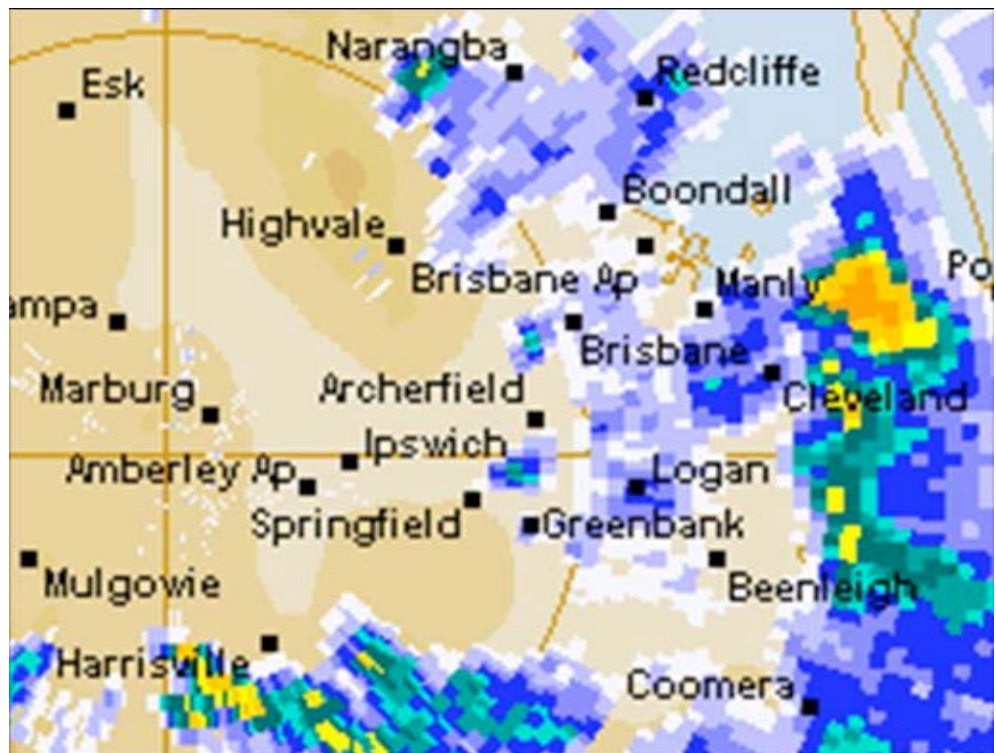
Figure 3: Weather radar image at 1050

Weather radar information provided by BoM showed that a band of moderate rain passed over Archerfield, moving east, at about 1000. At the time of the accident, the weather radar showed areas of light rain to the east of the aerodrome (see Figures 3 and 4).
