RAIL SAFETY INVESTIGATION
2004/001

Near collision between stationary
Coal Train LD166
and an empty
Endeavour Passenger Train D743

Sandgate, New South Wales
25 February 2004

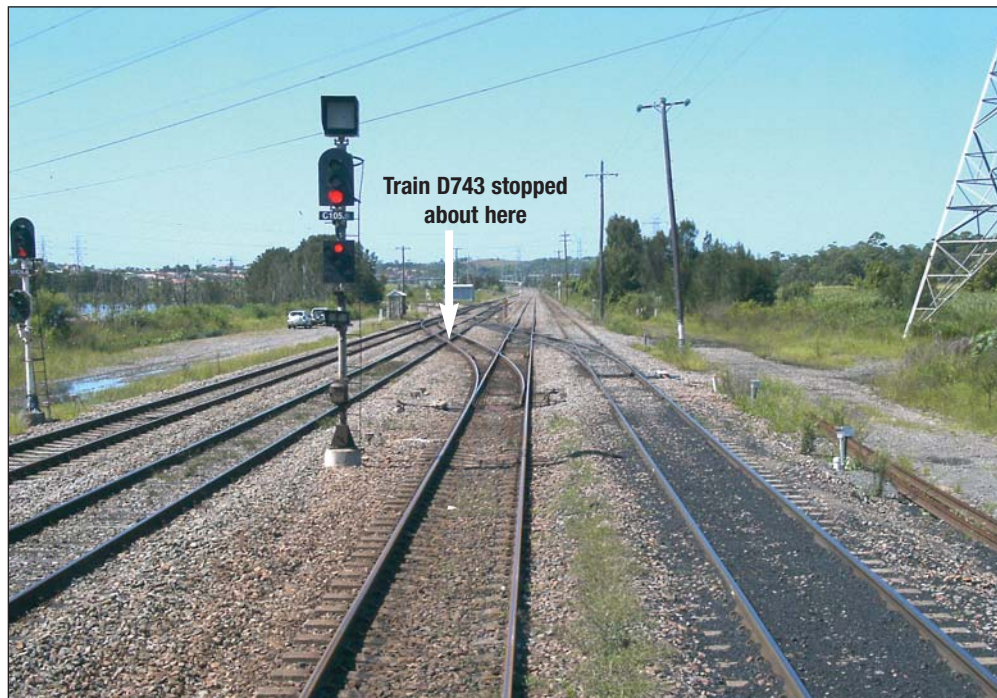
FIGURE 2: Representative driver's view from train LD166 (157 points in normal position)

The crew of train LD166 had noticed the unusual movement of train D743 on the Up Main line. The crew then realised that the points were in the incorrect position (reverse) and that train D743 did not appear to be slowing down. The crew became aware of the imminent collision and immediately evacuated the crew compartment of the leading locomotive 9001 of train LD166. As the crew were leaving the train they realised that train D743 was going to stop short of their train so they returned to the locomotive to contact Hanbury Junction signal box.

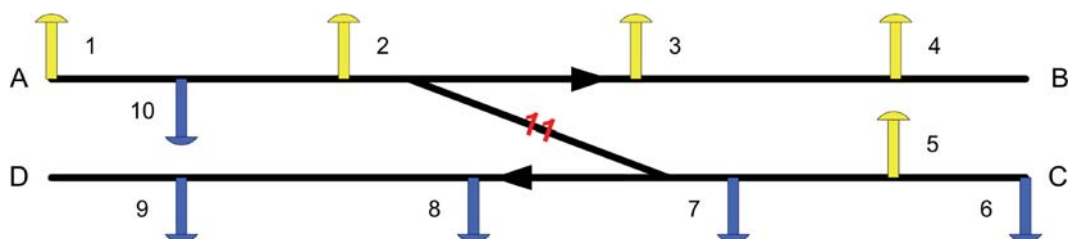
FIGURE 4: Example of push button panel

The signal box contains a signalling panel used to manipulate signals and points within the area bounded by Waratah and Tarro, a section of 12.7 kilometres. The main signalling panel consists of an indication board¹¹ and manipulation¹² panel. A secondary panel for the Hexham area is a combination of both indication and manipulation functions. Both panels are operated by push/pull buttons (eNtrance-eXit [NX]). To set a route for a train the signaller would press the ‘start/entry’ button and then press a ‘finish/exit’ button to select a route. The selected route is illuminated by white lights on the indication board. The interlocking system proves the system to be safe, and if it is, the points move and signals indicate proceed for the selected route. For example in figure 4, if a train wanted to travel from A to B the signaller would select the route by pressing button 1 to start then press button 2 to finish, then likewise from buttons 2 and 3 then 3 and 4, until all the signals would indicate proceed. If the train wanted to travel from A to C the signaller would select the route by pressing buttons 1 and 2, then 2 and 5. The points numbered 11 would move to the reverse position and the protecting signal would indicate proceed.

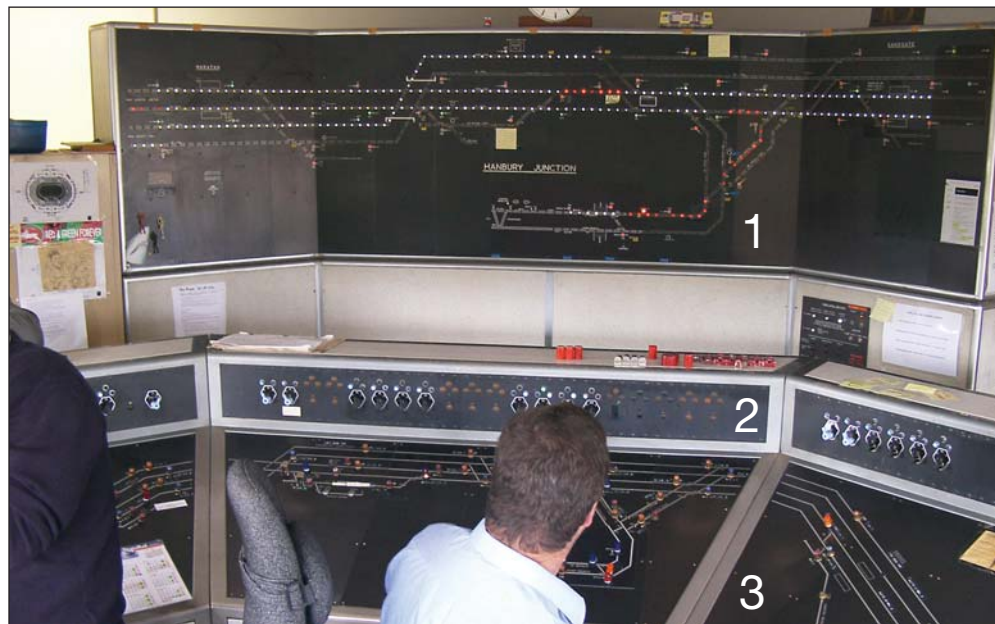
FIGURE 5: Hanbury Junction signal box signalling panel layout

The design of the signalling panel is such that it divides the attention of the signaller by up to three ways in emergency conditions (degraded working). Figure 5 shows the location and separation between the indication board (number 1 in the background) and the manipulation panel (number 3 in the foreground). Also contributing to the physical separation for the signaller, the clusters of rotary point switches¹³ (number 2) are located on the panel not in the vicinity of the corresponding points.

During normal train operations, the signaller interprets information from panel 1 and analyses and scales the information to an action on panel 3. During times of heavy workload, such as emergency conditions or degraded operating conditions, the signaller analyses both sets of information from panels 1 and 3 and takes action by using the rotary point switches on panel 2 to set routes for trains.

The main signalling panel exhibits poor spatial compatibility between the three panels shown in figure 5. The Australian Standard SAA HB59-1994, Ergonomics – A human factor, states:

- When the signalling system is manually operated during degraded operating conditions (i.e., using rotary point switches) there is no visual indication of the route set as there is with the usual NX setting of the routes. Consequently there is little feedback to the signaller indicating whether the points have been set, or whether his actions are correct apart from the indicator lights at the rotary switches. When the NX panel is used, the display of white route lights and the change of a signal aspect to proceed, provides proof that the actions of the signaller and the interlocking are correct. Such confirmation that is absent when under manual operation during degraded operating conditions.

The Australian Transport Safety Bureau recommends that RailCorp review the human interface design of signalling equipment at Hanbury Junction signal box.

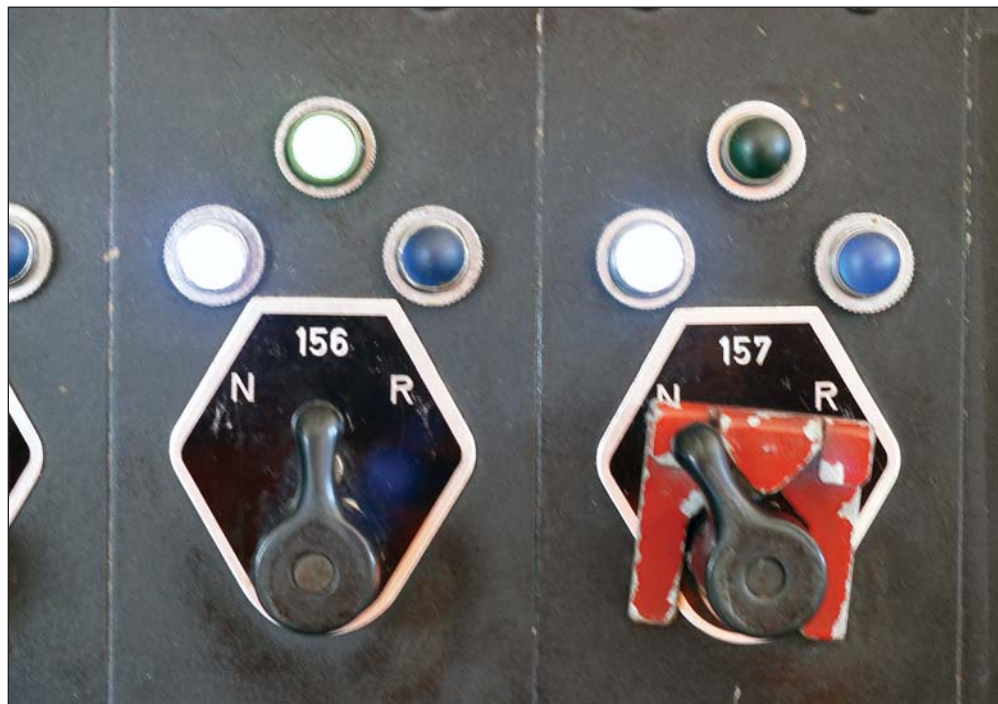
FIGURE 6: Red blocking facility on rotary point switch

Blocking facilities are physical devices used by the signaller on the control panel as memory aids to prevent inappropriate issue of Proceed Authorities, or signalling or point equipment operation. Blocking facilities act primarily as a visual reminder, a form of defence, to protect track sections. Irrespective of whether blocking facilities had been applied or not, the type of error may occur again predominantly due to the lack of defences to protect the system. The signaller applied blocking facilities to the signal entry and exit locations affected by the SPA, but did not block any points. If the signaller had applied blocking facilities to all signals and points systematically whilst checking the route it would have been visibly identifiable as to what had not been checked and protected.

Although the rules/procedures provide information regarding the removal, recording and storage of blocking facilities they do not specify what signals or points need to be blocked to ensure that the above conditions are met. Furthermore, the survey results indicated that 51.1 per cent of respondents did not place blocking facilities on those points and signals that protected the system to the greatest effect. This indicates that a potential defence for the system may not be used to the greatest effect.

The use of blocking facilities takes extra time and once placed should not be removed except where specified by the network rules. Under conditions of high workload and high task demands (i.e. when their role is potentially most critical) this additional task may not be done. It is not clear why the signaller did not use blocking facilities to the greatest effect (heavy workload – forgot, or routine practice) in the current incident. However, had they been used to the greatest effect the error may have been identified and rectified before the system became vulnerable.

The Australian Transport Safety Bureau recommends that RailCorp review and reinforce the use of blocking facilities to the greatest effect through initial and SMS employee training.

The Australian Transport Safety Bureau recommends that RailCorp consider random audits by supervisory staff to review and reinforce the use of blocking facilities to signal operators.

The Australian Transport Safety Bureau recommends that RailCorp consider reviewing the application of blocking facilities to provide effective protection.

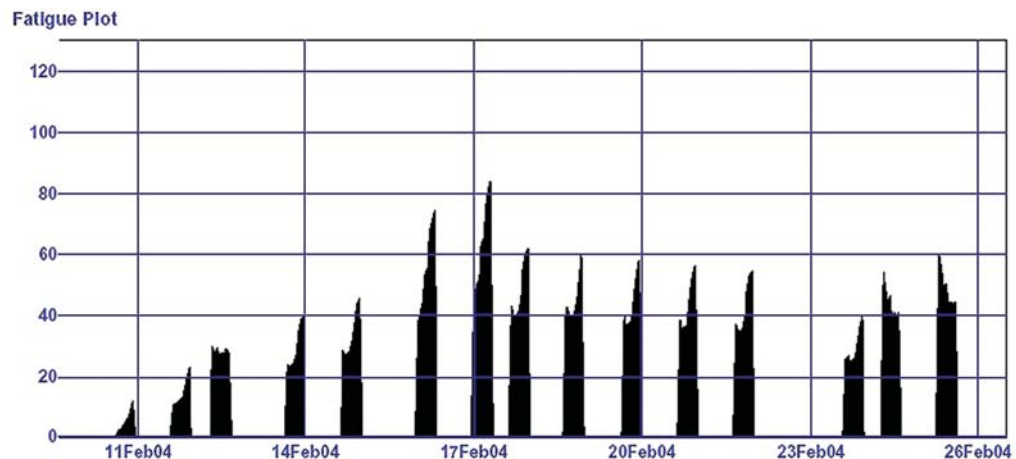
FIGURE 7: FAID results for Hanbury Junction Signaller based on the master roster

The FAID software was used to analyse the signaller's rostered work hours from 10 February 2004 to the time of the incident on 25 February. The FAID program gave a maximum fatigue score of 84.1 at 0700 on 17 February 2004. The signaller's fatigue score at the time of the incident was 43.6.

Based on work hours, and the assumption that the individual's time off duty included an appropriate period of recuperative sleep, the signaller was in the low range fatigue at the time of the incident. However, he told the investigation team that he was also experiencing abnormal sleep patterns.

Whatever the fatigue level of the signaller, based on the FAID rostering principles, the RailCorp master work roster was not considered to be a causal factor in this incident. However, a maximum score of 84.1 on 17 February 2004 is indicative that the RailCorp master roster, prima facie, did not sufficiently monitor and prevent roster-induced fatigue.

The Australian Transport Safety Bureau recommends that RailCorp review fatigue management principles to monitor and prevent roster-induced fatigue.
