**Fatal collision between
passenger train 3C37 and
a Ford Falcon station wagon
at the Hesp Road/Bennett Road level crossing**

**Aloomba
23 May 2003**

SEPTEMBER 2003

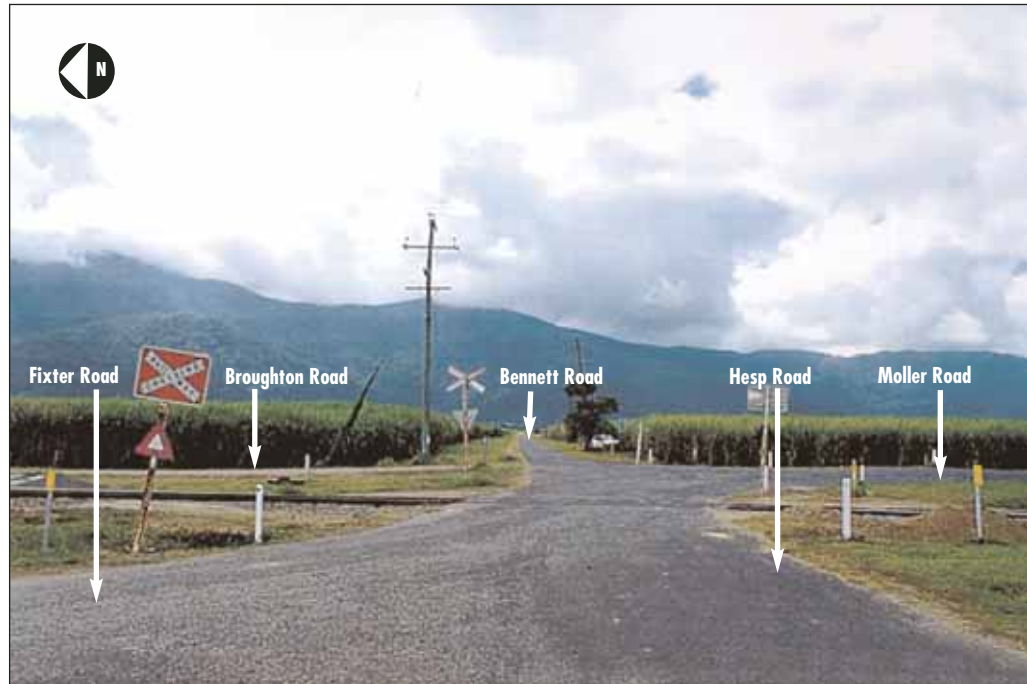
FIGURE 2:
Hesp Road/Bennett Road level crossing at 1651.80 km from Hesp Road

The level crossing at 1651.580 km is about 700 m southeast from the centre of Aloomba. It is also a junction of five roads: Fixter Road runs north of the crossing, parallel with and to the west of the track; Broughton Road north of the crossing, parallel with and to the east of the track; Hesp Road east of the crossing, Bennett Road west of the crossing and Moller Road south of the crossing, parallel with and to the east of the track. Fixter, Hesp, Bennett and Moller roads are paved bitumen roads.

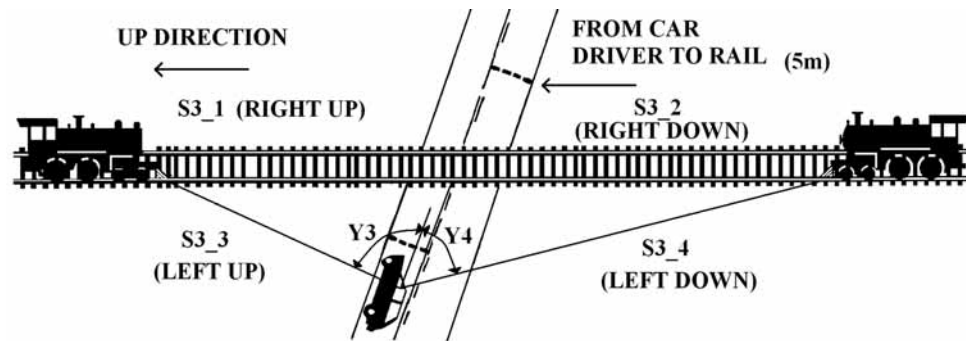
FIGURE 5:
Sighting distance diagram

this accident as the S3_3 taken at a distance of 5m from the nearest rail. S3_3 is the minimum distance of an approaching train from the crossing, so that there is sufficient sight distance for a vehicle driver stopped at the crossing to be aware of an approaching train, and subsequently decide if they can safely cross the tracks as a result of the sight distance. Ability to see is made at a height of 1.15m above the road, (a car driver's eye height), to a target at 2.40 m above the rail centre line, (the height of a train headlight). The sighting distance is recorded as the distance from the driver to the target so that the target can be seen to a maximum allowed angle of 110°. (refer diagram below)

If the assumption is made that a car stops at a stop sign which is placed 3.5 m from the nearest rail and the driver is a further 1.5m from the stop sign (5 m in total from the nearest rail) the application of this requirement for a vehicle travelling from Moller Road to Fixter Road would provide an S3_3 sighting distance measurement significantly less than 480 m. Based on the angle at which road vehicles were observed negotiating the level crossing from Moller to Fixter Roads, an approximate measurement of the S3_3 sighting distance was measured to be about 90 m.

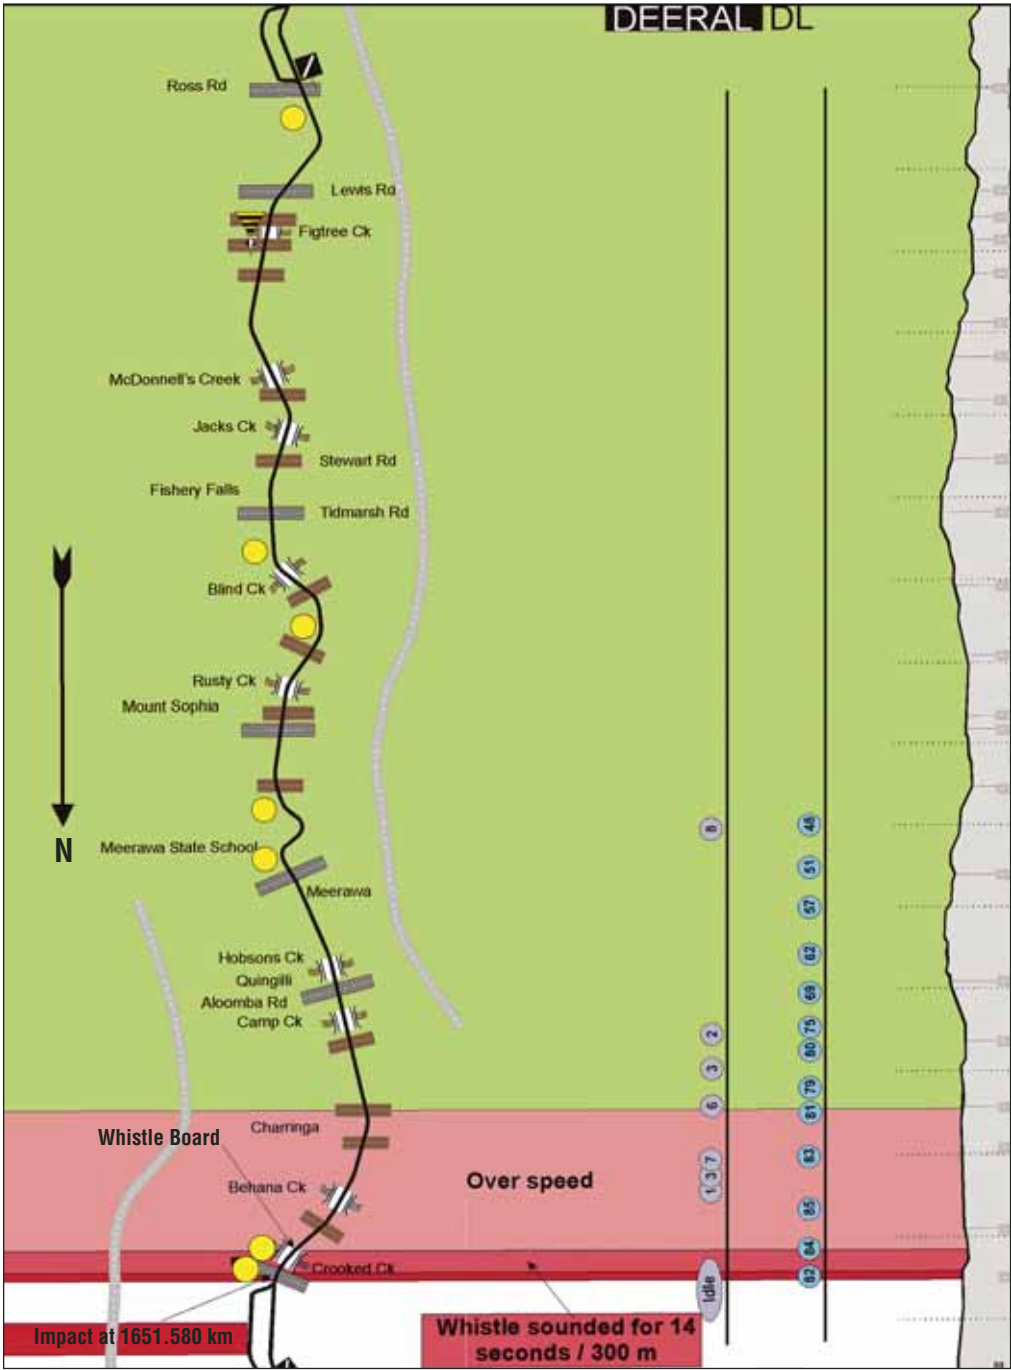
FIGURE 4:
Sequence of events overlay

Emergency braking calculations, based on the mass of the train, speed, gradient and track condition provides a stopping distance of 475 m with a driver delay (reaction time) of 1½seconds, without reaction time the distance is 440 m. Given that the driver went for full service braking prior to emergency, the driver brought the train to a halt within the theoretical emergency stopping distance.

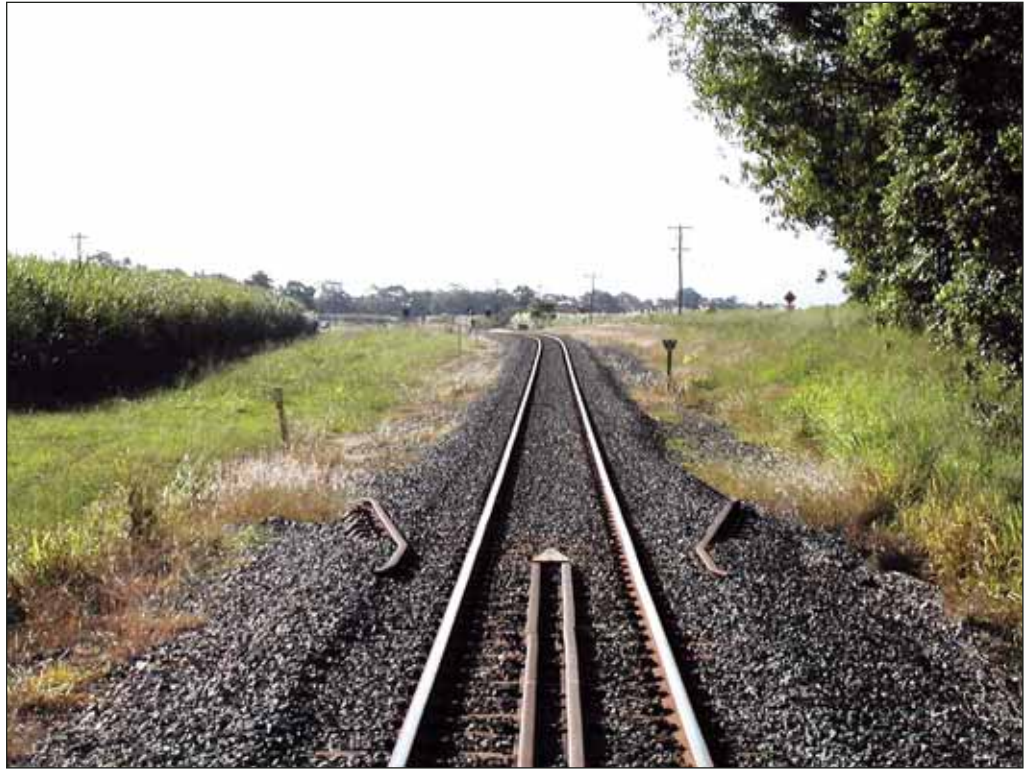
FIGURE 6:
Locomotive driver's view about 300 m from Aloomba level crossing, approx position of first sighting the Ford Station wagon

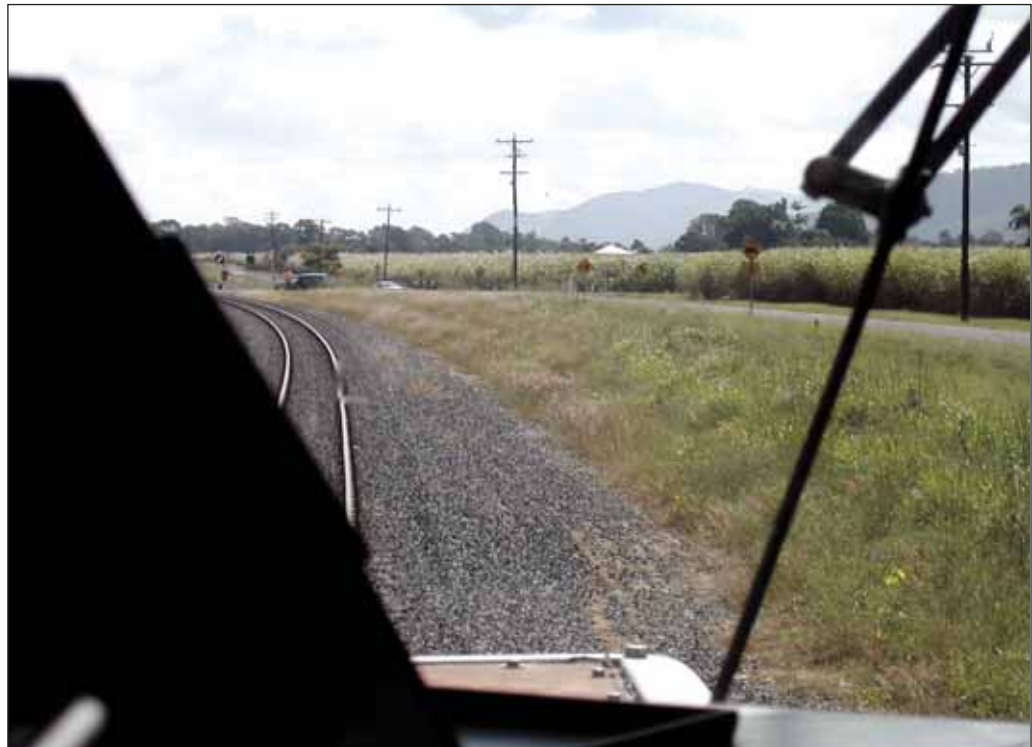
FIGURE 7:
Locomotive driver's view about 180 m from crossing

Note car at crossing

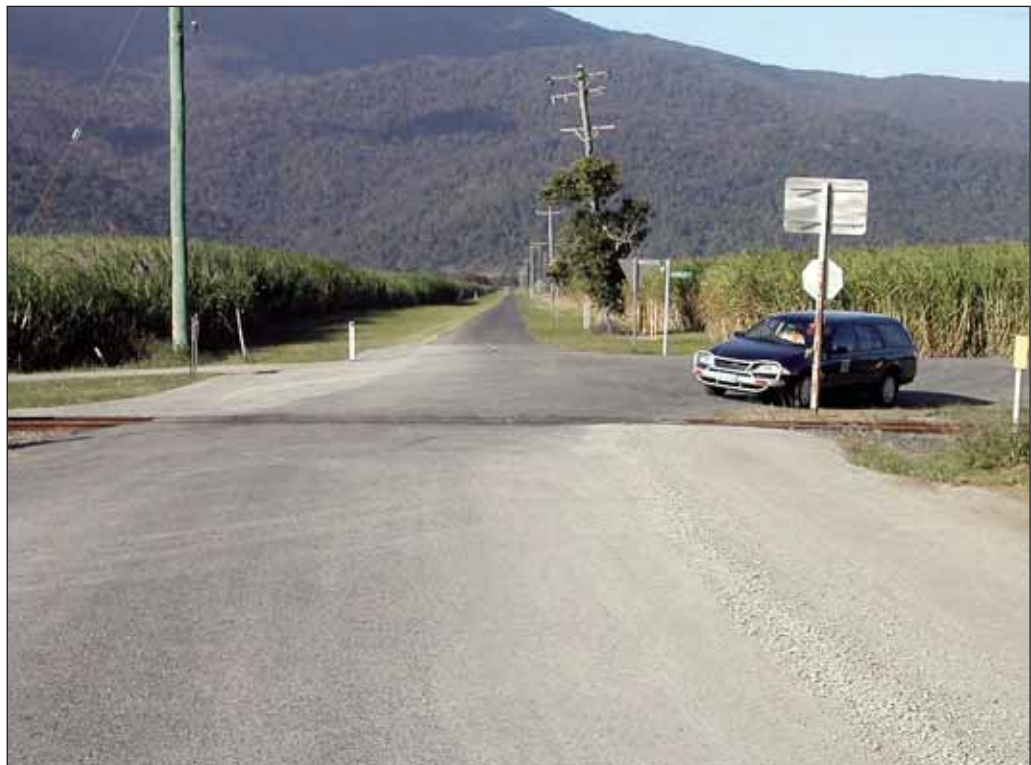
FIGURE 8:

Vehicle stopped at Aloomba crossing, note angle of approach

Note: The signage was changed from 'Give Way' to 'Stop' between July and November 2002

Cars on Moller Road, however would tend to arrive at the stop sign at an angle, particularly if their route took them along Fixter Road. The same would be true for vehicles travelling in the opposite direction. About 20 vehicles were observed negotiating the level crossing from Moller Road onto Fixter Road. All drew up at an angle. This typically made an acute angle of between 60° and 70° to the railway line. The approach angle was very much a function of the road alignment and possibly a lack of visible cues to encourage cars to approach the crossing at right angles. This meant that car drivers had to look to their left at an angle greater than 110° , the result being that the track to the south could be partially obscured by the door pillar, or had to be viewed through the rear driver's side passenger window. The angle that a car arrives at a crossing and the distance from the railway line makes a significant difference in the direct sighting distance of an approaching train.

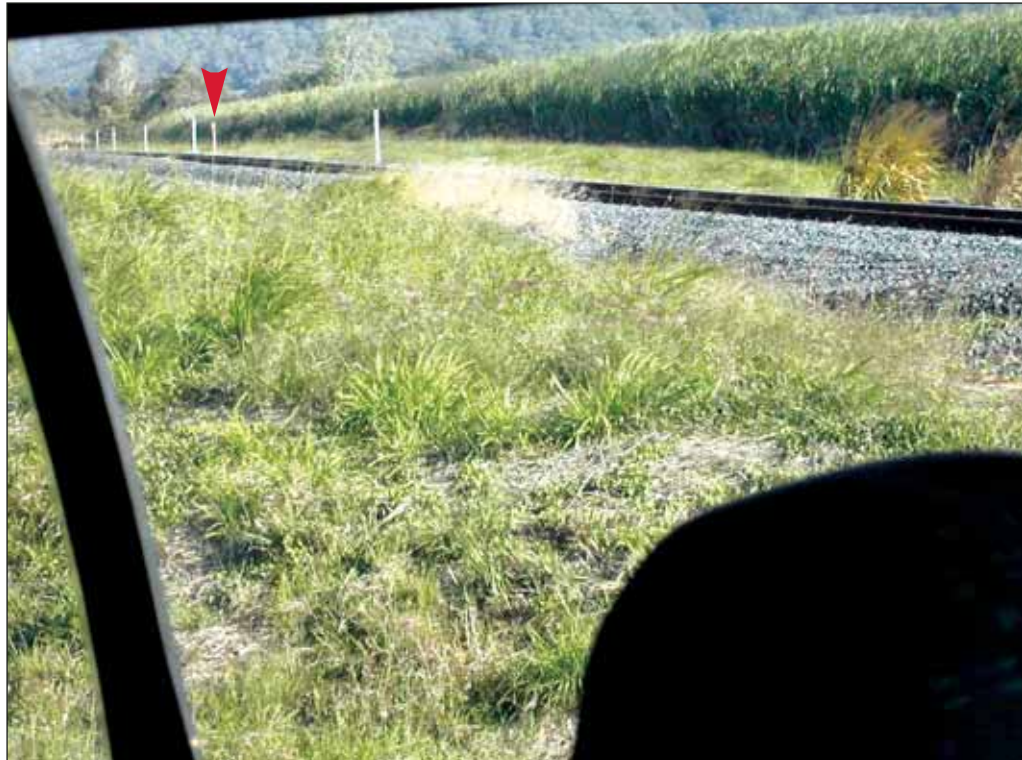
FIGURE 9:

View from road vehicle. Driver's side from Moller Road looking in Up direction. Red arrow marks about 80 m from crossing, about position of train 3C37 when Ford Falcon station wagon started to cross

- 3.12 To achieve S3 sighting distances of 480m (S3_3) and >700m (S3_2), sighting distances would have been taken at right angles or nearly right angles to the crossing. For a vehicle travelling from Moller Road/Fixter Road due to the angle at which cars were observed to traverse the crossing the sighting distance is significantly reduced.
